# BUILDING INSPECTION REPORT

**Clients:** Paul Phillips & Susan Zimmermann

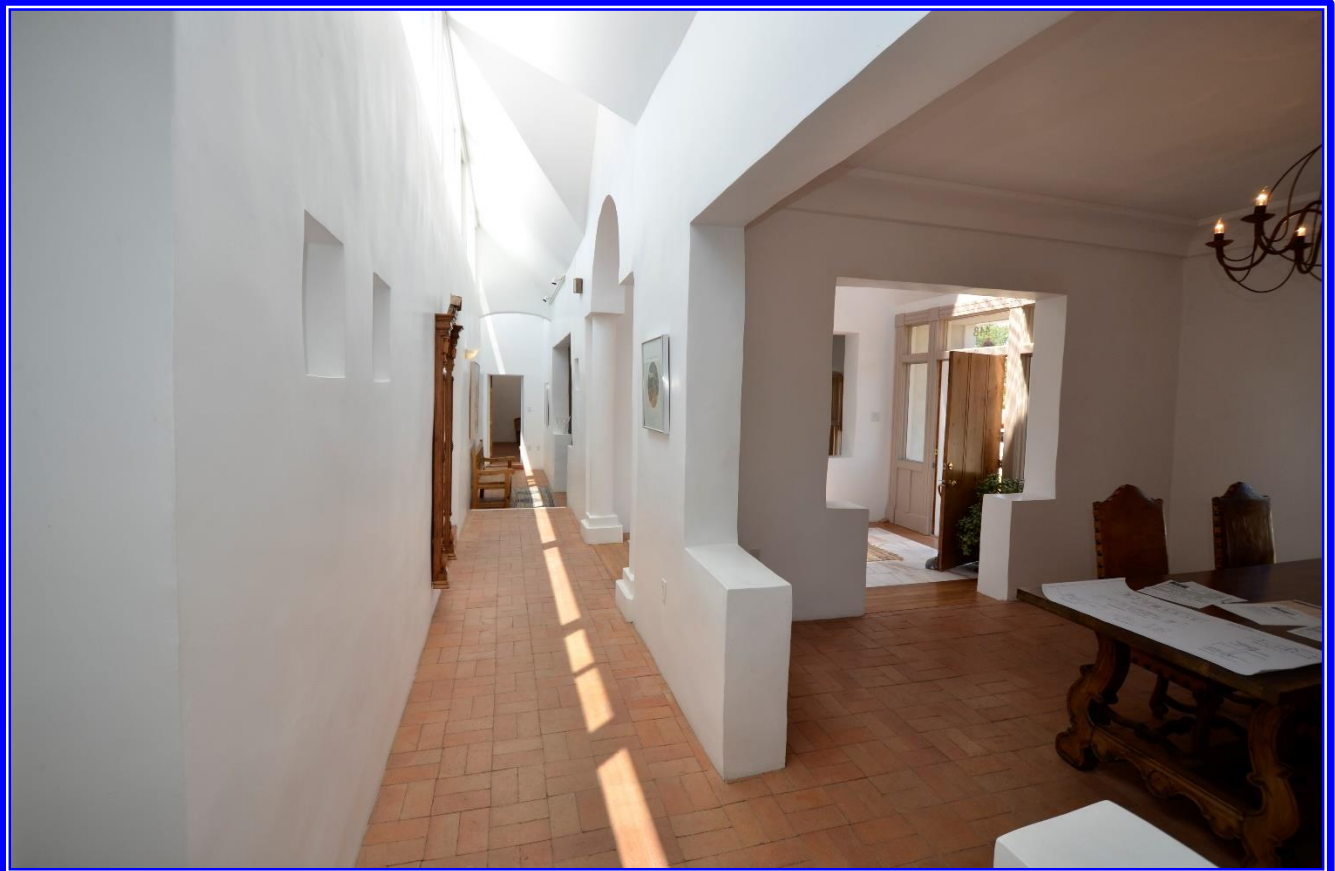
**ACTIVEHOME INSPECTIONS™**

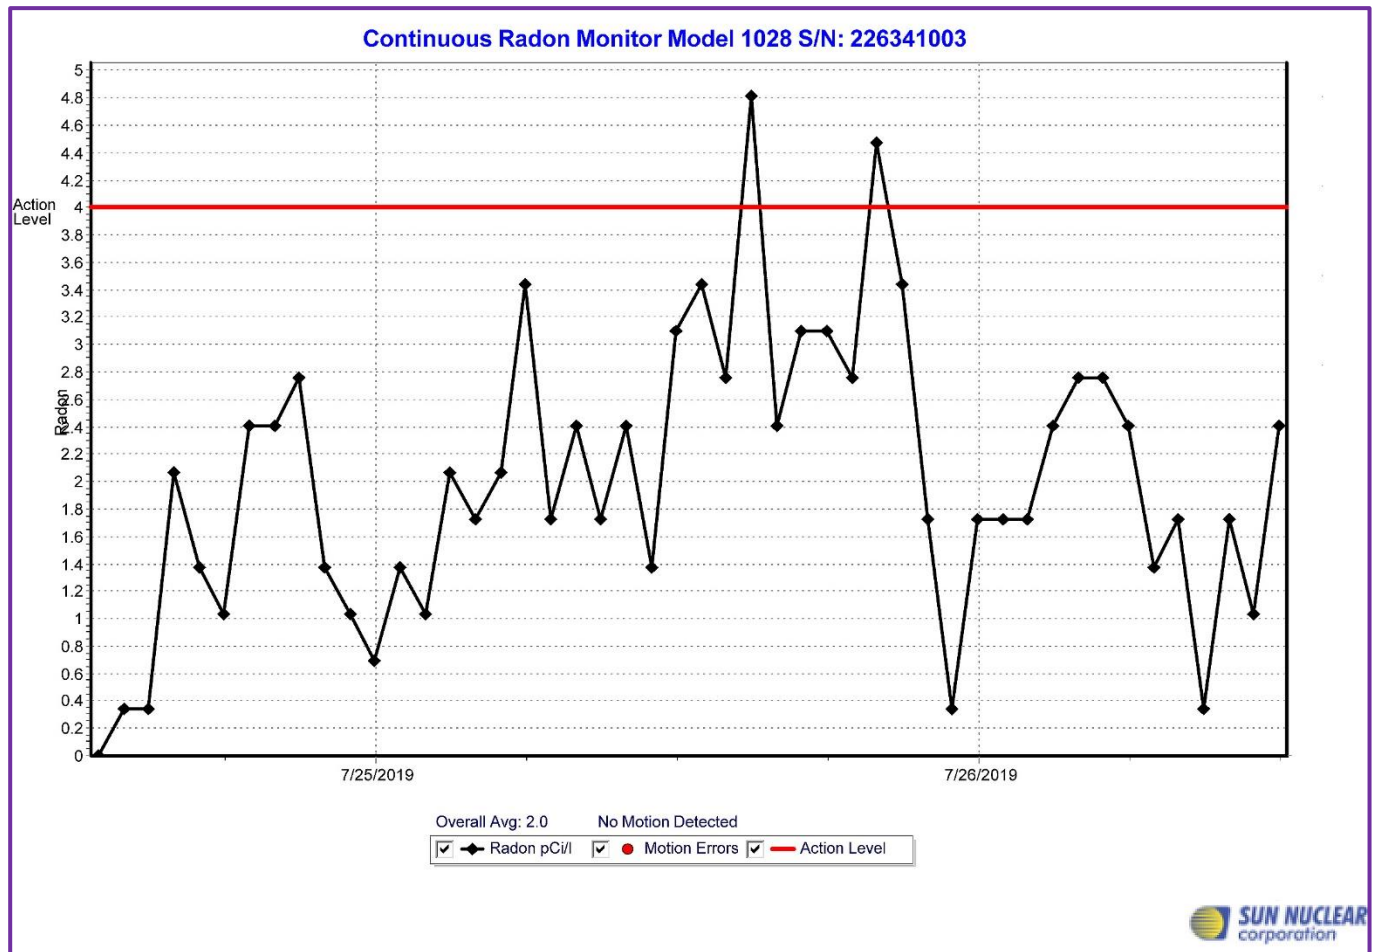
## Gallery of Photographs

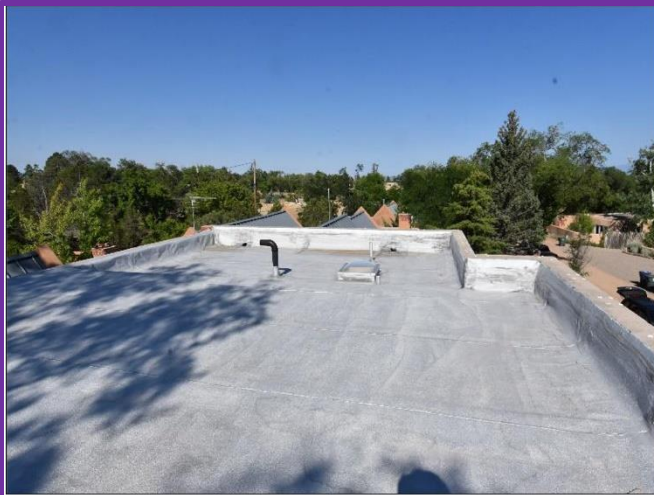
1. Torch-down roof membranes with a recent application of Aluminum fibers coverings on **Main House & Casita** are in Satisfactory Condition.

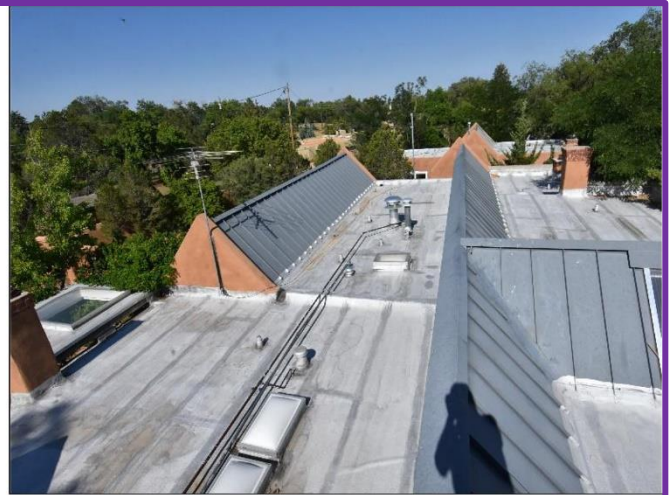
2. Torch-down roof membranes with a recent application of Aluminum fibers coverings on **Main House & Casita** are in Satisfactory Condition.

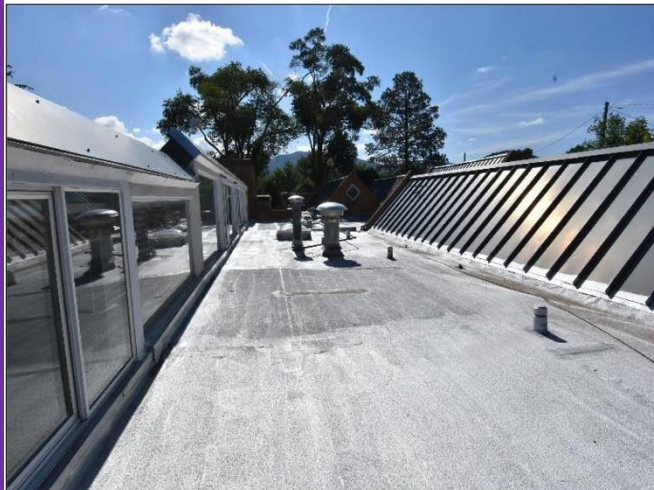
3. Clearstory windows and the high-pitched metal standing roofs are on the **Main House & Casita** are in Satisfactory Condition.

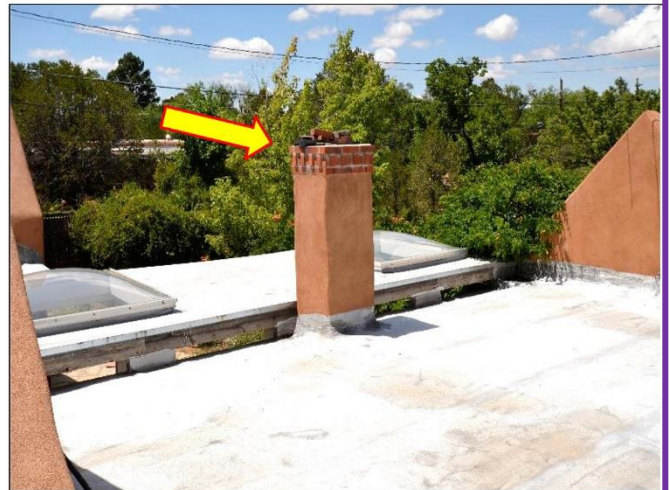
4. Chimney over the Recreation Room is damaged and will need brick work to repair the top and to provide a fire arrestor screen with cap.

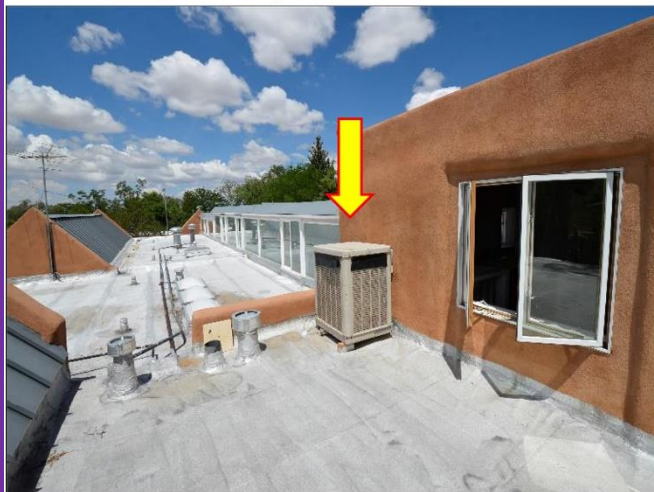
5. Swamp Cooler is not working at the time of Inspection but should be removed for a better cooling system such as with mini-splits.

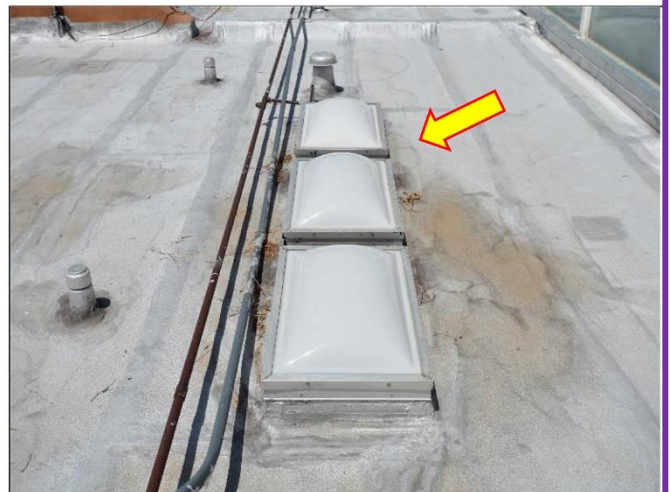
6. Row of Skylights can be replaced with one continuous hip type to better lighting.

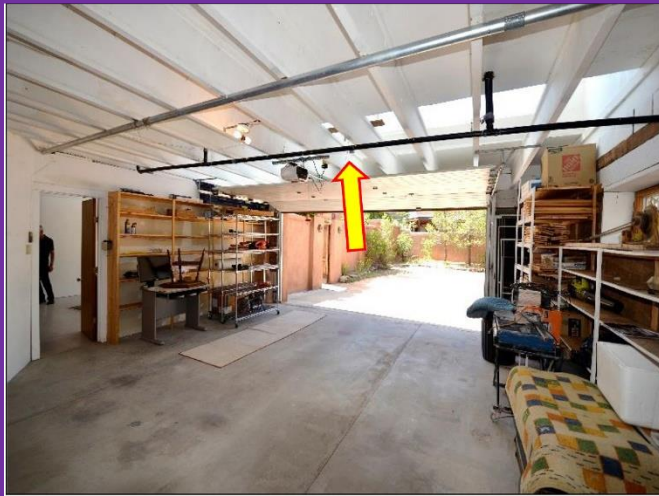
7. The piping below the Garage for drainage is too small in diameter to inadequate to drain the roof and could clog.

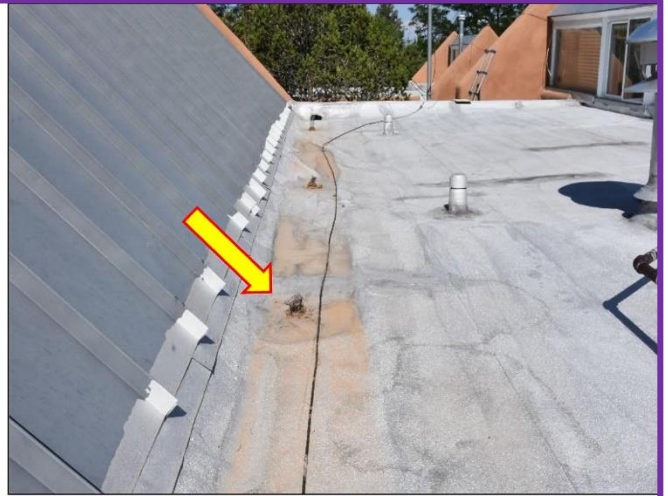
8. Drain openings on the roof above the Garage are too small and will clog because there are no leaf and debris grates

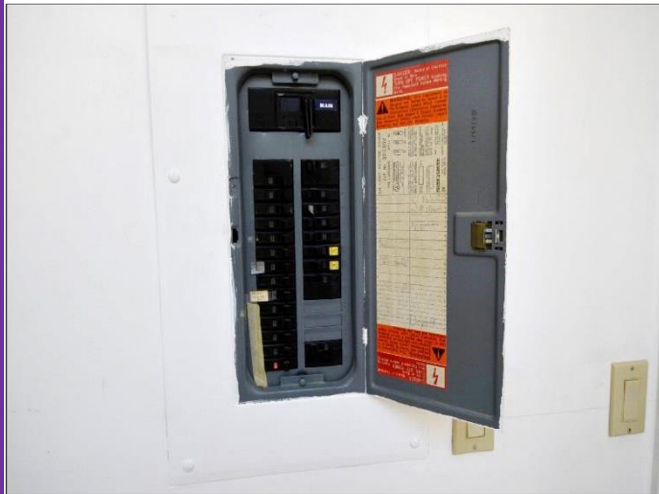
10. **Main House** 200Amp Electrical panel with labeled breakers and 3-subpanels were found throughout including **Casita** are all properly installed.

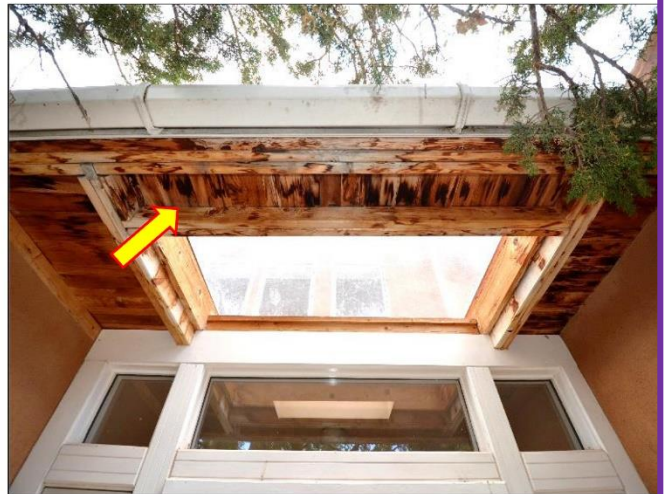
11. Water stains from prior leaking will need to be encapsulated with paint.

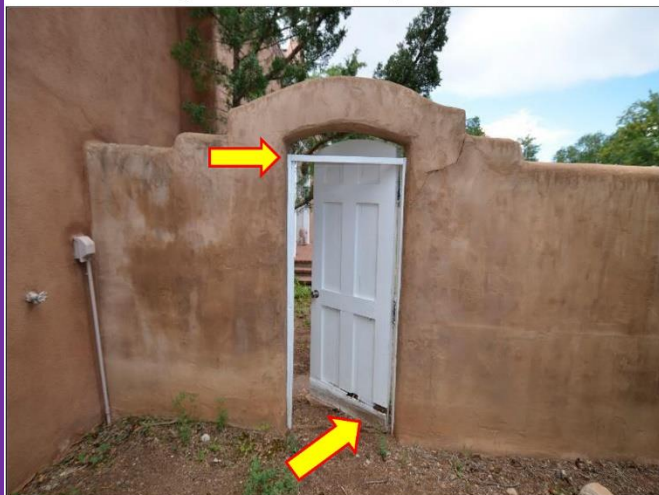
12. Gate door is rotting and will need to have the wood components replaced or replace the entire gate. Frame doesn't line up with the Gate.

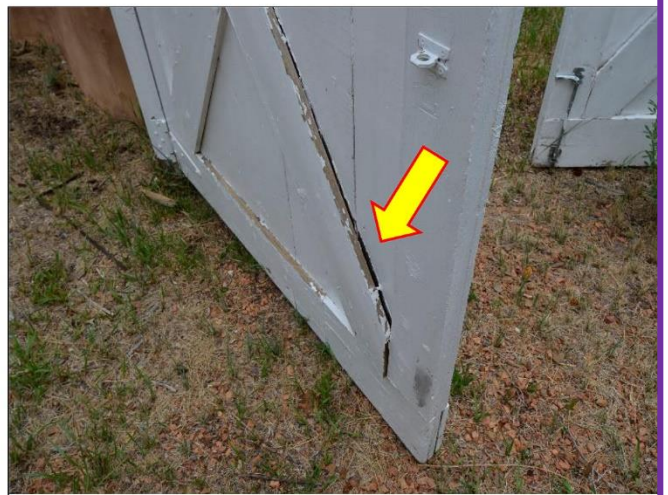
13. Gate Entry doors are rotting at the bottom and will need to have the wood components replaced and repainted.

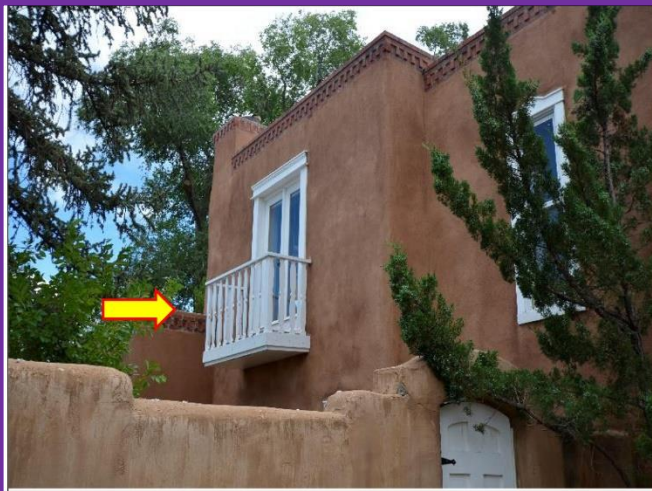
14. Balcony on the 2<sup>nd</sup> floor Bedroom is in danger of pulling away from the wall and needs an architectural fix.

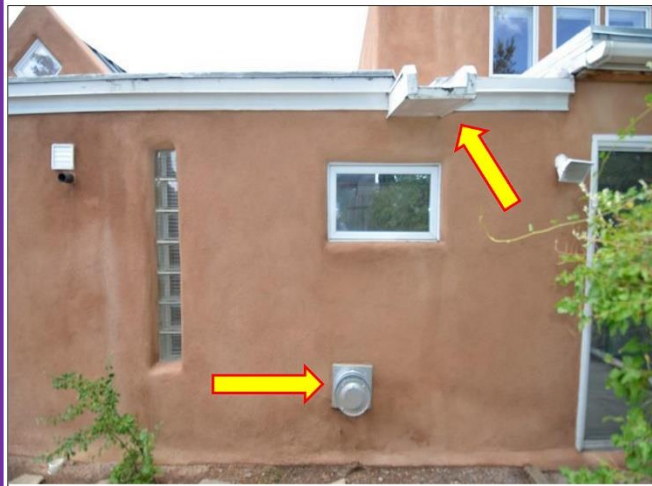
16. Bad arrangement having the exhaust vent below the window is a safety cod violation and it's not recommended to have a canale over a window.

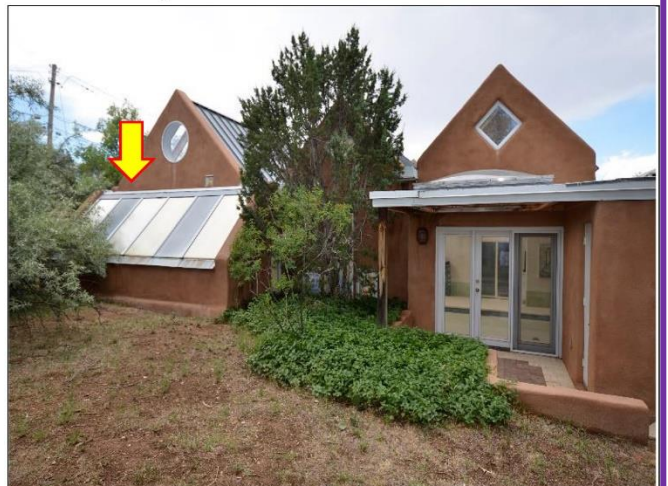
17. Plastic panels on the sloping walls are deteriorating and should be replaced.

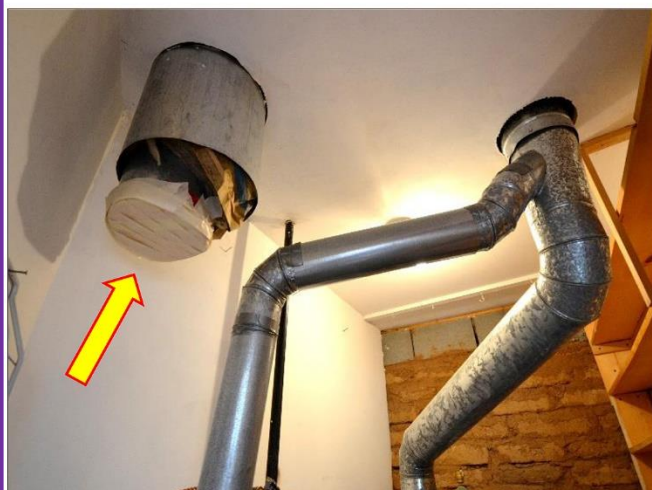
18. Combustible air vent in the Mechanical Room should never be covered up and it should be reopened as per State UMC Codes.

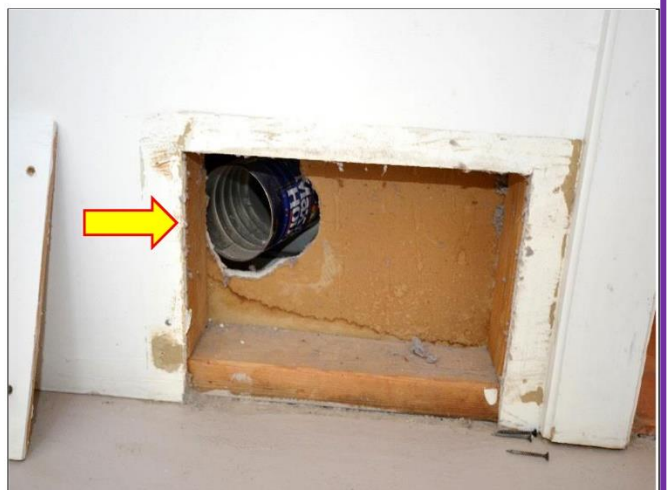
19. Coffee can was found behind the Laundry Dryer and is venting its lint into the wall cavity. It should be routed to the roof or to install a wall lint trap.

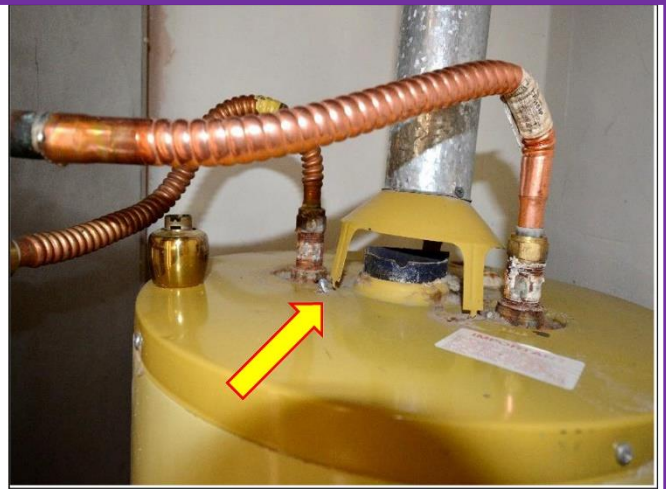
21. **Casita** H<sub>2</sub>O heater exhaust jacket is loose and needs to be secured to tank for CO safety.

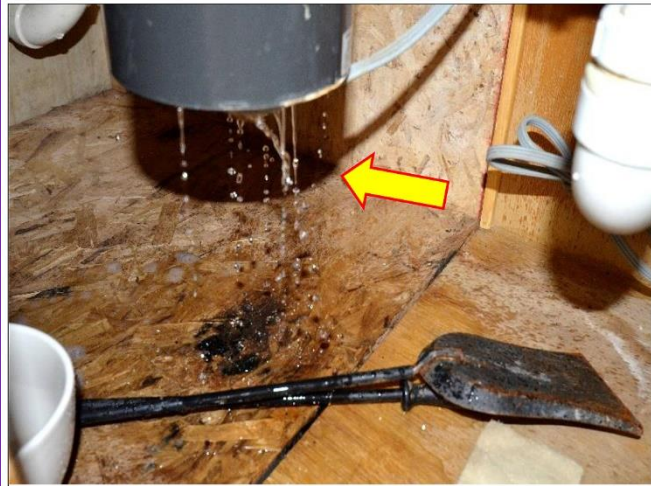
22. **Casita** waste disposal is badly leaking and will need to be replaced. Possible mold is present and will Remediation.

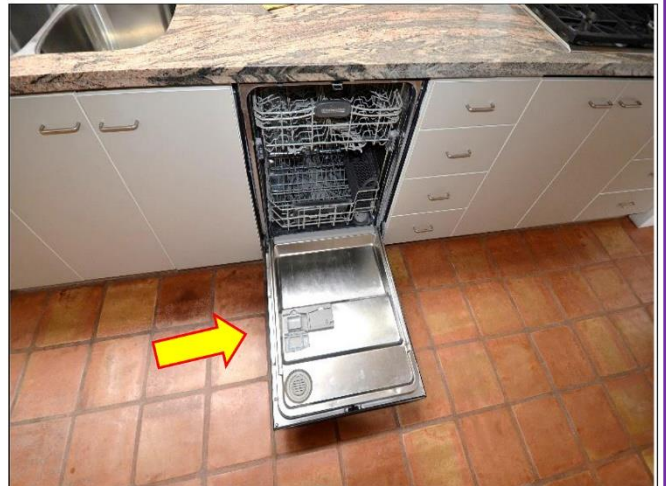
23. KitchenAid Dishwasher door on the Main House is broken and falling without having spring supports.

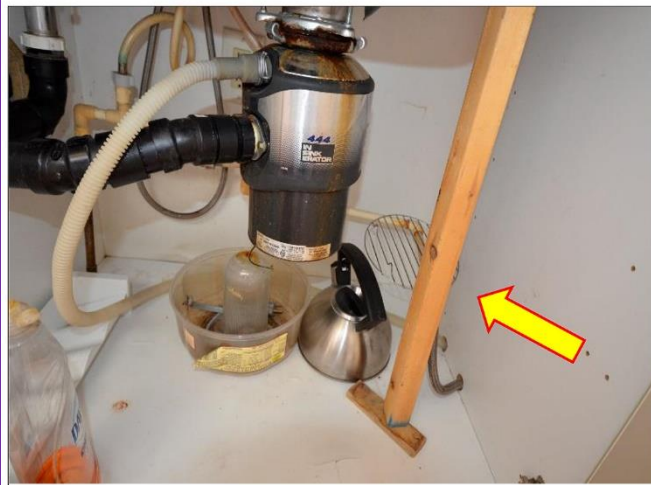
24. Prop stick found under **Main House** Kitchen sink is improperly holding up the stainless-steel sink and needs attention.

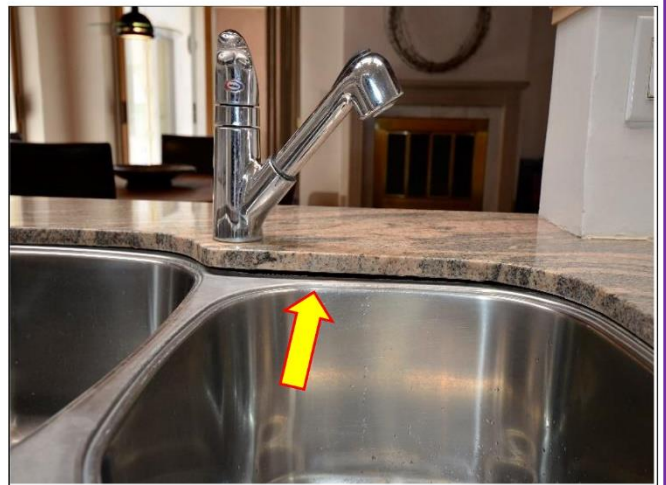
25. Granite countertop in Kitchen on the **Main House** and the stainless-steel sink are pulling apart, hence for the reason of an improper prop stick.

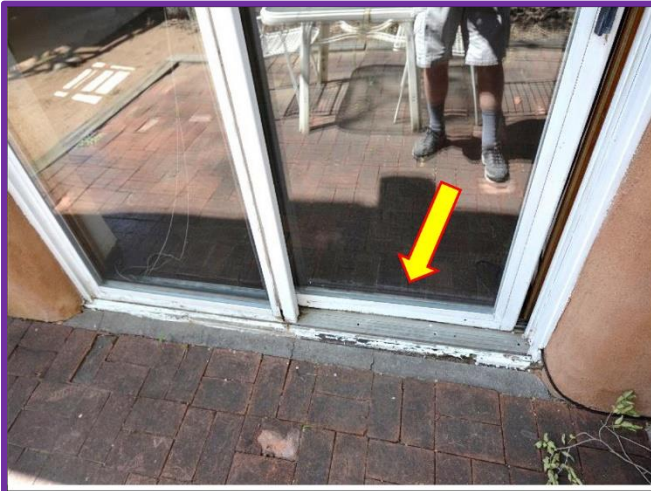
26. **Casita** sliding glass door units are falling apart and will need to be replaced.

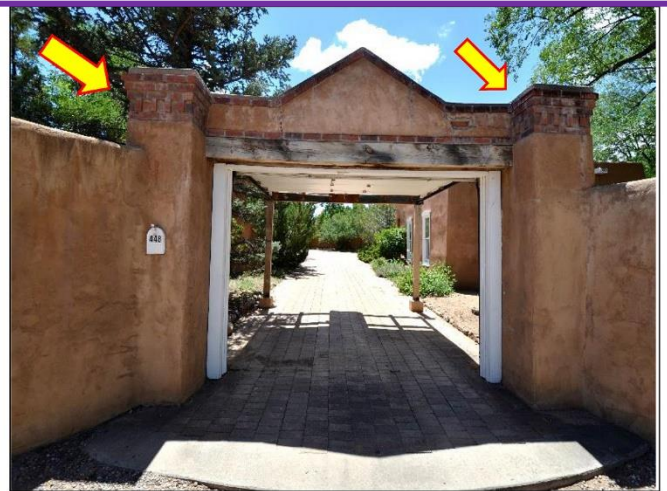
27. Territorial bricks above the wood arch beam are separating and will need to be repaired by a mason.

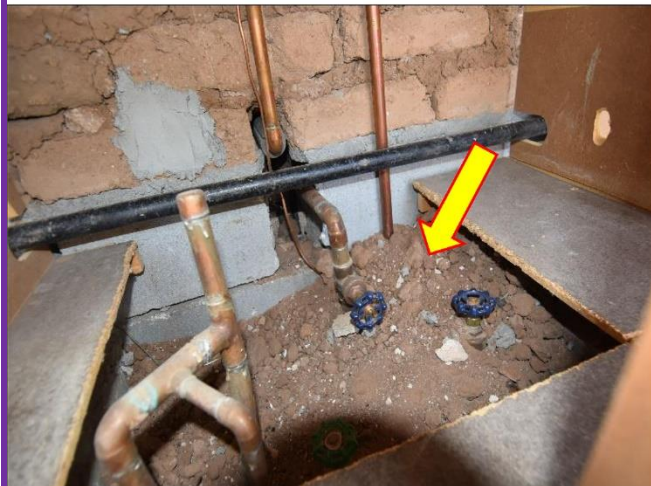
28. Brass & copper valves should never be covered-up with dirt to prevent corrosion and freezing up.

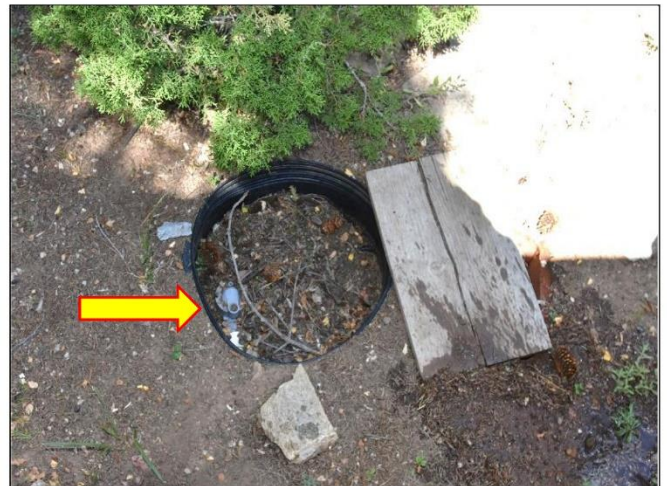
29. Access pit has a valve that is improperly covered by dirt and will need to be cleared.

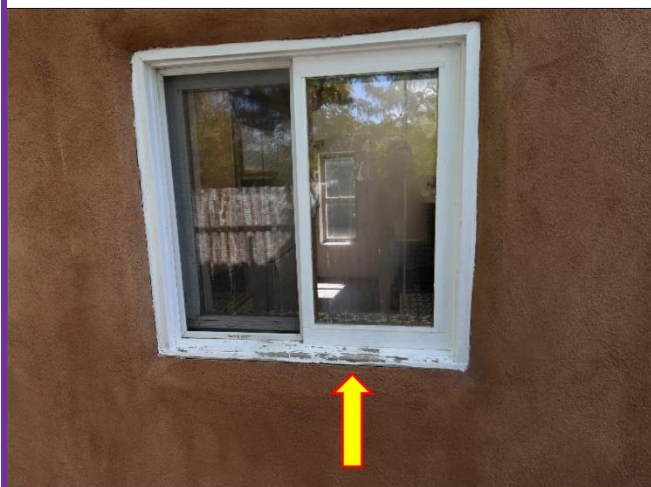
30. Typical window of many that need the trim repainted to prevent wreathing and rot.

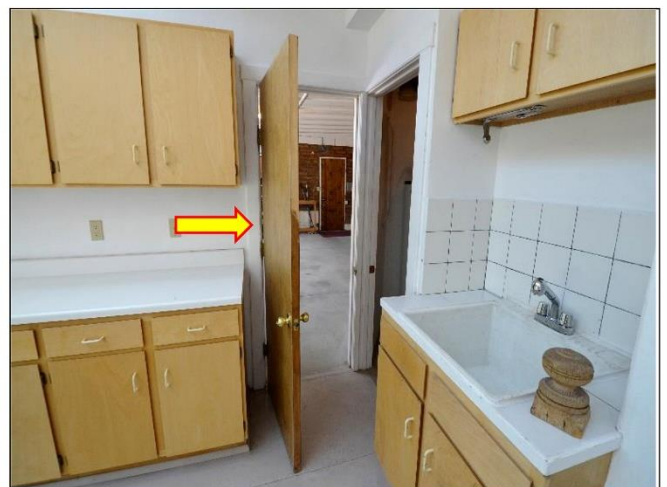
31. Rear door to Garage from the House is in Code violation and will need self-closing hinges as per ICC and State UBC Codes.

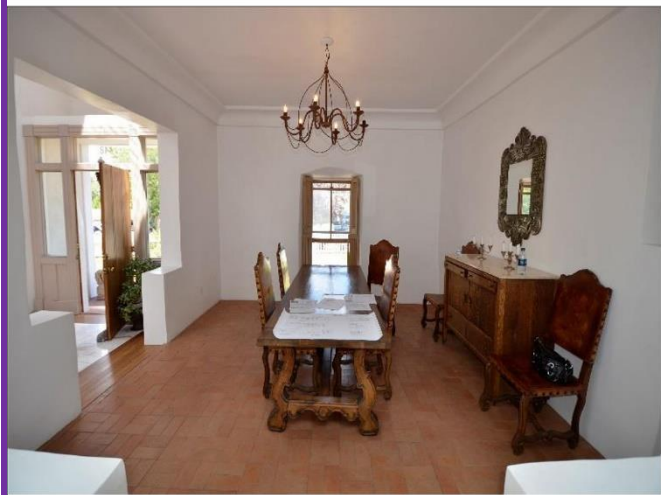
34. Formal Dining Room inside the **Main House** is in Satisfactory Condition with Brick & Sand floors, except the radiant floors are not working.

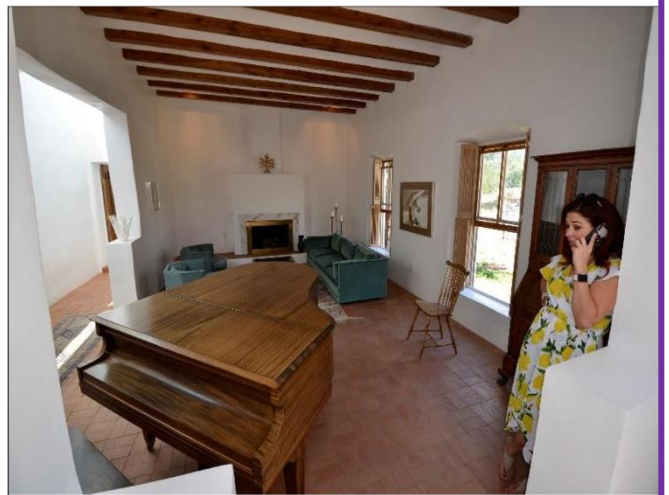
35. Formal Living Room inside the **Main House** is in Satisfactory Condition with a cove plaster ceiling, except the Radiant floors are not working.

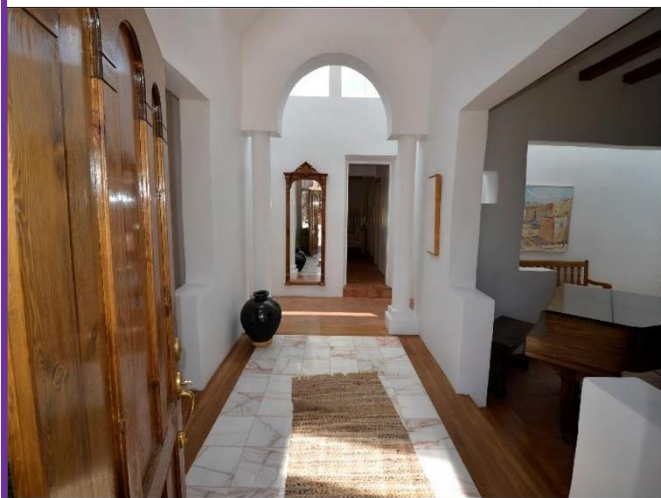
36. Entrance Hall with wood floors and marble insert tiles are in Satisfactory Condition, except the radiant floors are not working.

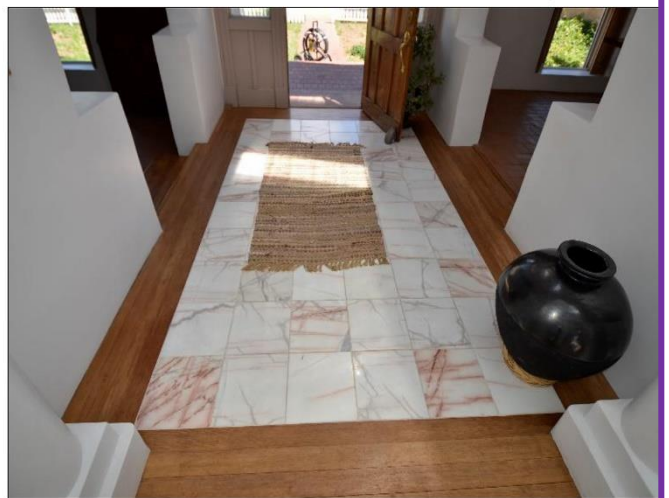
37. Entrance Hall with wood floors and marble insert tiles are in Satisfactory Condition, except the radiant floors are not working.

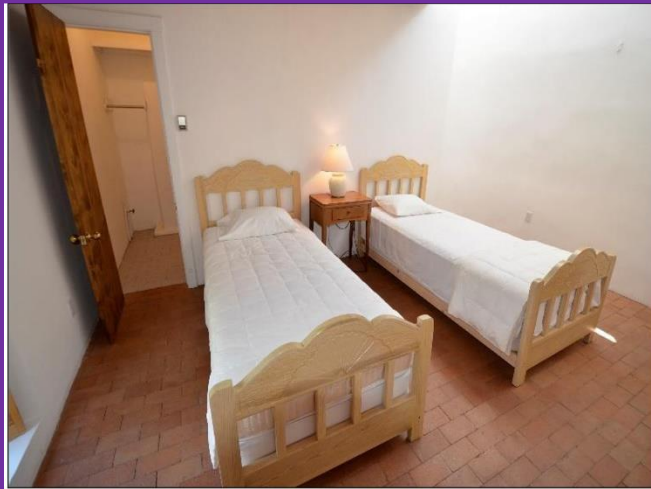
38. Bedroom at the end of Hallway is in Satisfactory Condition, with radiant floors that are working.

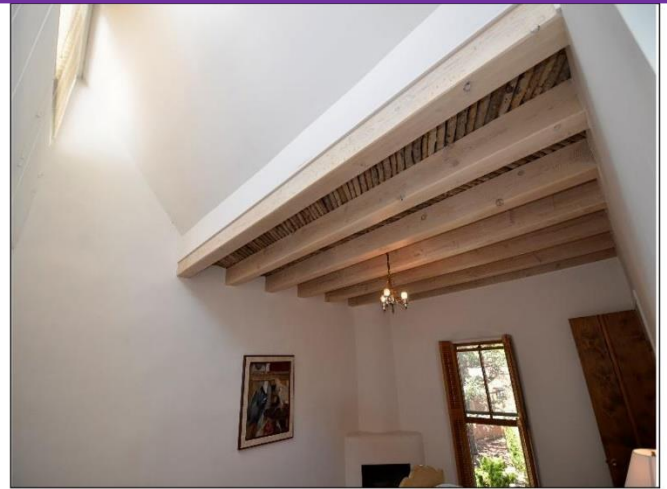
39. Bedroom at the end of Hallway with white pickle beams and herringbone latias are in Satisfactory Condition with radiant floors that are working

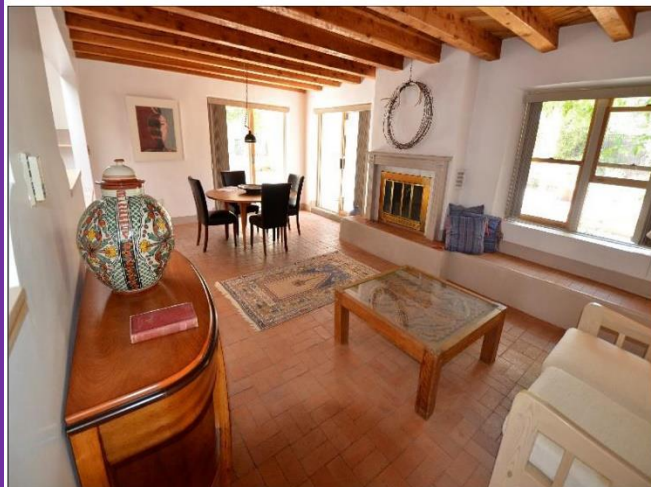
40. Recreation Room with beam and herringbone wood decking and brick & sand floor with working radiant floors are in Satisfactory Condition.

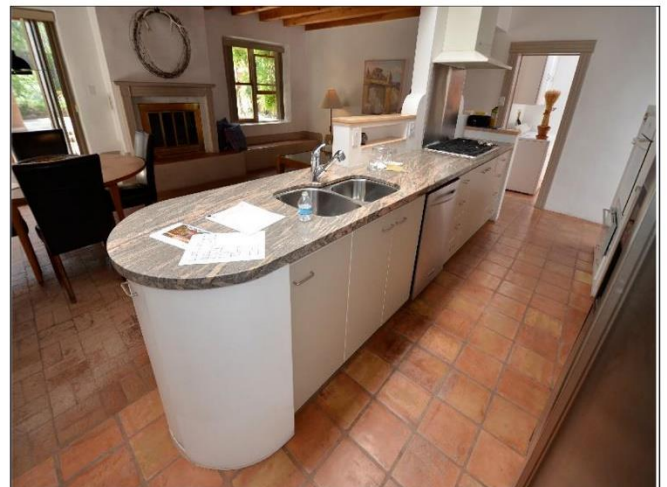
41. **Main House** Kitchen with Saltillo tile floors and a working radiant floor still has a lot of problems that will need architectural attention in design.

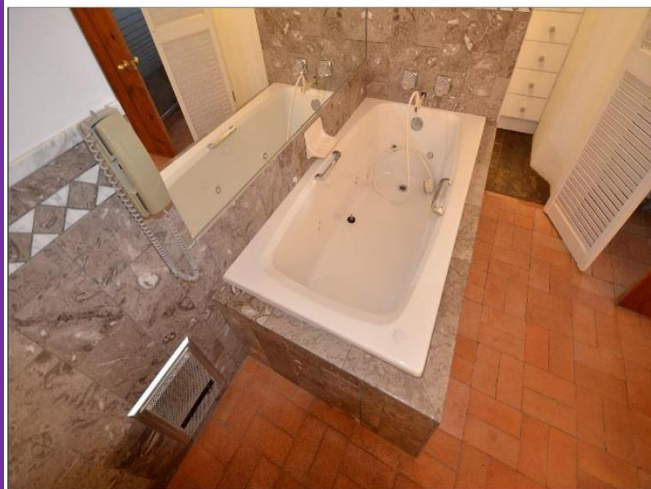
42. The Kohler Air Bathtub in the Master Suite Bathroom is working in Good Order and is in Satisfactory Condition.

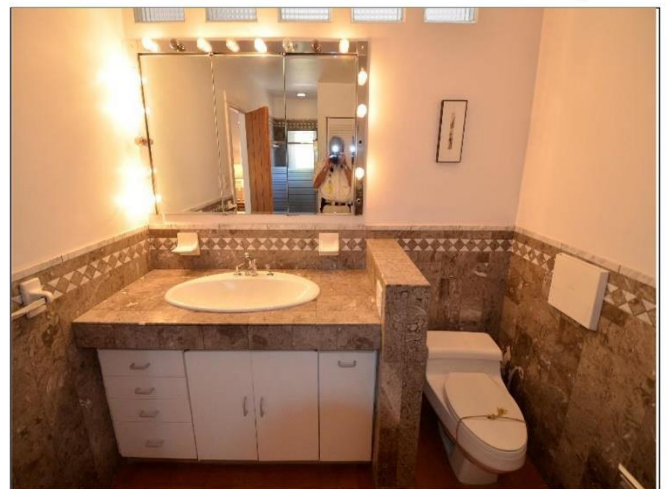
43. Typical Bathroom of six throughout the **Main House & Casita** are in reasonably good working order.

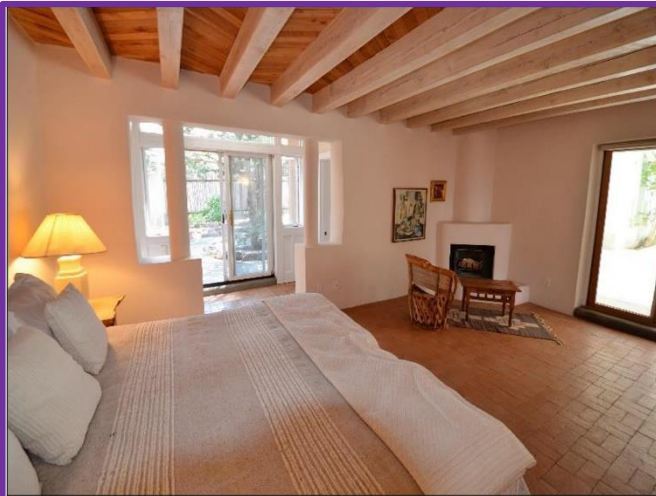
44. Master Suite Bedroom is in Satisfactory Condition.

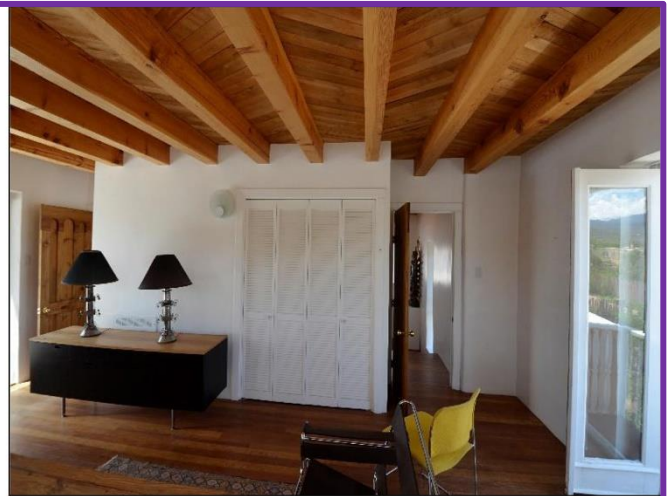
45. 2<sup>nd</sup> Floor Bedroom with wood floors and beams with herringbone wood decking has a hydronic wall heater, not radiant in Satisfactory Condition.

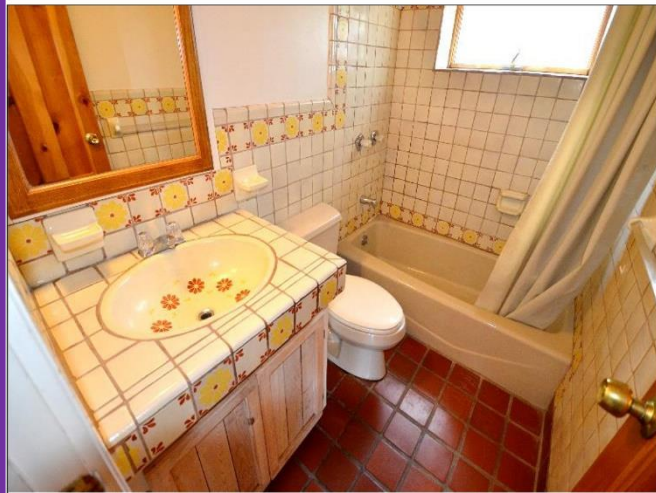
46. Casita Bathroom with Mexican tiles and ceramic tile floors are in Satisfactory Condition.

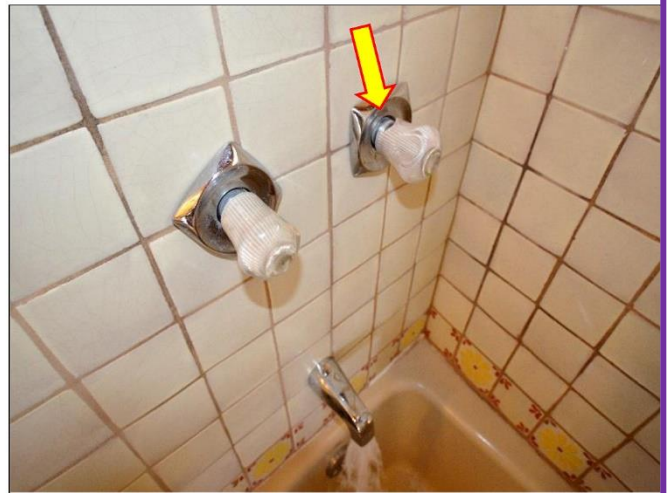
47. Casita shower knob is cracked and will need to be replaced.

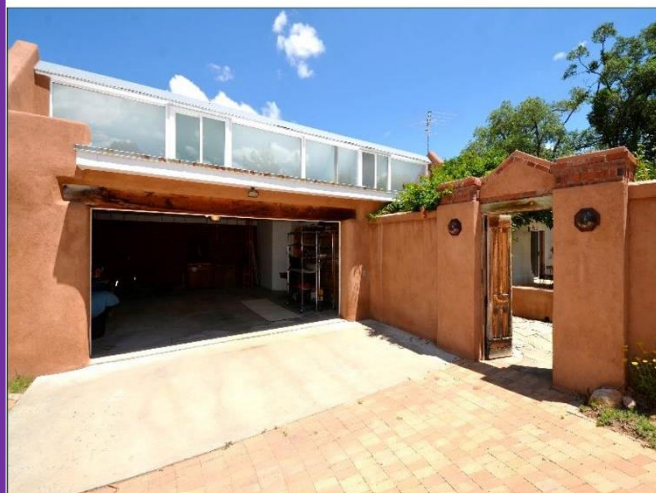
48. Garage opening with an overhead automatic door and concrete apron are in Satisfactory Condition.

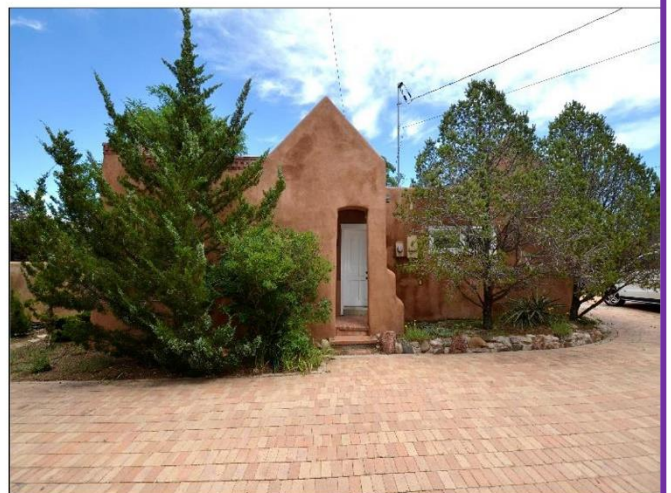
49. Beautiful brick design on the driveway to the Garage is in Satisfactory Condition.

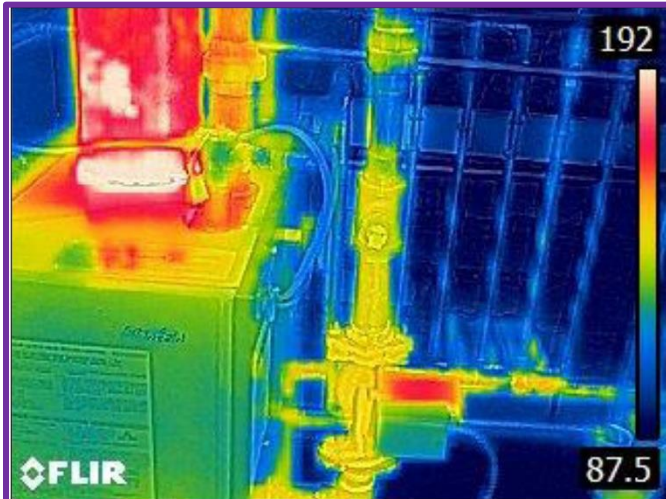
50. InfraRED Thermal Image showing mechanical SlantFin Boiler and 5-Zone valves are working in good order except for one Zone valve that isn't.
