# TWO MODULAR HOMES' INSPECTION REPORT

18331 Highway 64 East  
Tierra Amarilla, NM 87575

Inspection Date: 12/3/19

Report Number: **10706**

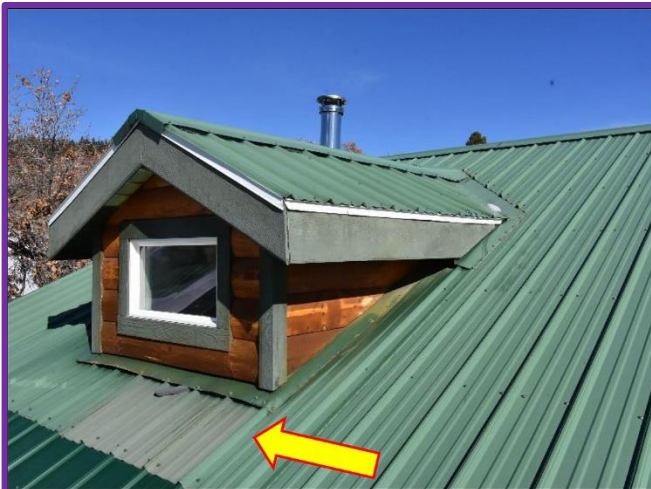
1. Propanel roof system is in Satisfactory Conditions but maintenance is needed every 5-years. Screws need to be checked to make sure they're secured.

- Repair:** Modular Homes will need Propanel maintenance and screws secured at least every 5-years.
- Repair:** First Modular Home needs a shaft extension on the bathroom fan from the rooftop, (see picture #22).

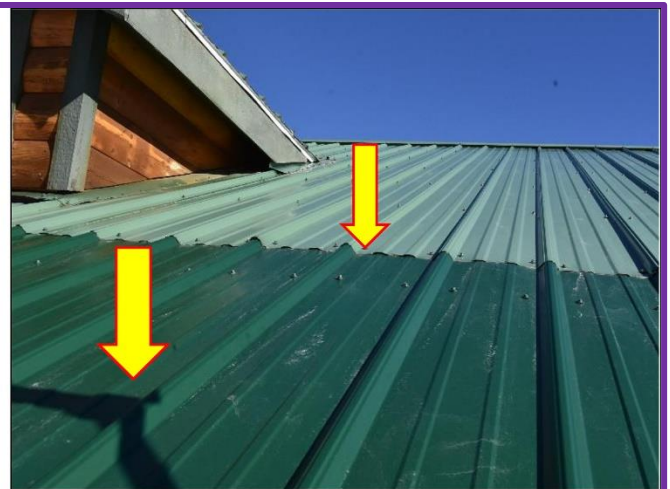
2. Propanel roof system is in Satisfactory Conditions except for this open gap with the panel replacement.

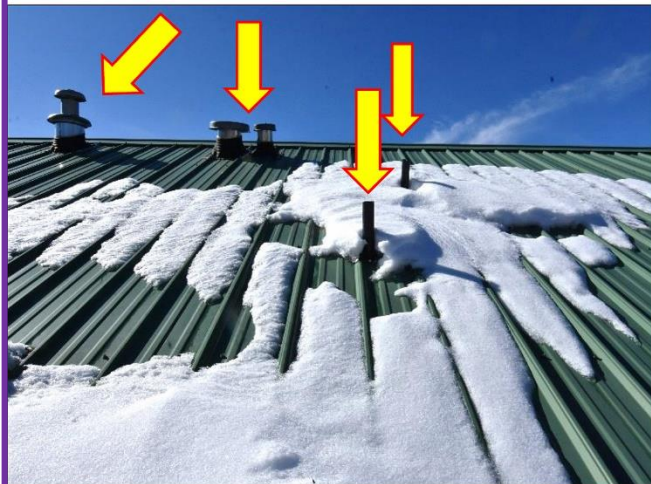
3. All Roof Jacks are in Satisfactory Conditions, except on the First Modular Home's bathroom fan jack, (see picture # 22).

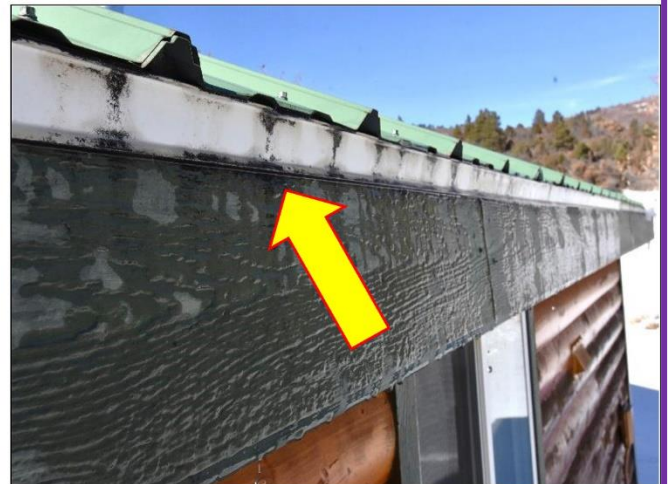
4. Fascia boards will need painted every few years and to be checked and/ or new angle trims should be installed to prevent wood rot.

13. **Repair:** Modular Homes will and painting on the fascia and wood trim every 5-years.
14. **Repair:** Modular Homes fascia boards may need better protection and/ or to replace the above flashing.

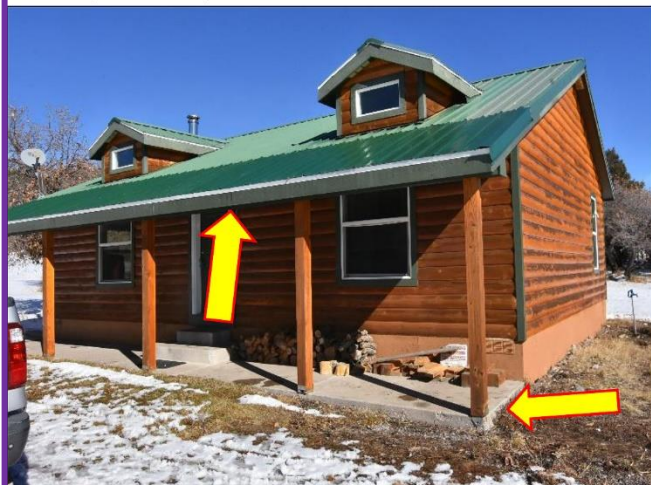
5. Porch post will need to be nailed at their bases as per ICC and State UBC Codes. Consider adding gutters and downspouts to control H<sub>2</sub>O run-off.

- Repair:** Modular Homes will need major repairs and track replacements & adjustments on the vinyl windows.
- Repair:** Modular Homes will the Porch posts will need to be nailed at their bases as per ICC & State UBC Codes.

15. **Repair:** Modular Homes should have gutters and downspouts on both down slope side to protect the fascia boards.
16. **Repair:** Modular Homes are slightly out-of-level and will need to be releveled by professional means.

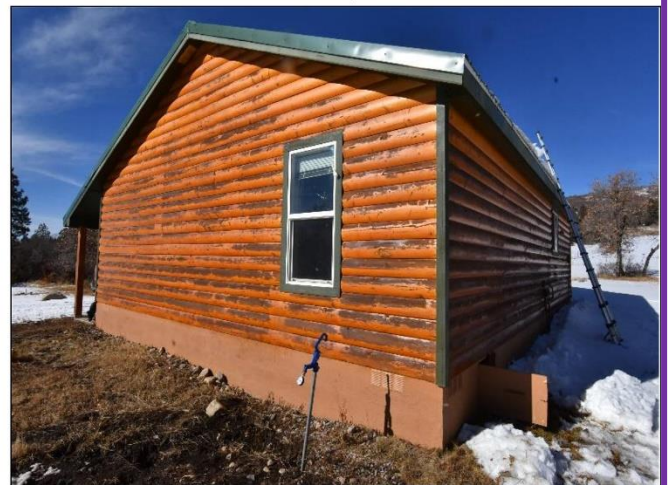
6. Split log siding will need to be re-stained to prevent deterioration.

- Repair:** Modular Homes will need re-staining on the wood split log siding.
- Repair:** Modular Homes Kitchen faucets are leaking at the valve stem and will need repairs or replacements.

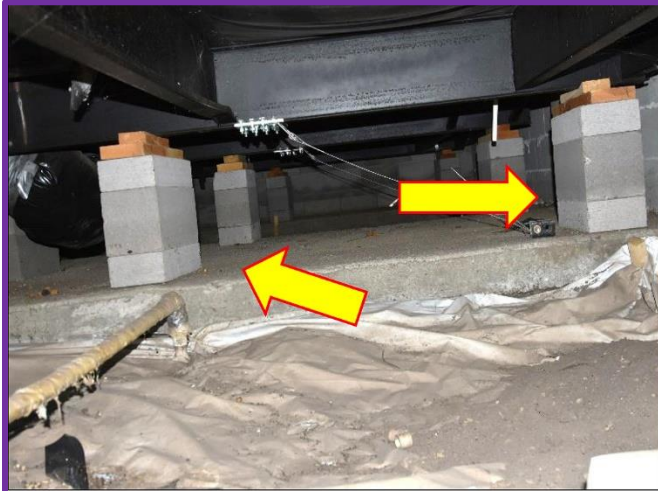
7. Crawl Spaces are properly built to support the Modular Homes but re-leveling might be necessary.

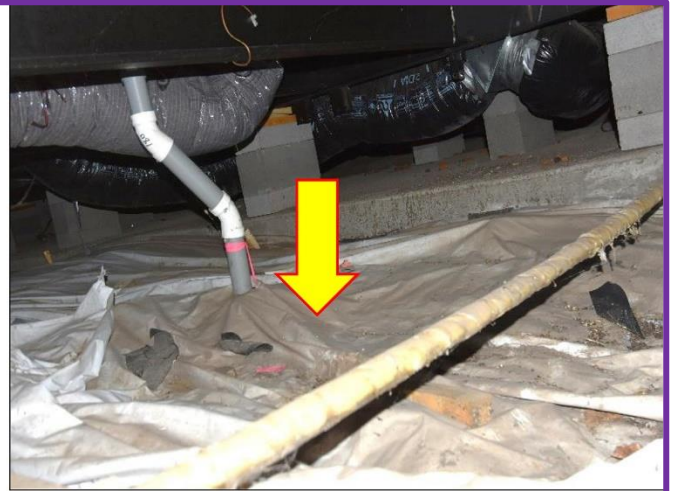
8. Crawl Spaces have plastic lining that will prevent Radon gasses.

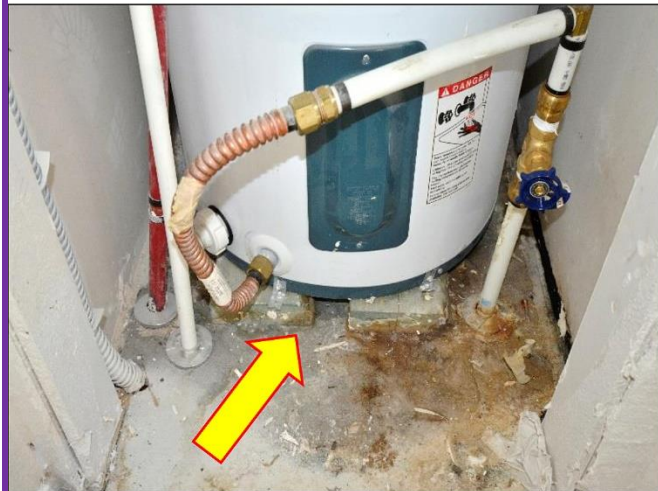
9. H<sub>2</sub>O heaters should have safety pans installed with drain pipes to an outside source.

- Repair:** Modular Homes' H<sub>2</sub>O heater closets need safety pans under tanks with drainpipes to outside sources.

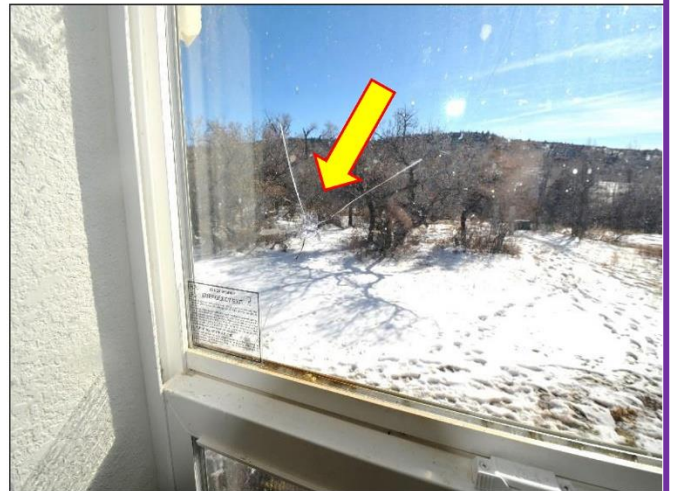
10. Broken window found on Master Suite Bedroom inside the First Modular Home that will need to be replaced.

- Repair:** First Modular Home needs the floor heating resister properly connected under the Crawl Space.
- Repair:** First Modular Home needs a thermopane window replacement due to a broken window.

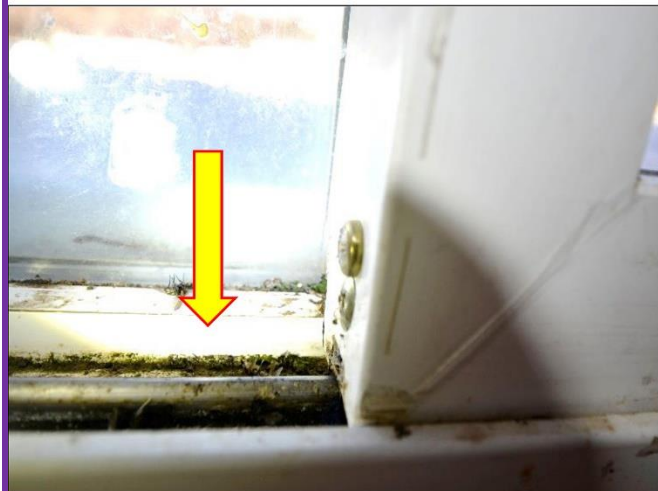
11. Sliding doors tracks on both Modular Homes will need to be cleaned and lubricated to operate properly.

17. **Repair:** All Kitchen Ranges should be cleaned to function properly.
18. **Repair:** Vinyl Windows and Sliding Doors will need professional attention with adjustments, track hardware replacements and lubrication to operate more smoothly and to securely latch for all single hung windows.

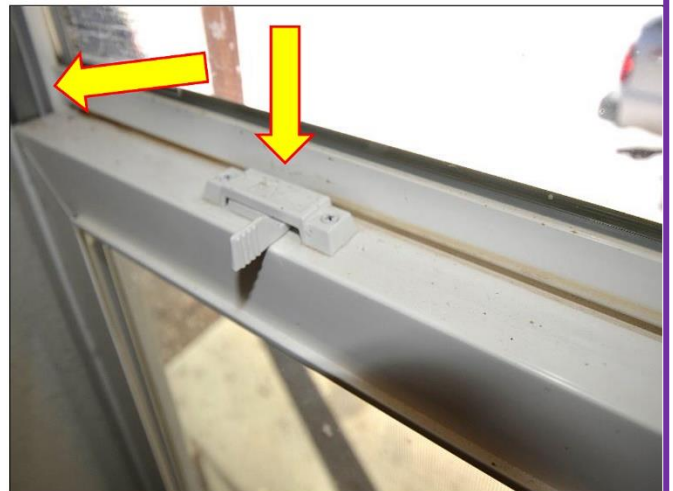
12. Some of the Window latches are not locking and will need further adjustments, track hardware replacements and lubrication.

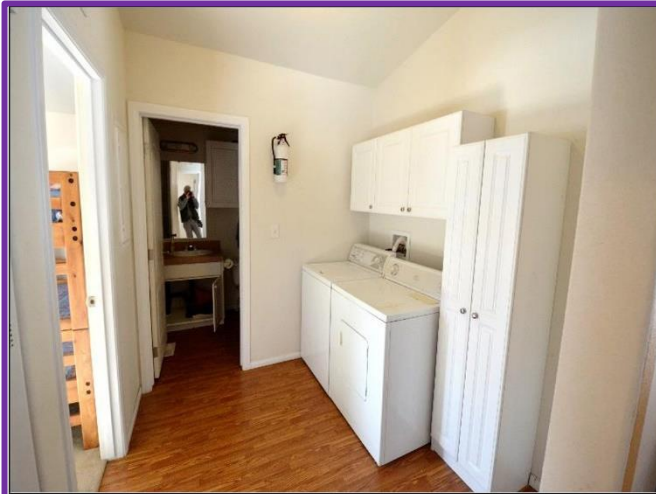
13. Both Annex areas with the Laundry Machines are in Satisfactory Conditions.

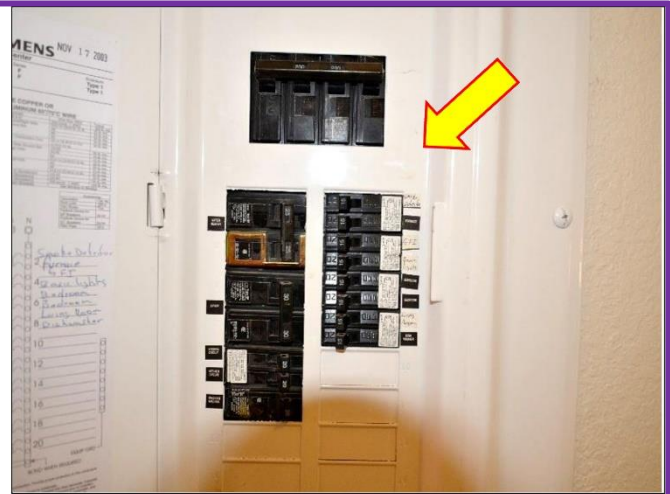
14. Both Siemens 200Amp Electrical Panels with breakers are properly labeled and are in Satisfactory Conditions.

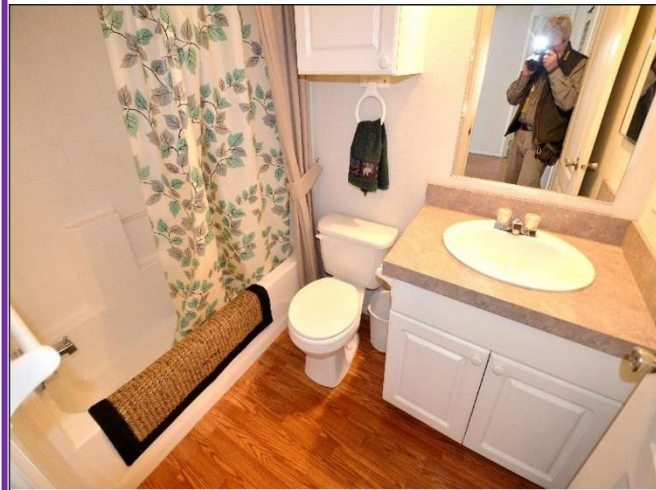
15. Both Bathrooms are in Satisfactory Conditions, except the First one need to have the heating register hook-up under the Crawl Space.

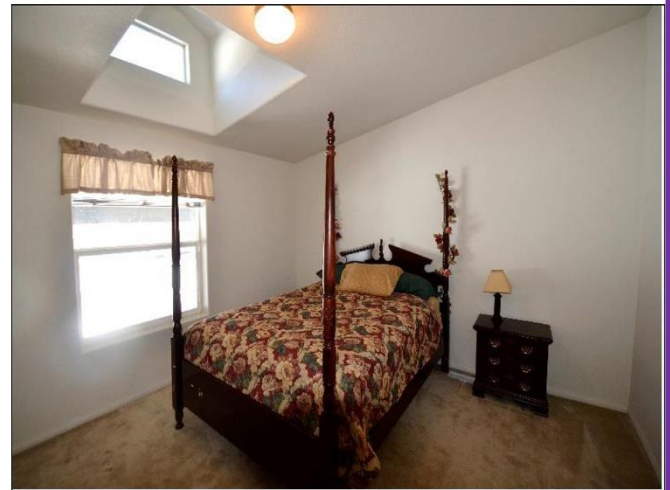
16. Typical Bedroom of four are in Satisfactory Conditions.

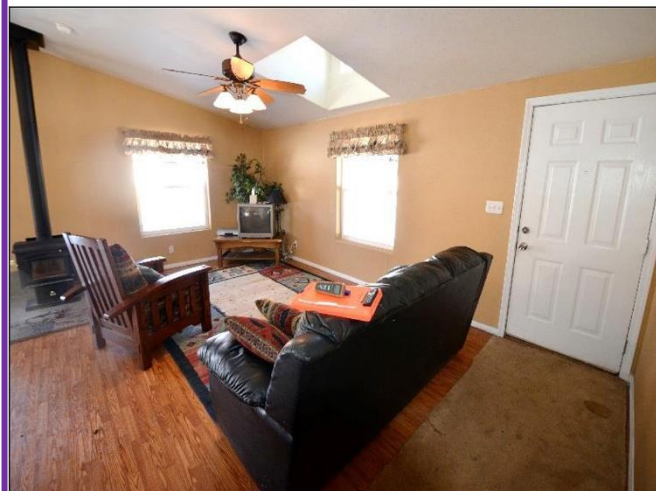
17. The two Living Rooms with wood stoves are in Satisfactory Conditions.

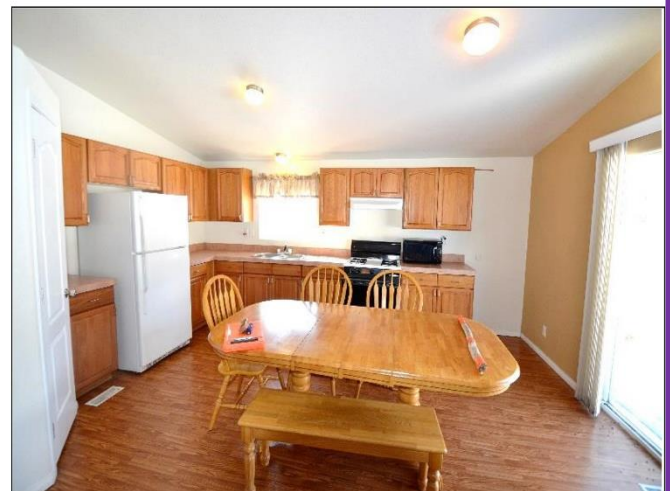
18. The two Kitchens with two the appliances, range and refrigerators are in Satisfactory Conditions.

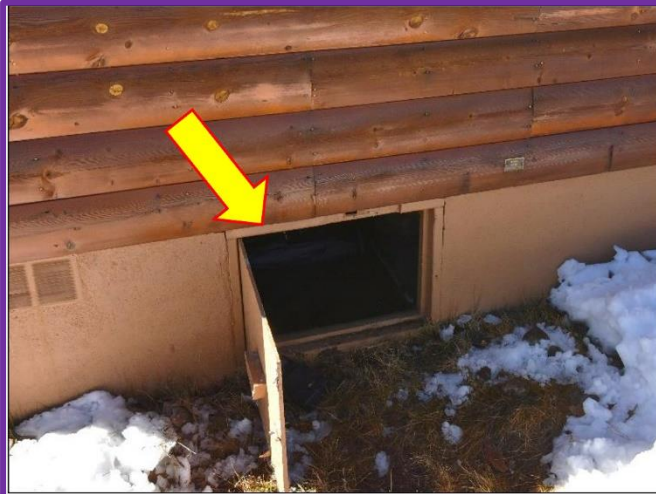
19. Single hatch found on both Modular Homes to access the Crawl Space.

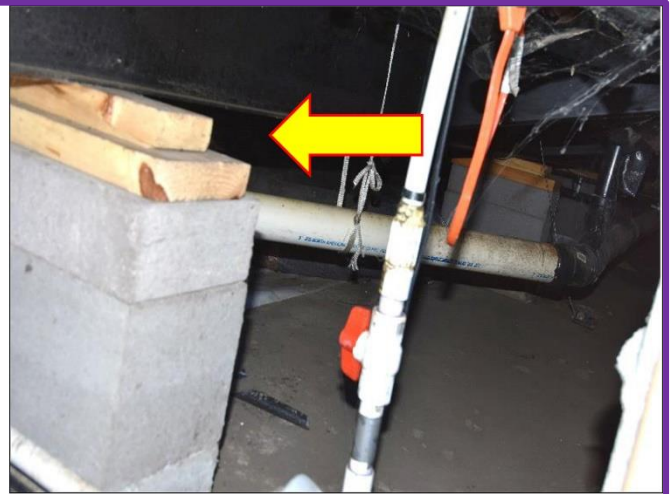
20. All foundation piers have wood shims that will need to be periodically checked and tightened to prevent settlement.

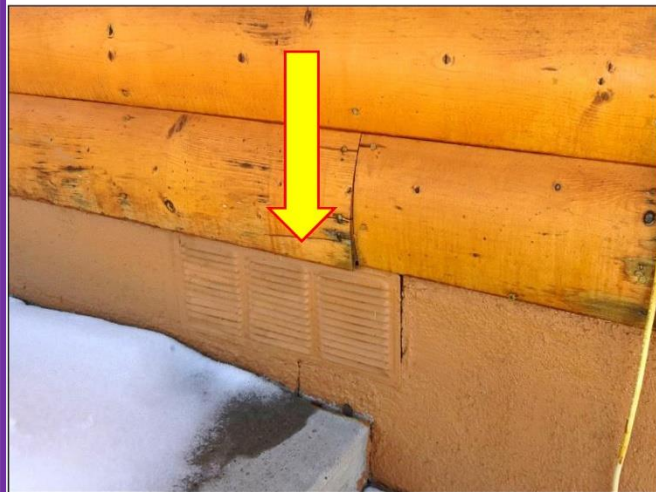
21. Foundation vent found on both Modular Homes space approximately 15-feet apart as per code.

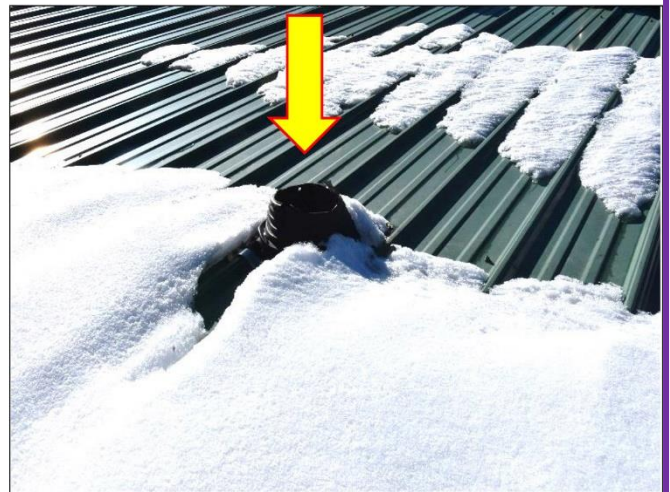
22. First Modular Home Bathroom roof jack for ceiling fan is open and needs the shaft pipe added to prevent leaking.

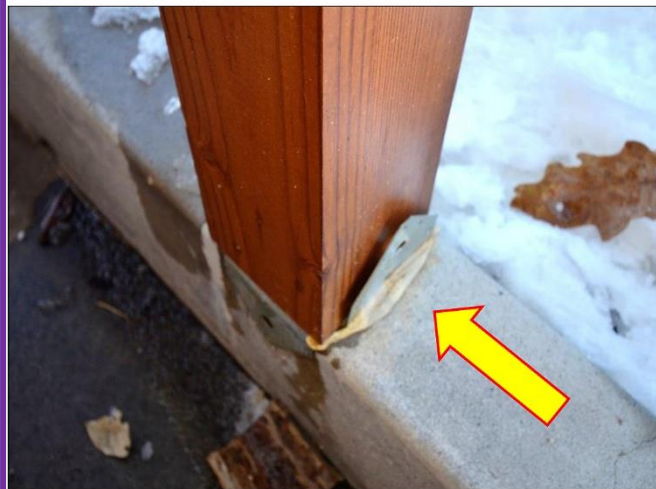
23. Example of Porch Post bases that should be nailed-off as per ICC and State UBC Codes. Glue is only a temporary solution.

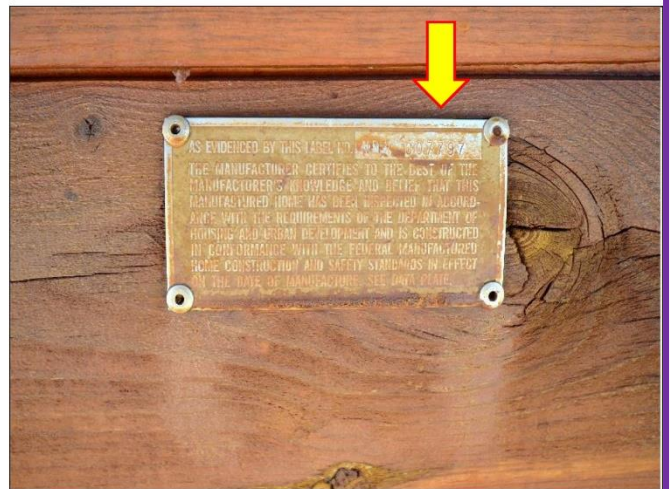
24. Modular Home identification tab with the Serial Number.
