TOWNHOUSE INSPECTION REPORT

Client: Gregory Sands
Phone: (719) 499-1100
Email: gregsands3@gmail.com

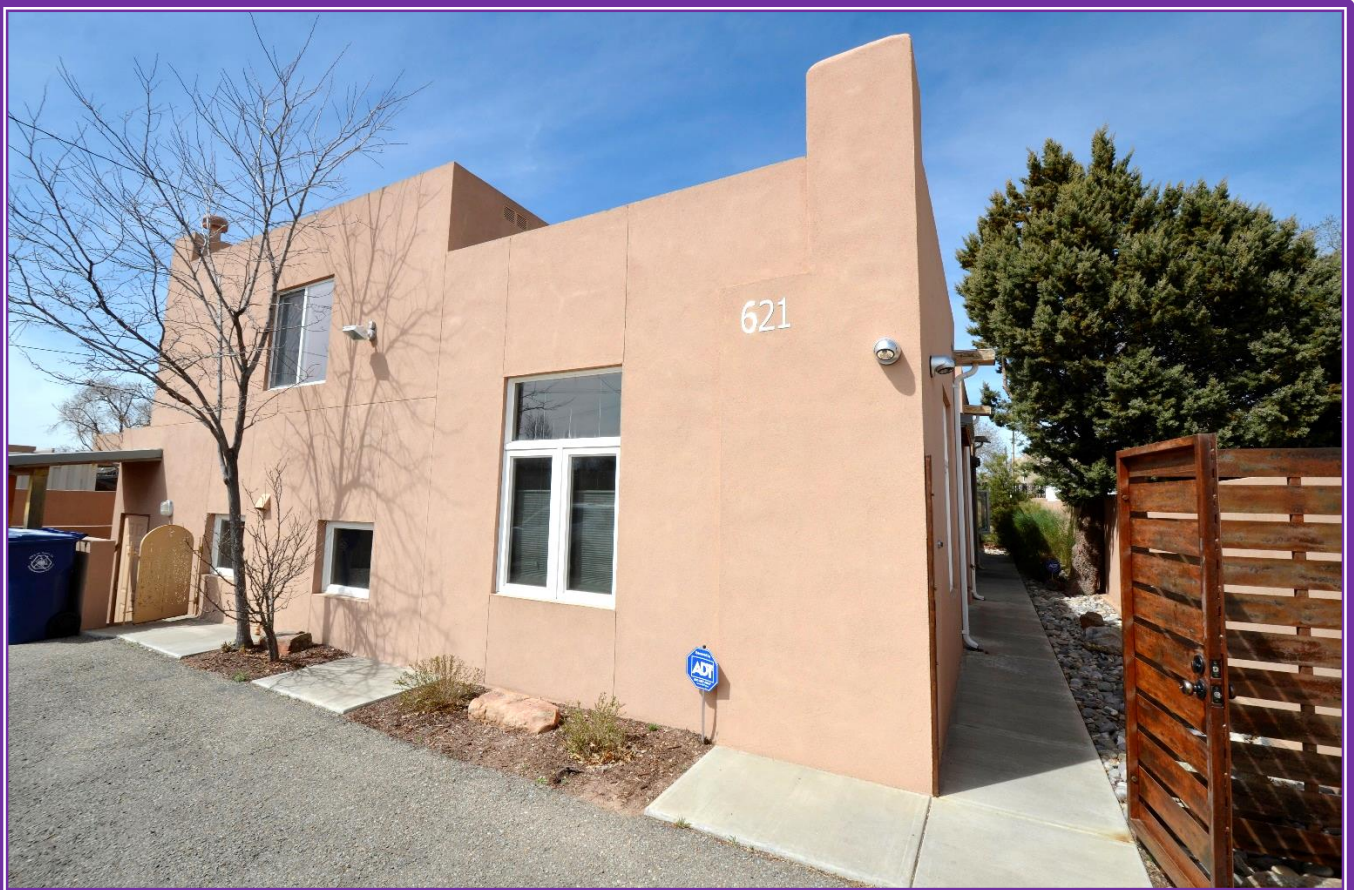
ActiveHome INSPECTIONS™

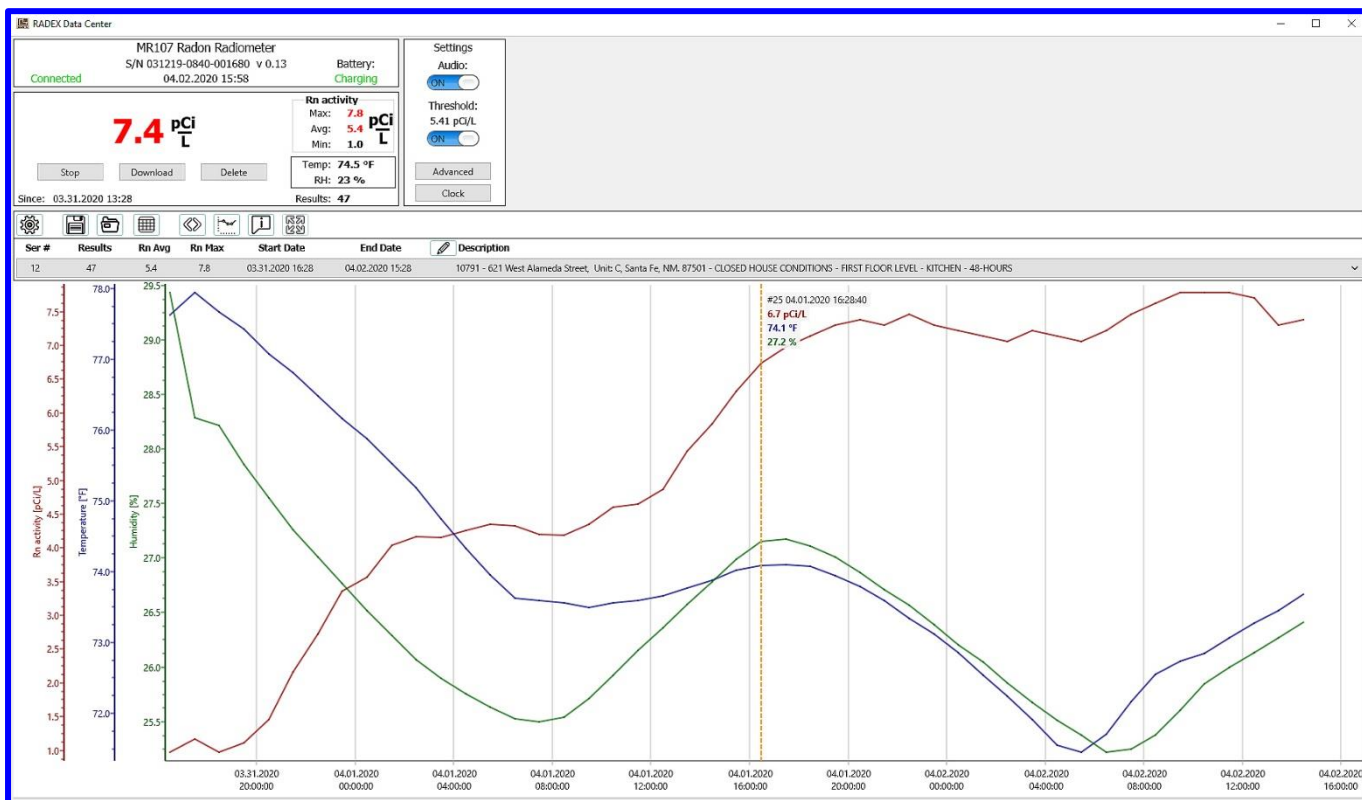
Please find the 11x17 chart provided for easier reading.

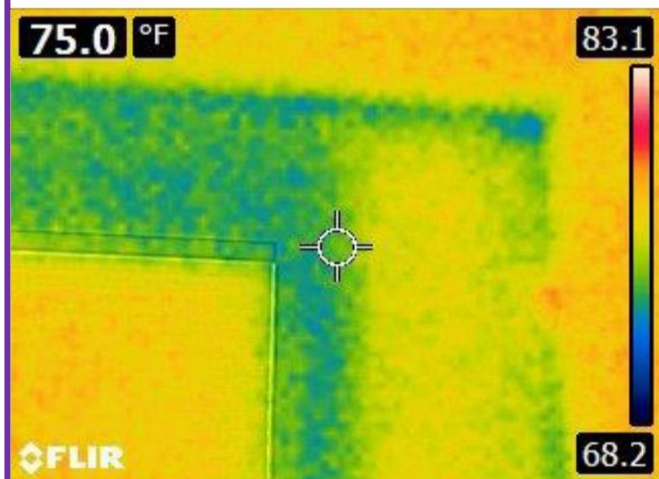
5. InfraRED Thermal Image on the Second Floor Level showing a moisture/ cool temperature build-up above the Master Bedroom window.

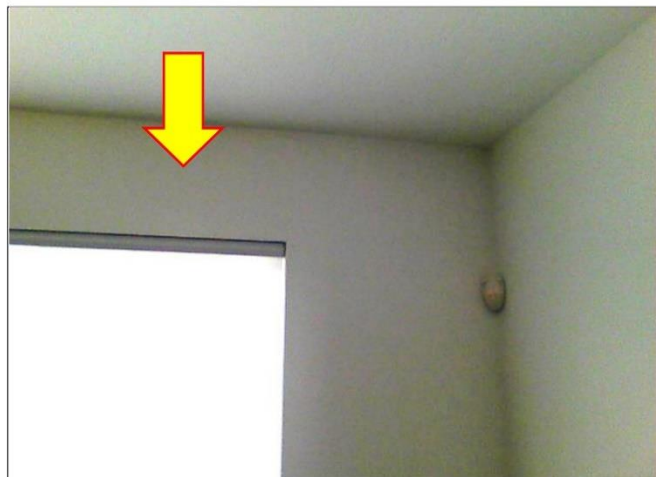
6. Same image without the InfraRED Camera.

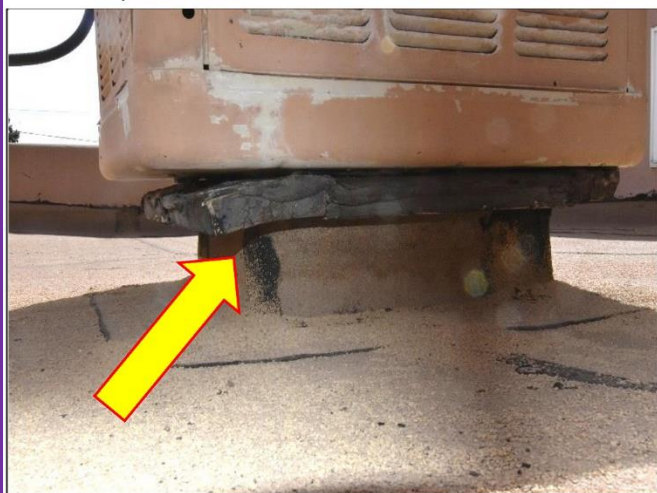
11. Chase under the Swamp Cooler looks like it might be leaking over the rooftop chase and this will need reevaluation by a roofing company.

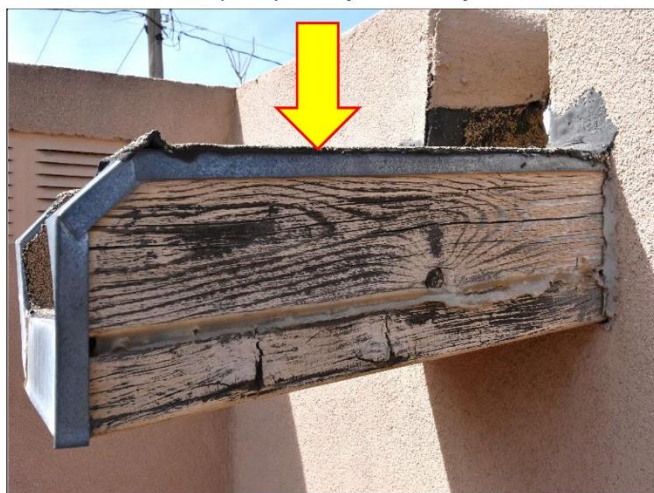
12. Typical wood canale will need to be refinished before taking possession of this Townhouse.

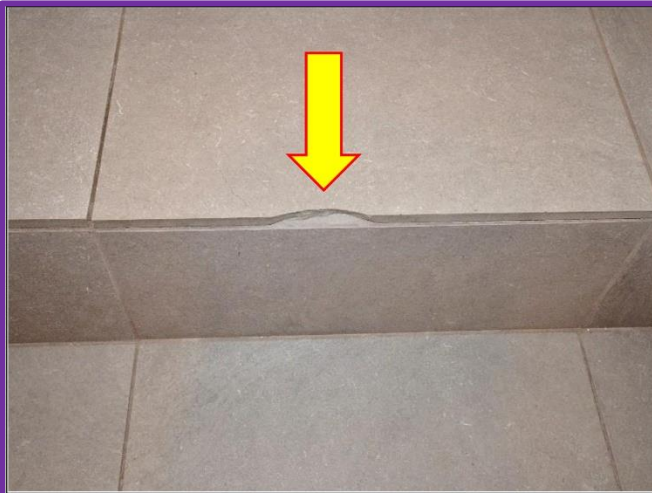
13. Chip found on tile tread to the Kitchen will need to be replaced.

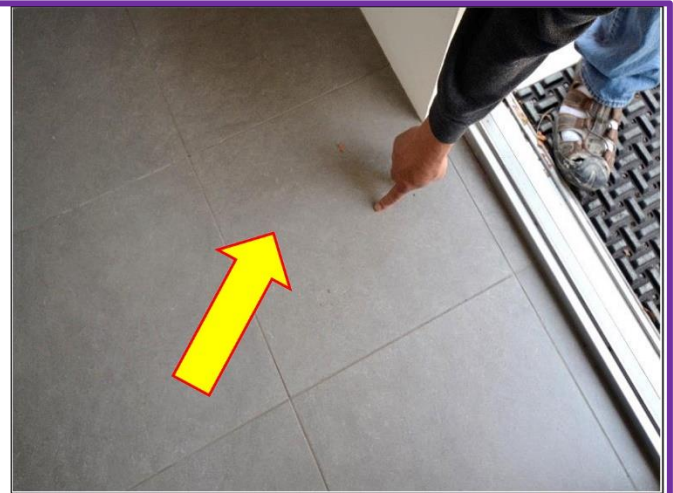
14. 4-cermeric tiles were found to be loose and sill need to be reset with adhesive.

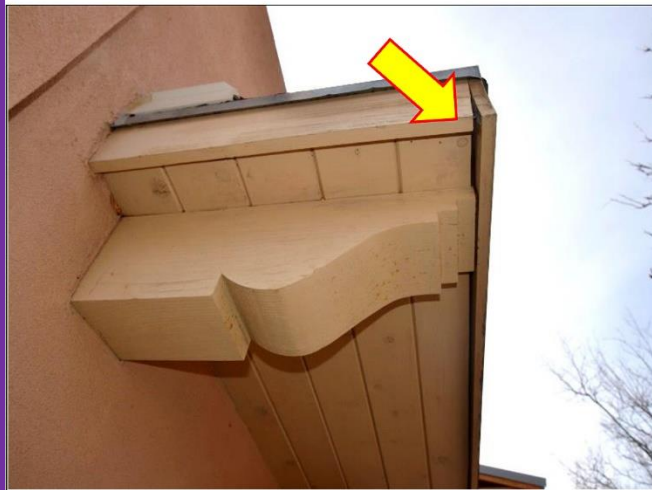
15. Fascia boards on both Patio door roof overhangs will need to be refastened and repaired.

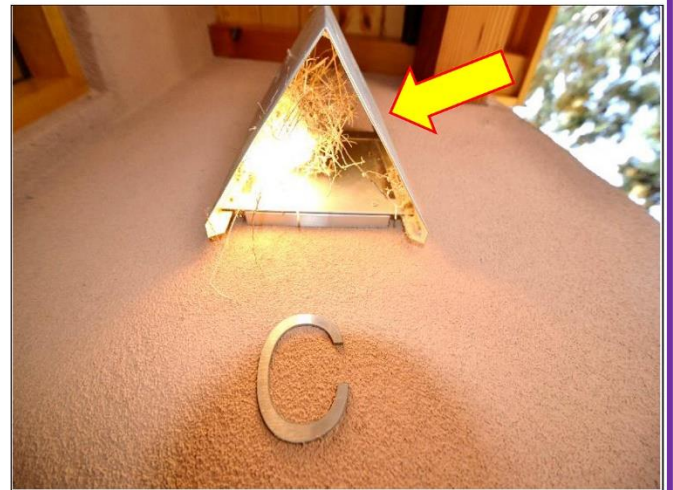
16. Birds' nesting found at the Front door light fixture will need to be removed.

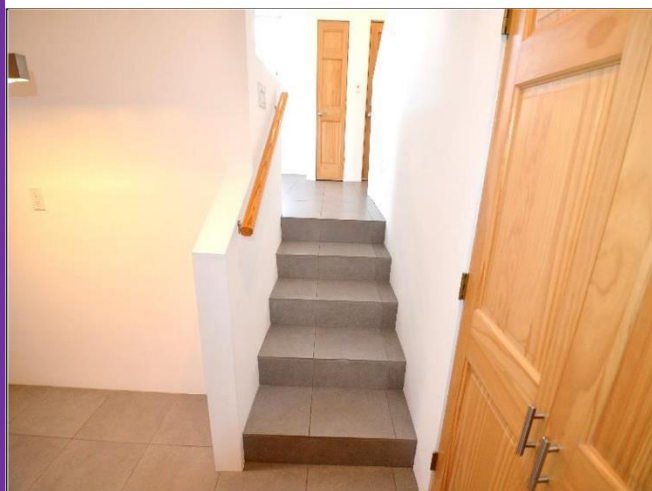
17. Split-level staircase has one tread that is chipped and will need to be replaced.

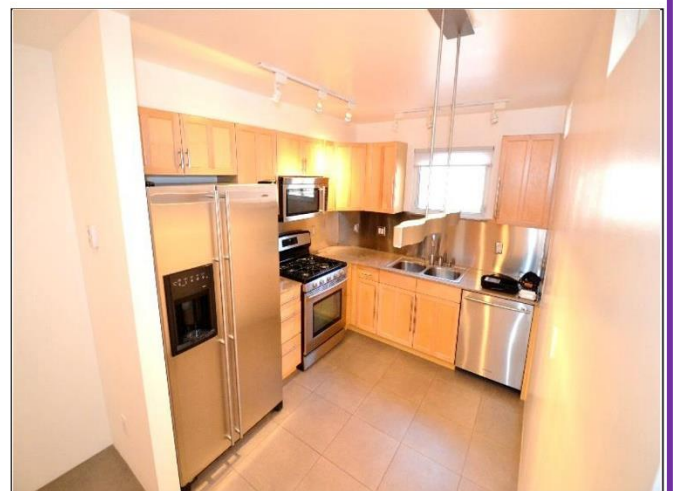
18. Kitchen amenities and appliances are in **Satisfactory Condition** and are **ASHI** Verified.

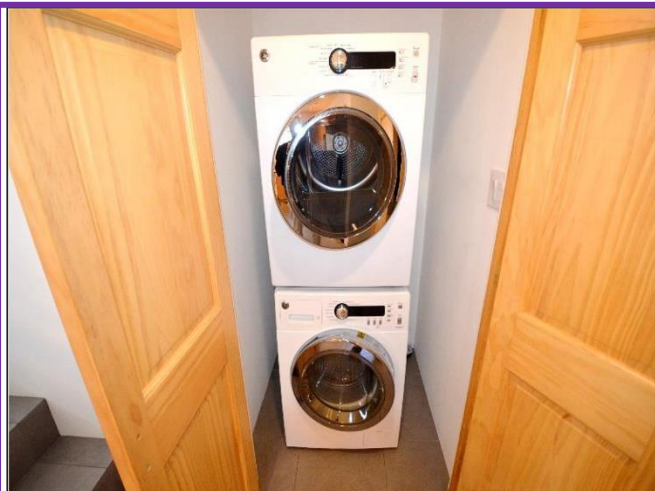
19. GE stackable laundry machines are in **Satisfactory Condition** and are **ASHI** Verified.

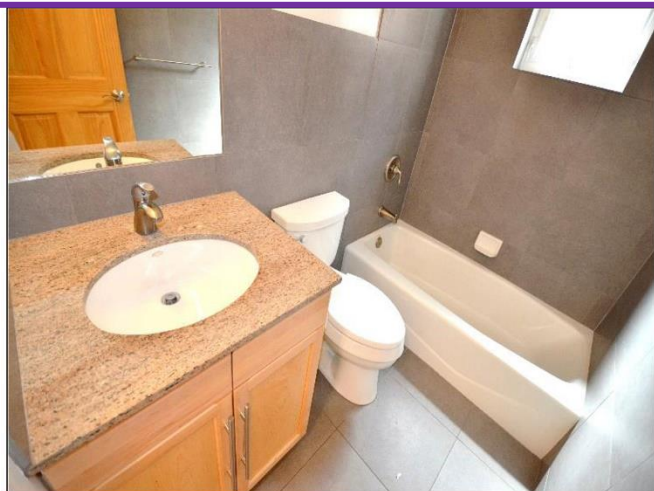
20. Lower level bathroom with **Kohler** fixtures/ vanity/ bathtub/ toilet are in **Satisfactory Condition** and are **ASHI** Verified.

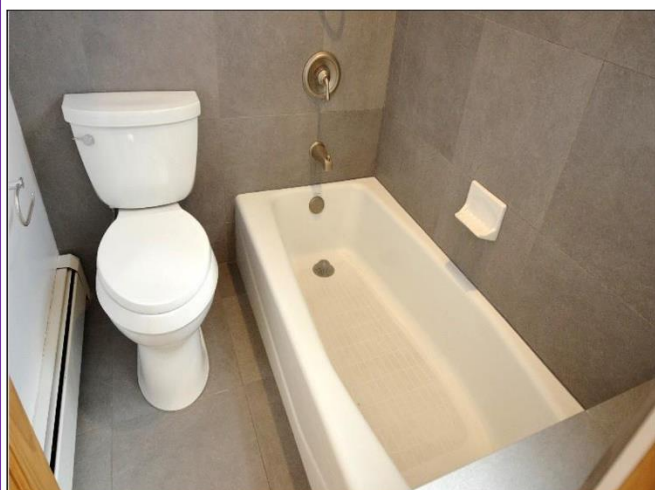
21. Upper bathroom with Kohler fixtures are in **Satisfactory Condition**.

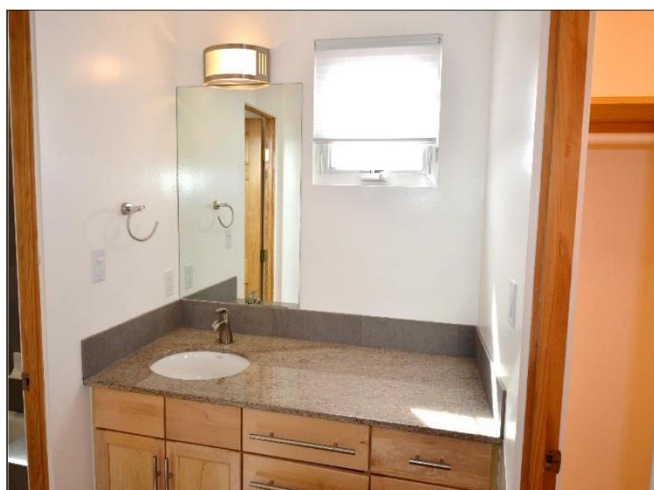
22. Upper Master Bathroom Vanity with 2cm Quartz countertop are in **Satisfactory Condition**.

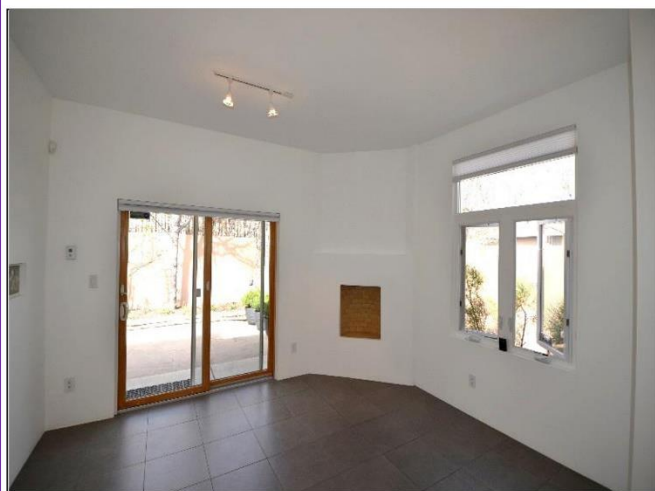
23. Living Room with **Anderson** sliding Patio doors and wood burning Kiva fireplace are in **Satisfactory Condition**.

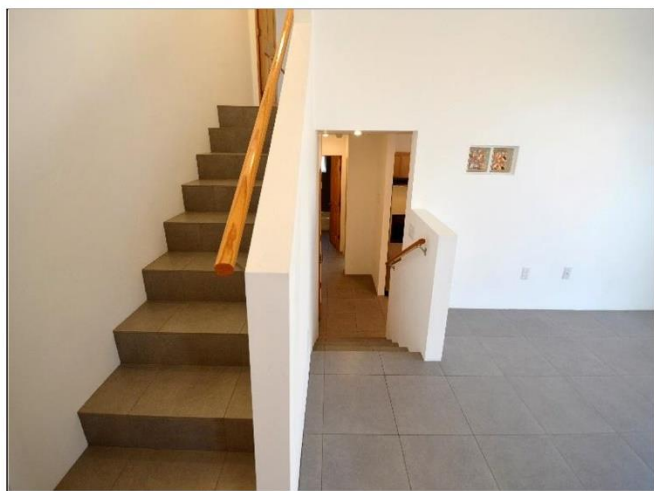
24. Upper and lower split-level staircases are in **Satisfactory Condition**.

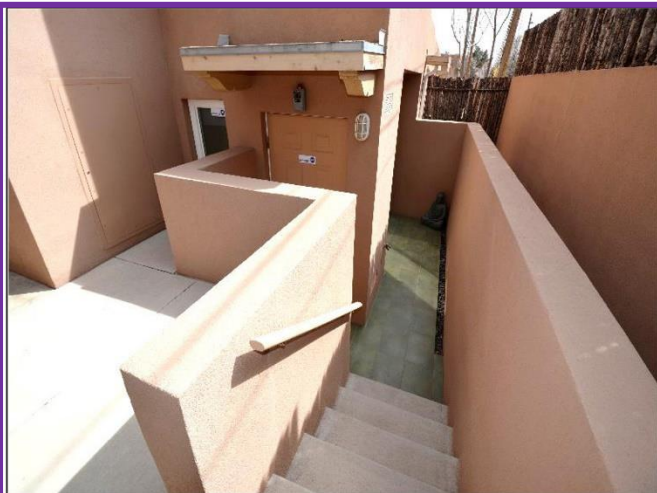
25. Outdoor Patio's lower staircase with Stucco CMU block retaining walls to the lower level subterranean Bedroom are in **Satisfactory Condition**.

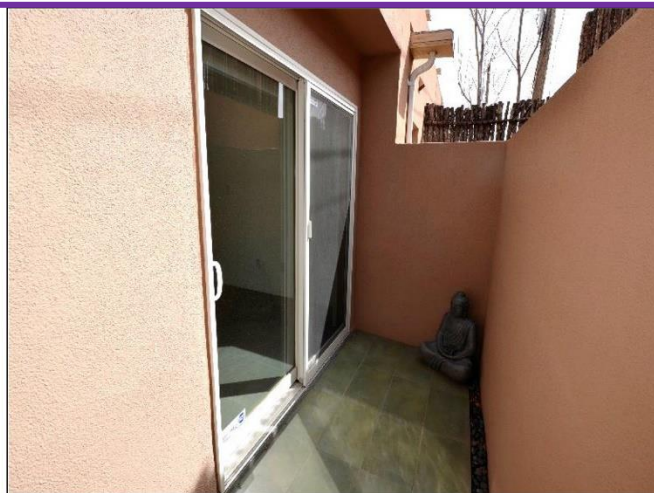
26. Outdoor Patio enclosed with Stucco CMU block retaining walls for the lower subterranean Bedroom are in **Satisfactory Condition**.

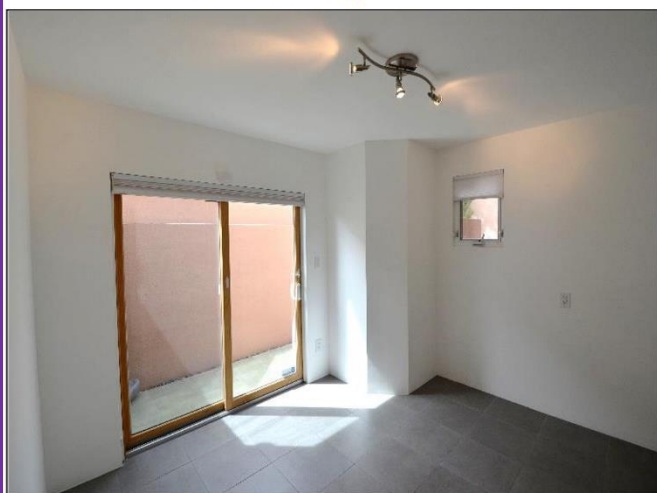
27. Lower level subterranean Bedroom with **Anderson** sliding Patio doors are in **Satisfactory Condition**.

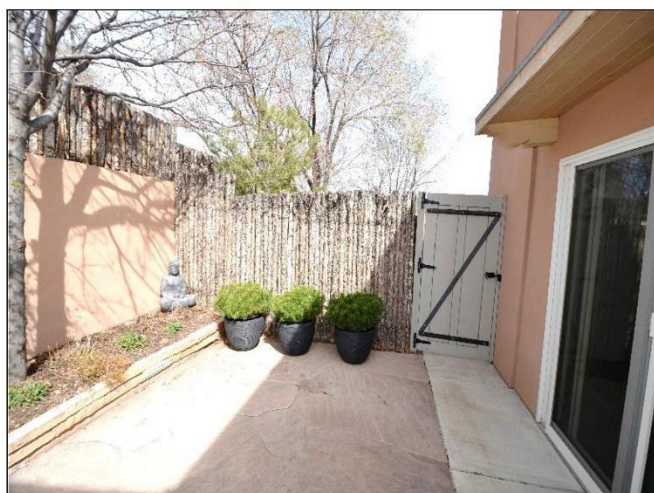
28. Outdoor Patio with cayote fencing & gate to the concrete Entrance sidewalk from the Living Room is mature and is in **Satisfactory Condition**.

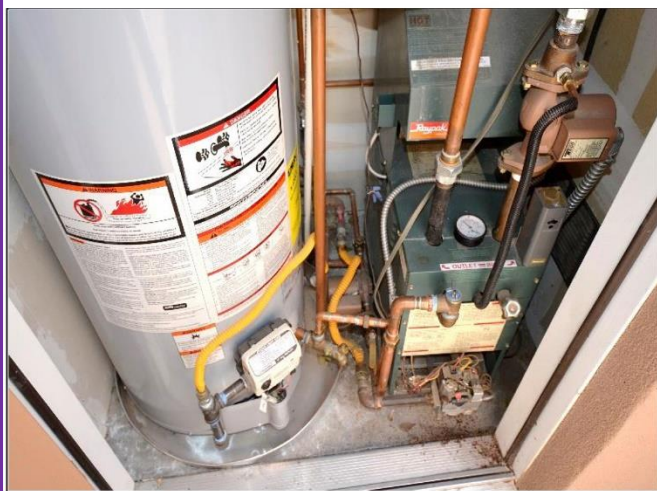
29. Mechanical closet with **Raypak** Boiler with 3-Zones and the **State Select** H₂O heater is in **Satisfactory Condition**.

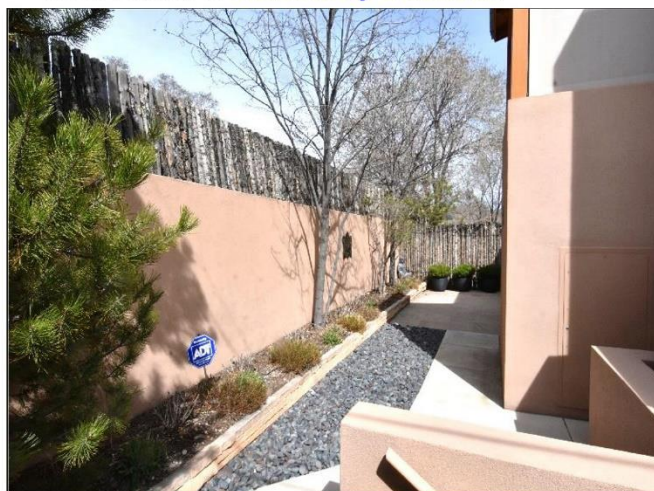
30. Outdoor Patio with concrete sidewalks and gravel are in **Satisfactory Condition**.
