COMMERCIAL CONDO INSPECTION REPORT

2019 Galisteo Street, Unit N-10/ B
Santa Fe, NM 87505

Inspection Date: 11/1/19

Report Number: **10699**

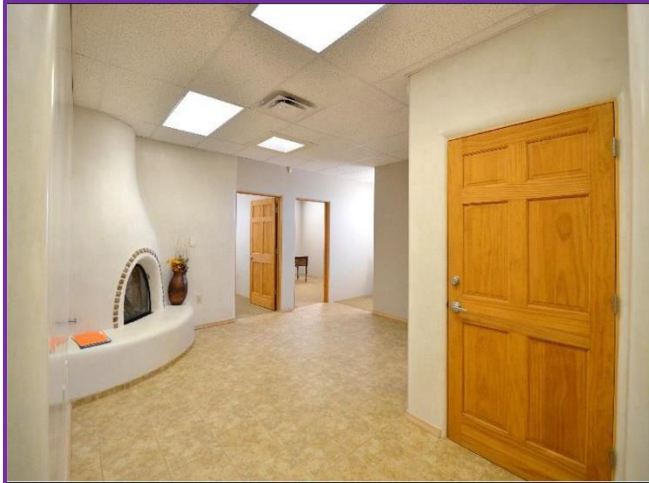
1. Reception Area with gas Kiva Fireplace, ceramic tile floors, diamond plaster walls and acoustical 9' drop ceiling is in **Satisfactory Condition**.

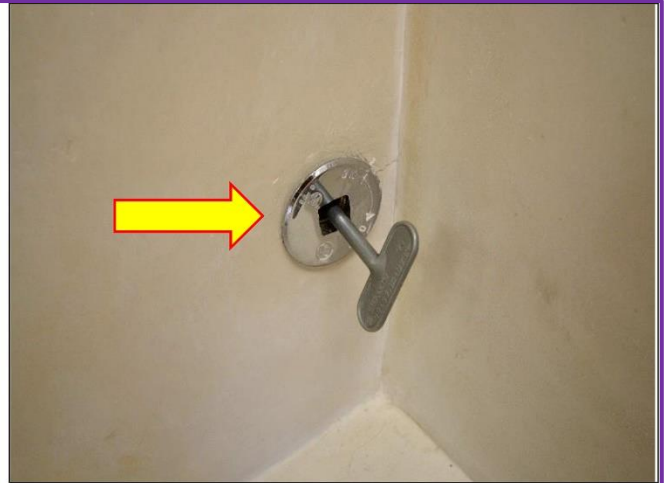
2. Gas valve to switchable Kiva Fireplace is badly stuck and won't open and needs attention.

14.1.3 The Kiva Fireplace gas valve is not operating and will need to be fixed.

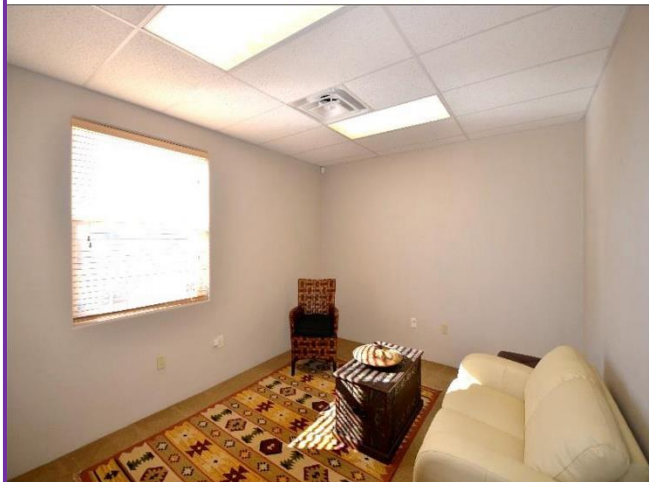
3. Office #1 with carpet floors, diamond plaster walls and acoustical 9' drop ceiling is in **Satisfactory Condition**.

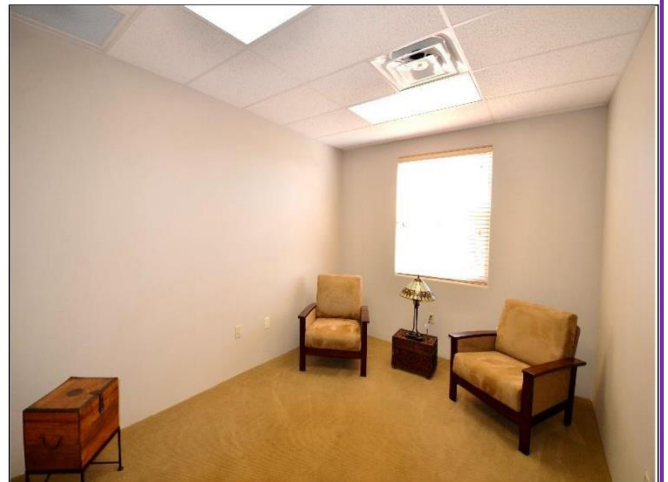
4. Office #2 with carpet floors, diamond plaster walls and acoustical 9' drop ceiling is in **Satisfactory Condition**.

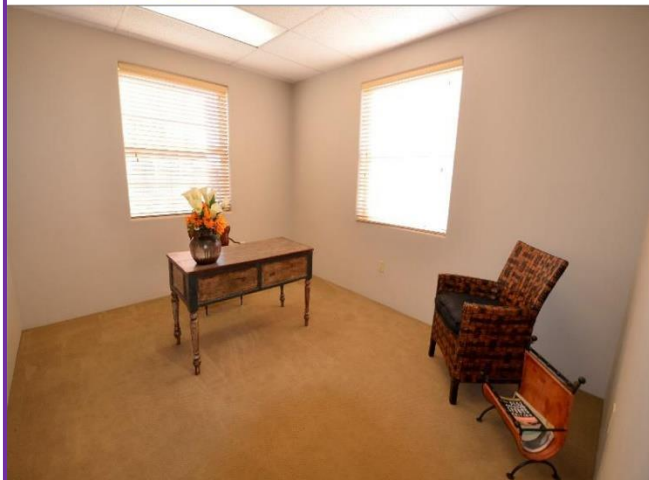
5. Office #3 with carpet floors, diamond plaster walls and acoustical 9' drop ceiling is in **Satisfactory Condition**.

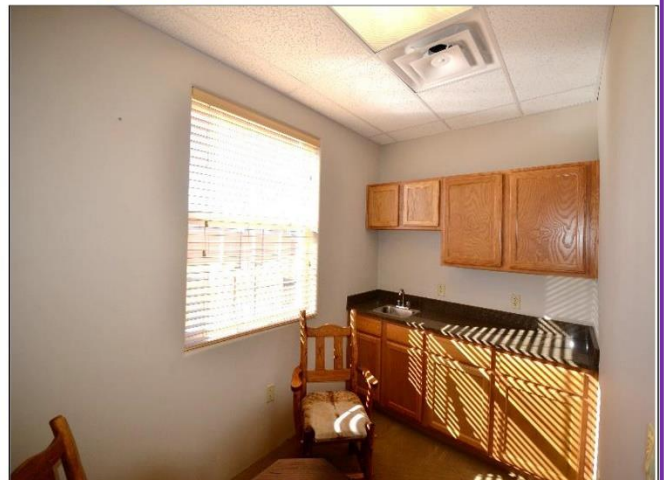
6. Breakroom with carpet floors, painted drywall, acoustical 9' drop ceiling and bar sink with cabinets is in **Satisfactory Condition**.

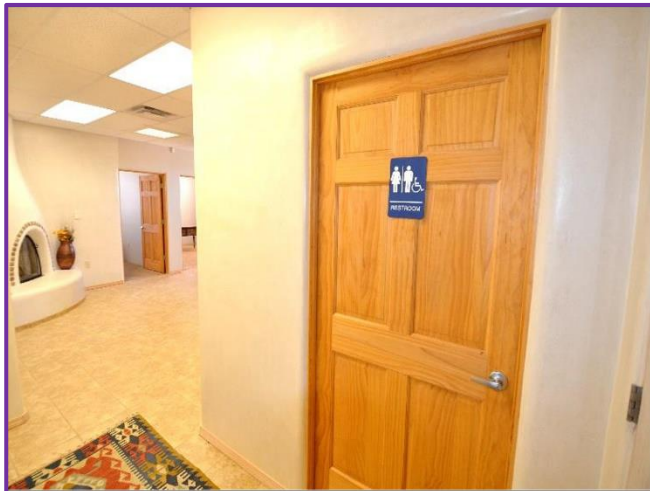
7. ADA Restroom with ceramic tile floors, painted drywall and acoustical 9' drop ceiling with toilet and wall hung sink is in **Satisfactory Condition**.

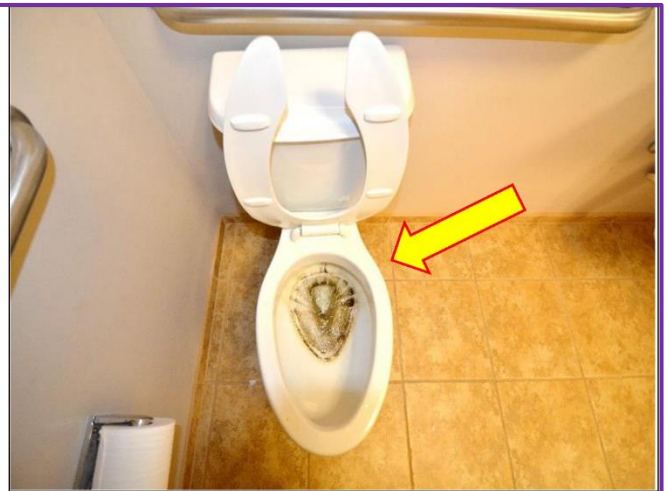
8. Sterling Toilet is badly stained and will need to be cleaned and/ or to replace if the stains are stubborn.

14.1.6 The Sterling toilet bowl in the Restroom is badly stained and will need to be cleaned or replaced.

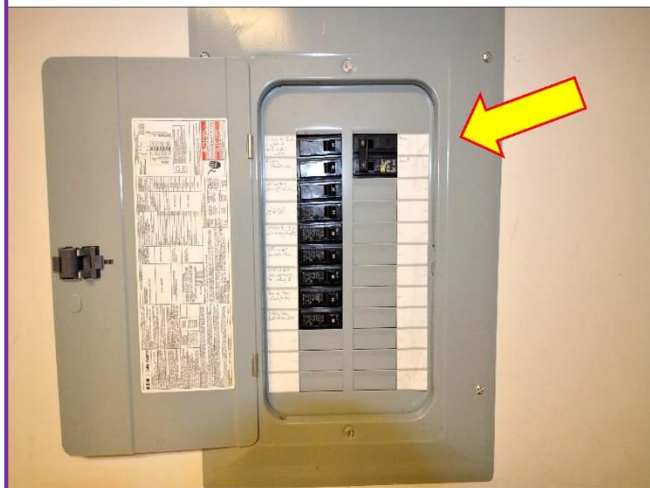
9. 200Amp rated panel in the Utility Closet is typical and has been professional installed without having a Main Disconnect Breaker.

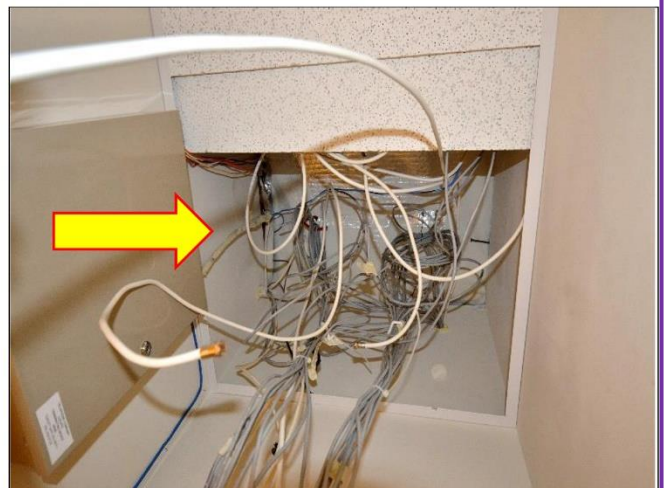
10. Communication wiring in the Utility closet is very messy and will need to be straightened out and be covered with an access panel.

14.1.7 The Communication wiring in the Utility room is messy and will need to be straightened out.

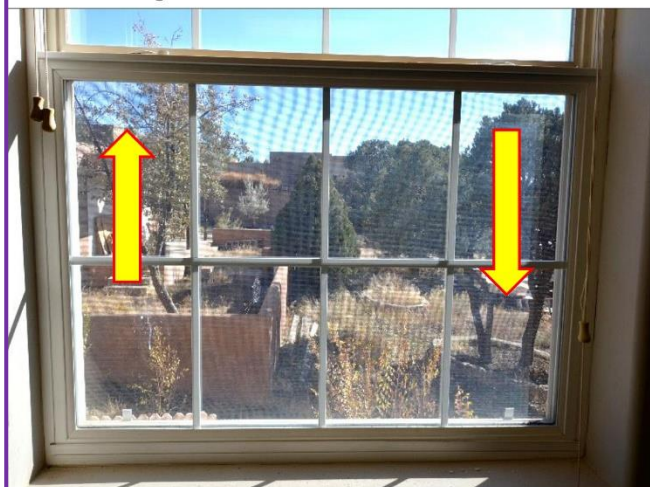
11. All of the vinyl Weather Shield Windows are difficult to operate smoothly and will need lubrication and adjustments by a Window Specialist.

14.1.4 The vinyl Weather Shield windows are difficult to operate smoothly and will need attention by a Window Specialist.

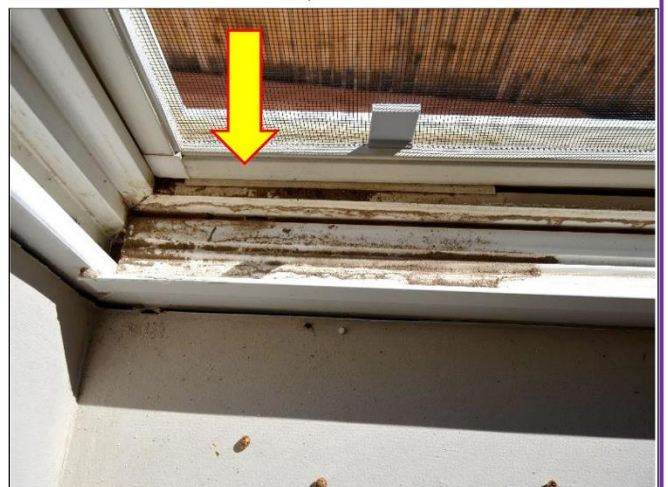
12. All of the vinyl Weather Shield Window tracks will need to be cleaned.

14.1.5 The vinyl Weather Shield window tracks are dirty and will need to be cleaned.
