# COMMERCIAL INSPECTION REPORT

**Client:**

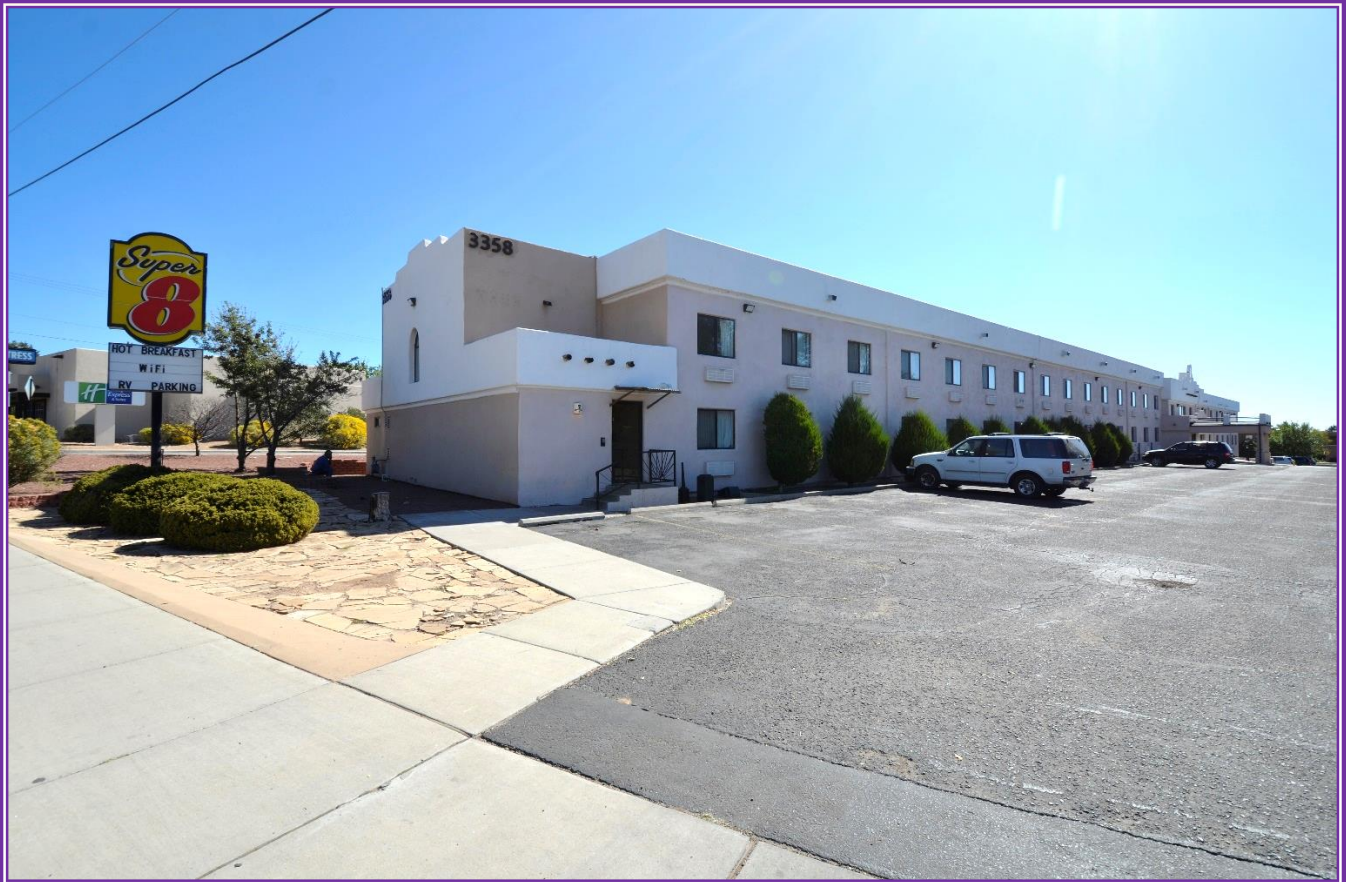
**ActiveHome INSPECTIONS™**

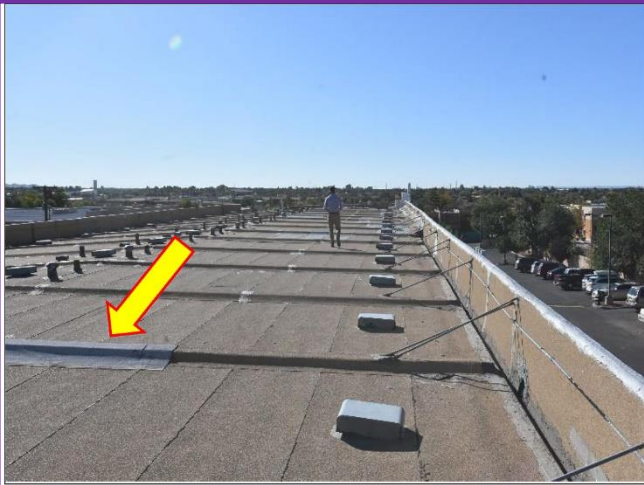
1. 1979 Portion of the Roof is Torch-down showing a lot of patching and will need professional reappointments in a timely manner.

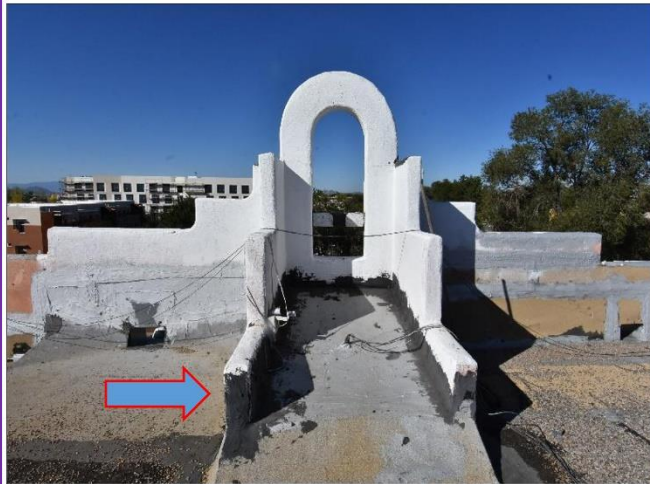
9. Faux Bell tower on the backside will need to be address with a Professional Roofing company because leaking may occur.

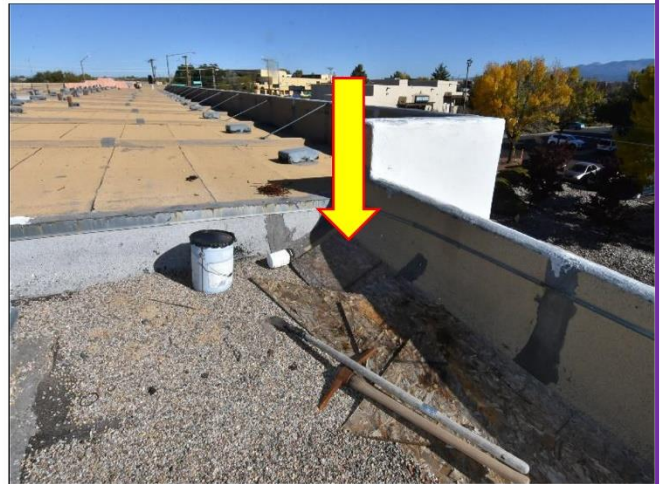
10. Debris and tools left out in the weather in bad and can cause deterioration of the membranes.

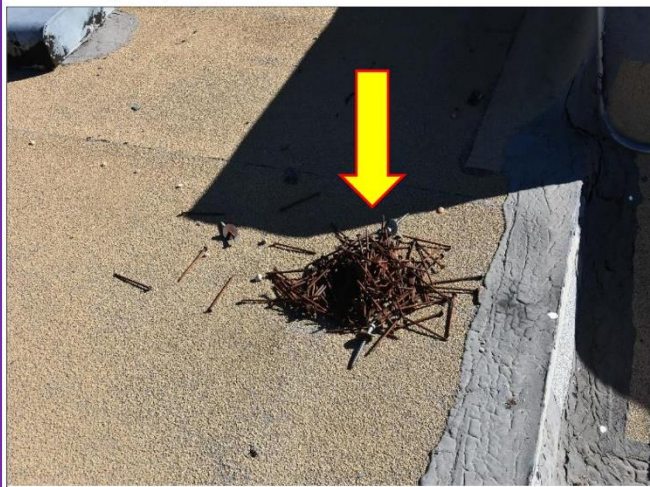
11. Left over nails that are rusted should be removed because they can cause deterioration of the membranes.

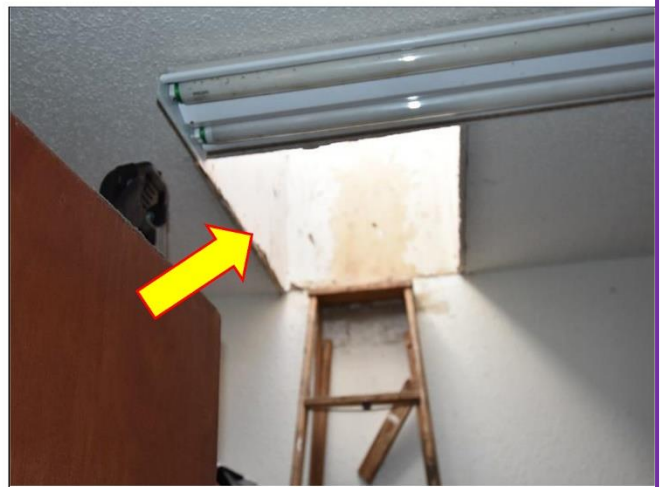
12. Hatch top the roof should have a better ladder for safety to inspect and maintained the roof.

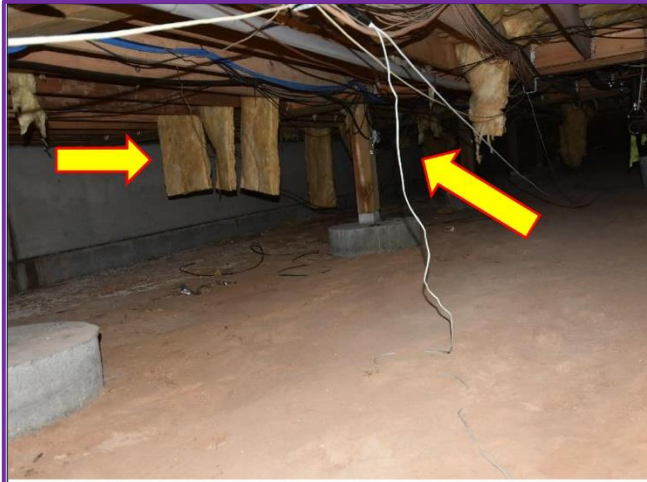
13. Under carriage of the building's Crawl Space will need attention to refasten the batt insulation and loose wires that have come loose.

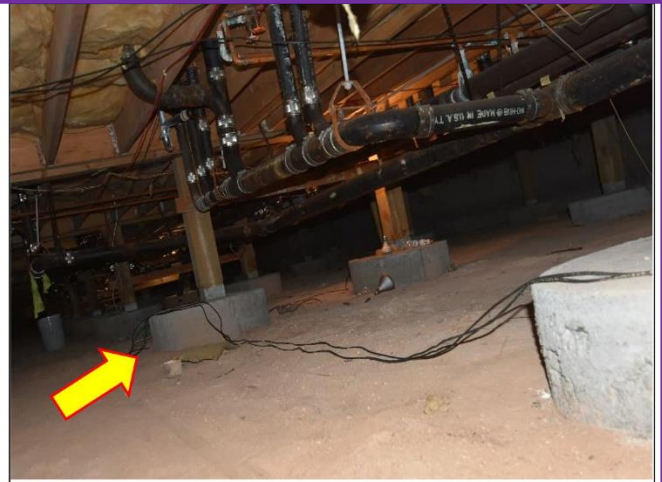
14. Crawl Space is showing a Platform type V-A construction with covered wood and supported by 4-rows of post-piers on circular concrete pads.

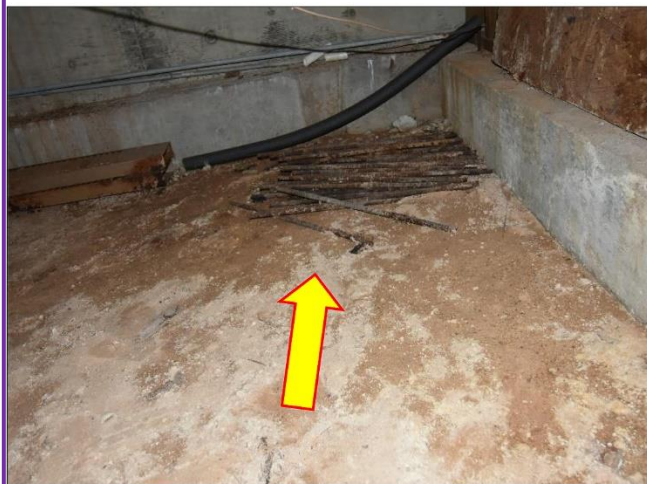
15. Moisture was found under the Crawl Space with water coming in from the exterior wall on the Northeast side that will need immediate remedies.

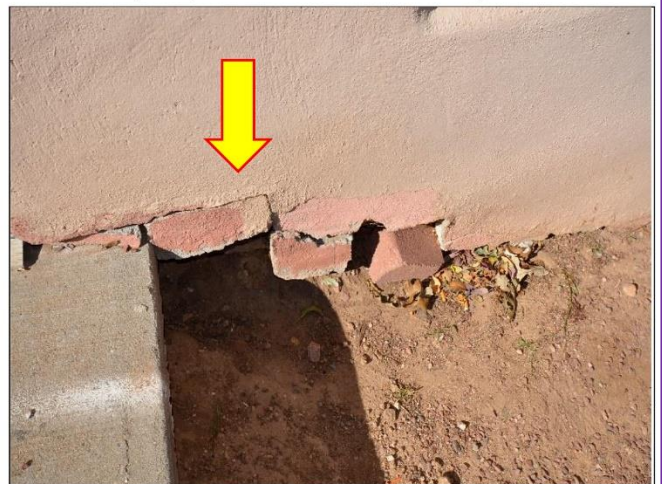
16. Water breach found on the Northeast side with loose bricks that are out of place with this type of construction should be removed with other remedies.

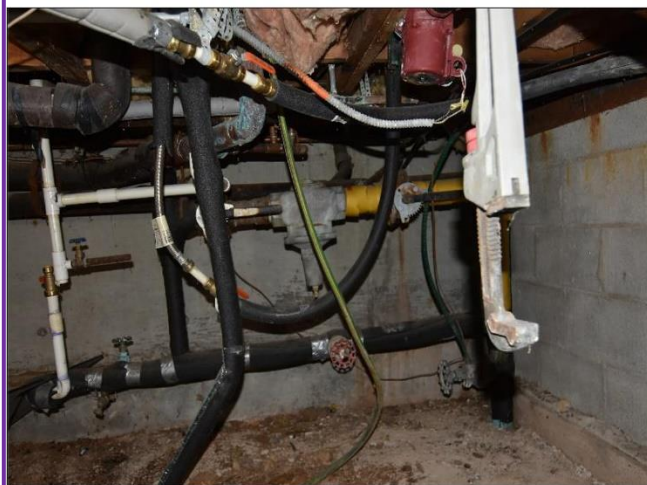
17. Plumbing pipes found under the Crawl Space seen to be reasonable with recent pipe wrap and without finding any other failures.

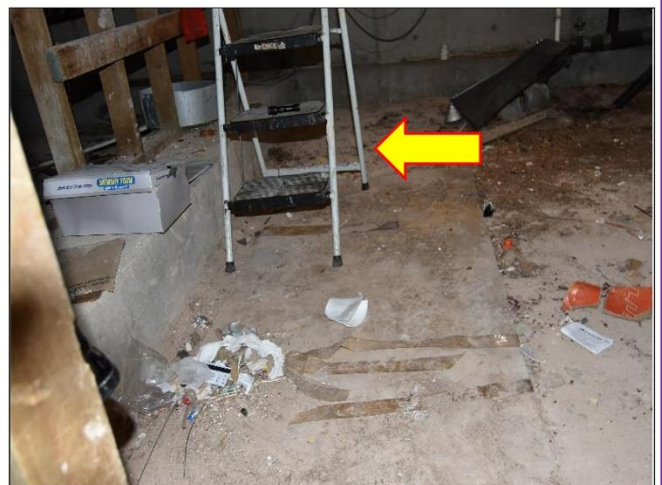
18. Access to the Crawl Space is minimal by using a kitchen type of step stool.

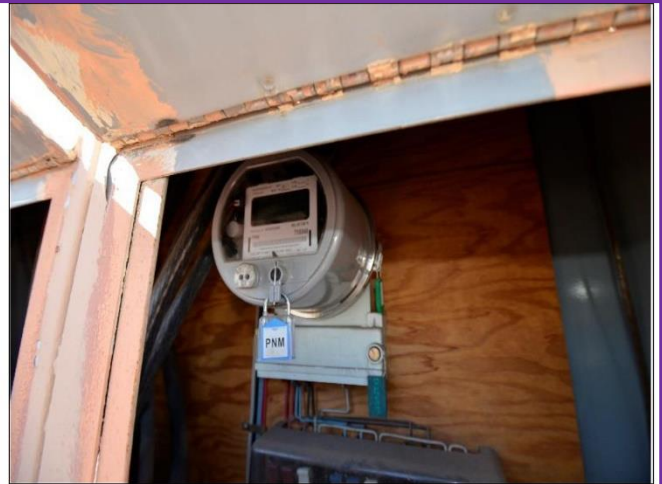
20. One PNM electrical Meter found on the East side of the Building has a cover door for readings.

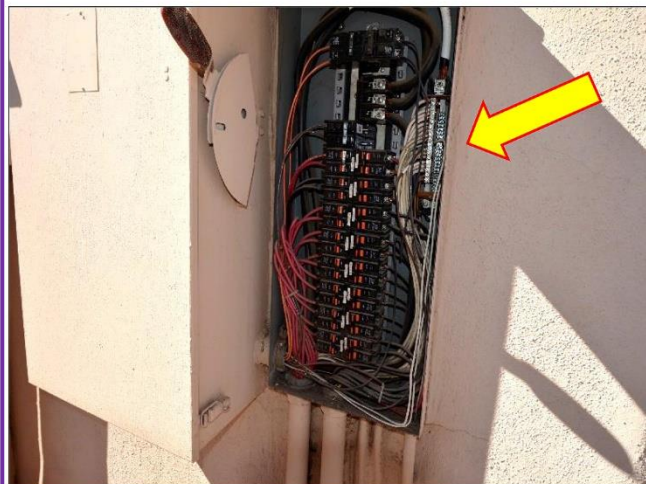
21. 200Amp panels found on the East side of the Building is in immediate need to provide an interior cover plate and an outer lockable door.

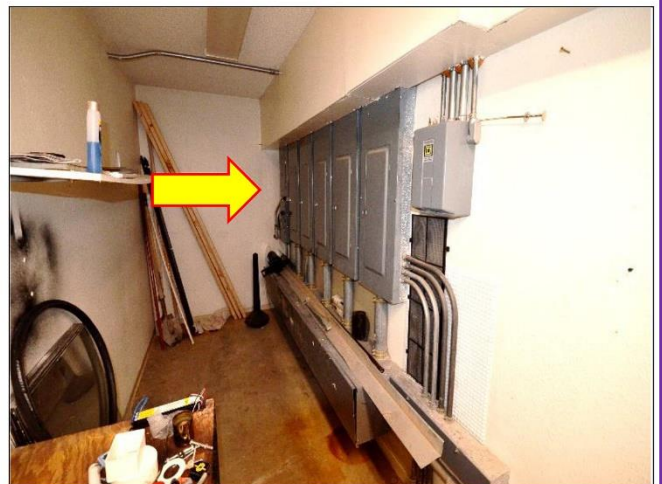
22. Five 200Amp panels found in the Service closet = 1000Amp Service to the 1989 portion of the Building. Better ventilation will be needed for this confined area.

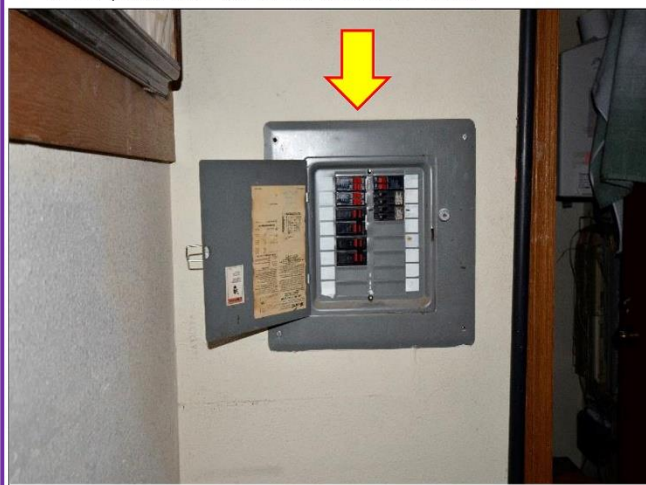
23. Typical 100Amp panel found on the First Floor of the 1979 portion of the Building having 15-panels to supply electrical circuits to 60-rooms at one per four.

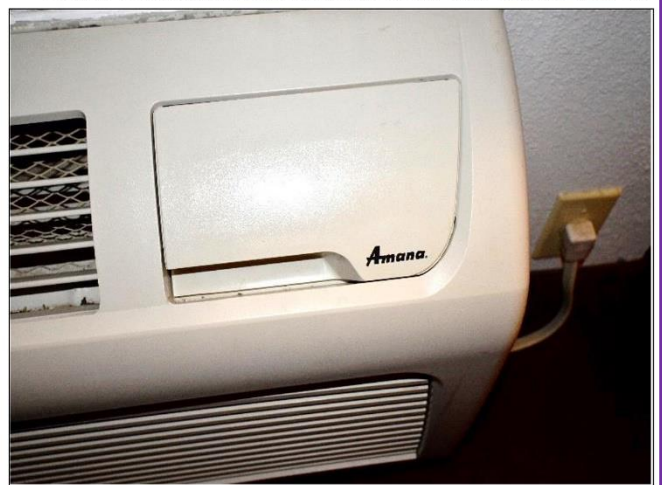
24. Typical **Amana PTAK** heating & cooling units are found in all Guest rooms and undergoing continuous maintenance and replacement as needed.

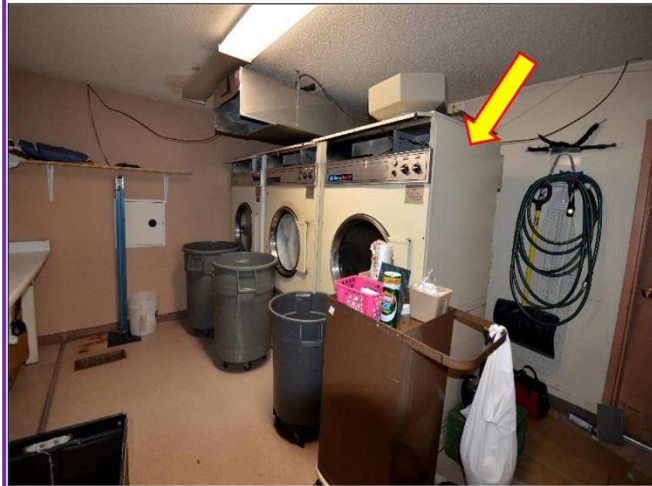
27. Three Laundry Dryers found, and one was NOT working at the time of the Inspection.

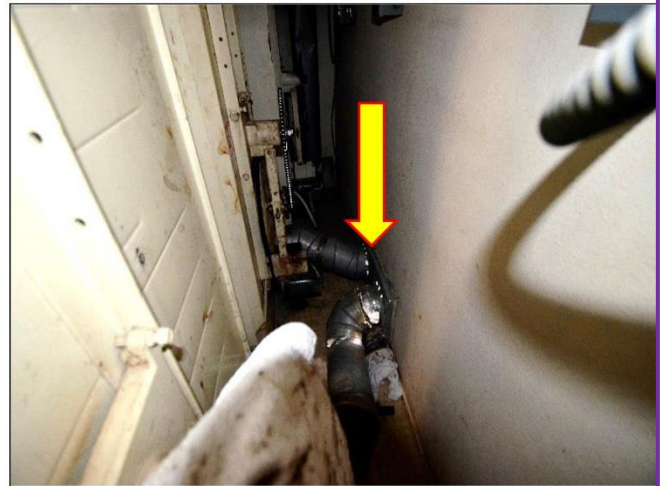
28. Ducting behind the Laundry Dryers for lint venting are badly damaged and will need to be replaced.

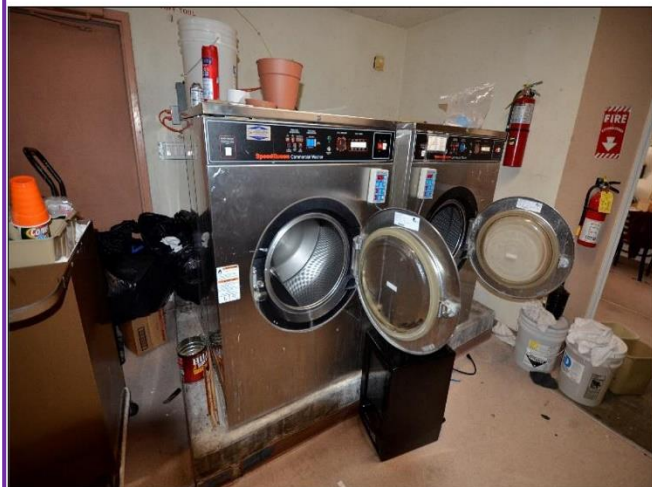
29. Two Laundry Machines found are working in good order.

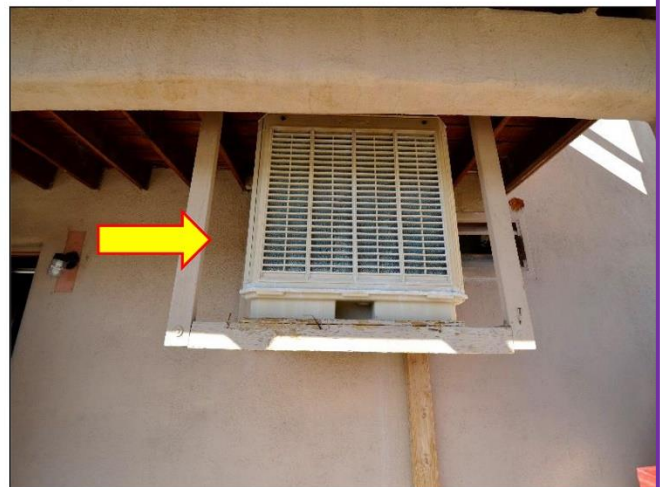
30. Swamp cooler found on the East side of the Building is for the Laundry Room only that will need annual servicing.

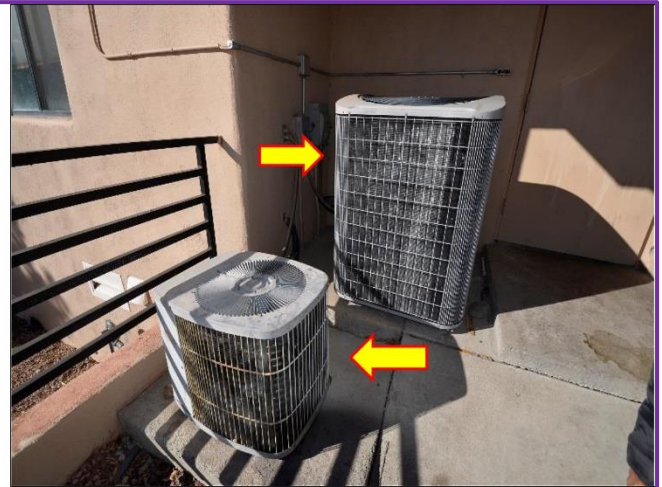
32. Two **Carrier** condensers found on the East side of the Building are for the Office, (smaller) and Lobby (larger) are for heating & cooling purposes.

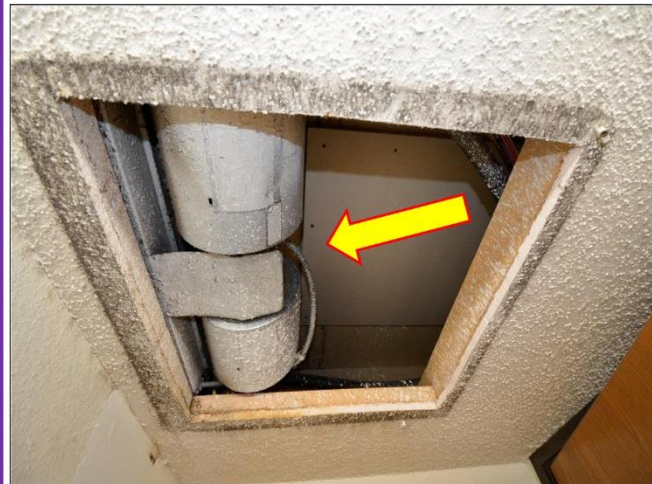
33. Inverter electrical heater for the Office in the Utility Closet's ceiling was NOT working at the time of the Inspections and will need service or replacing.

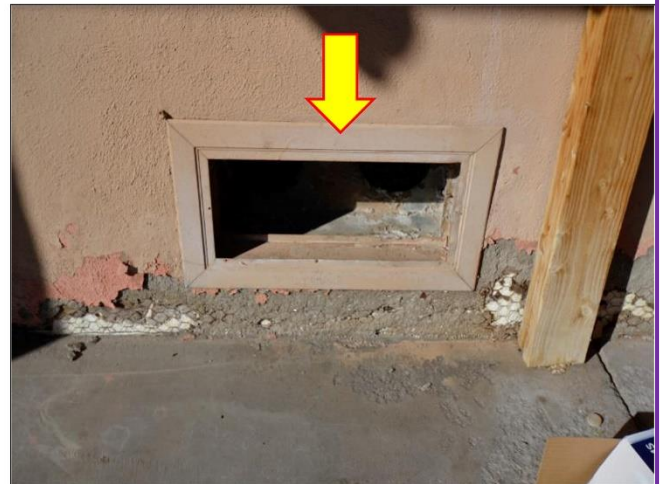
34. Vent opening at the Laundry Room needs a cover grill and the stucco wall below showing exposed lath wire will need to be repaired.

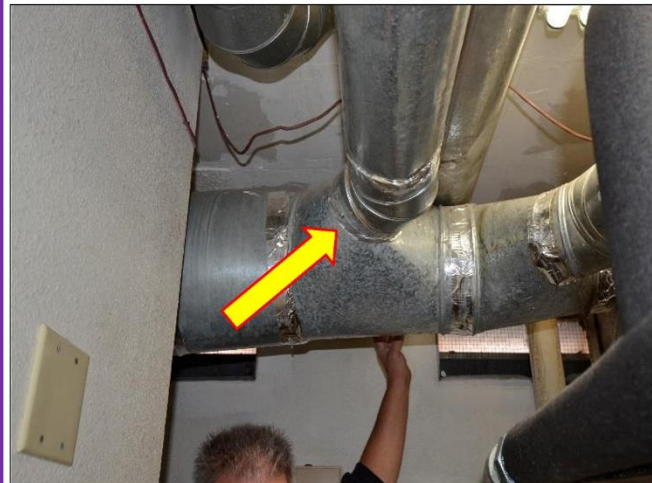
35. The Exhaust flue angle is too high and will not draft properly.

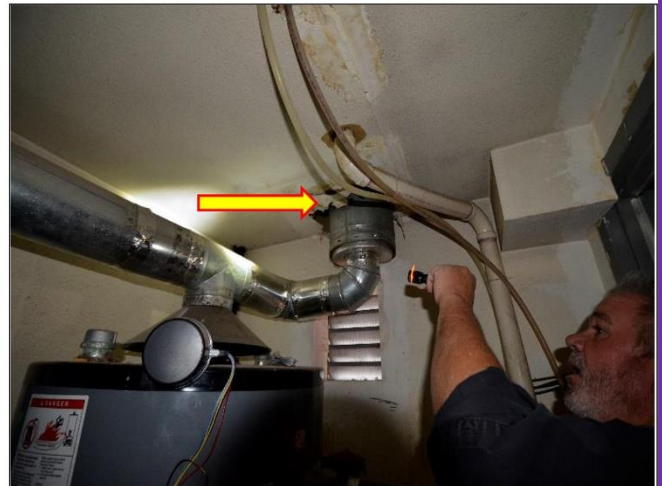
40. As per the *Thomas' Report*, the ceiling inside the Mechanical closet will need fireproofing and many other repairs.

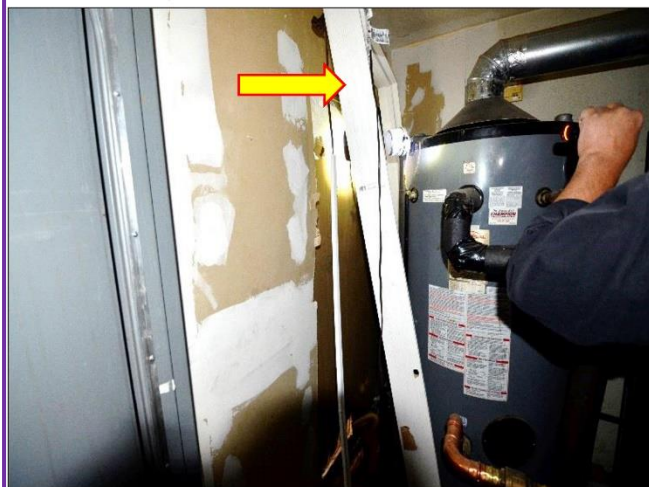
41. Mechanical closet having the two 100-gallon H<sub>2</sub>O heaters will need serious attention as reported by the *Thomas' Report*.

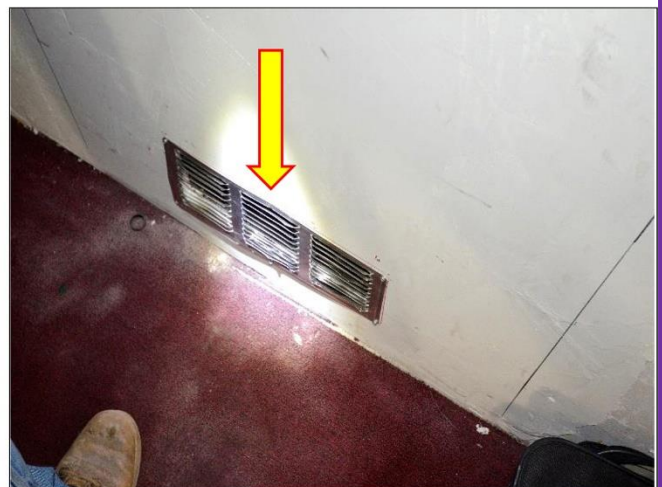
42. Outside Mechanical closet on the 1979 portion of the Building need immediate repairs as per the *Thomas' Report*. The vent is improper.

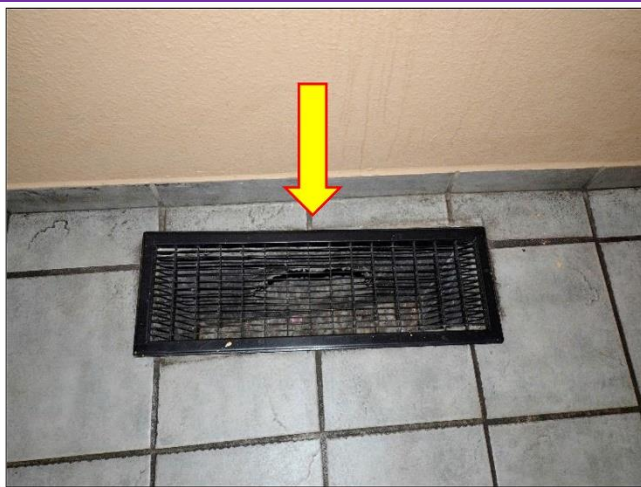
43. Downdraft vent found behind Lobby access area is for heating & cooling, but the register is loose and needs to be secured.

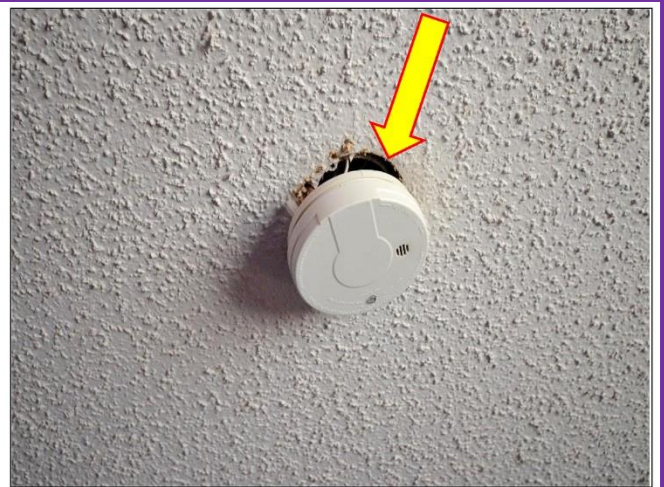
44. All Smoke Alarms throughout the Building and Guest Rooms will need to be Verified by a Licensed Electrician and Certified by the Fire Marshall.

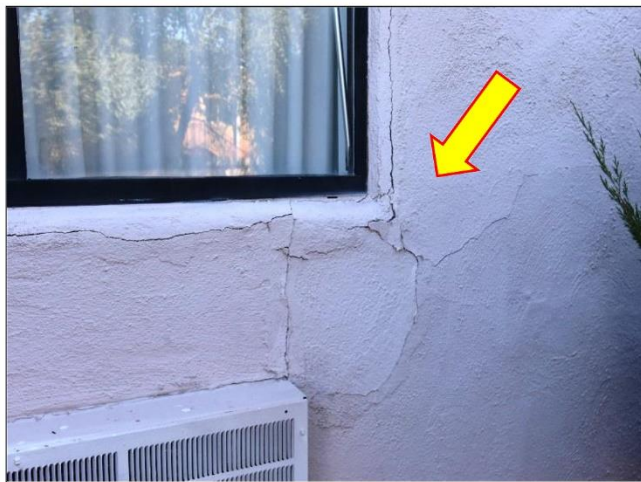
45. Example of some of the worst cracking found around windows, doors and PTAK openings that will need a Stucco repair and Stucco Restoration analysis.

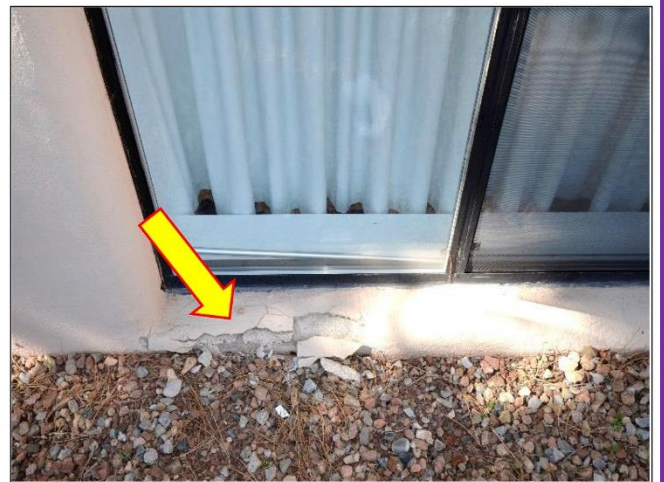
46. Windowsills at the Garden Level windows on the East side of the Building will need immediate attention for drainage and repairs to the stucco.

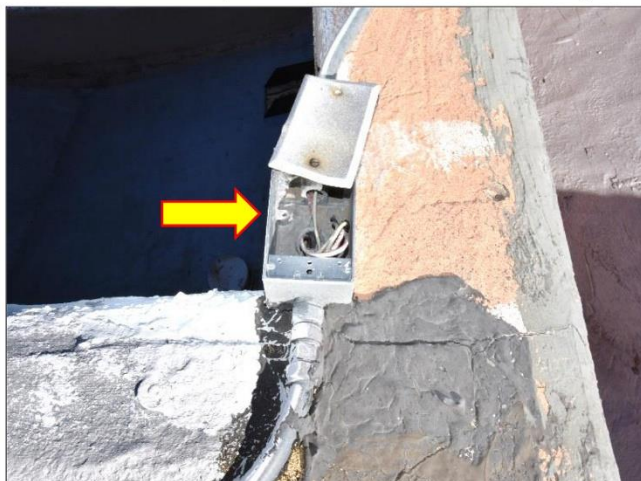
47. Example of Several electrical boxes that were missing cover plates and will need to be provided as per ICC & State UEC Codes.

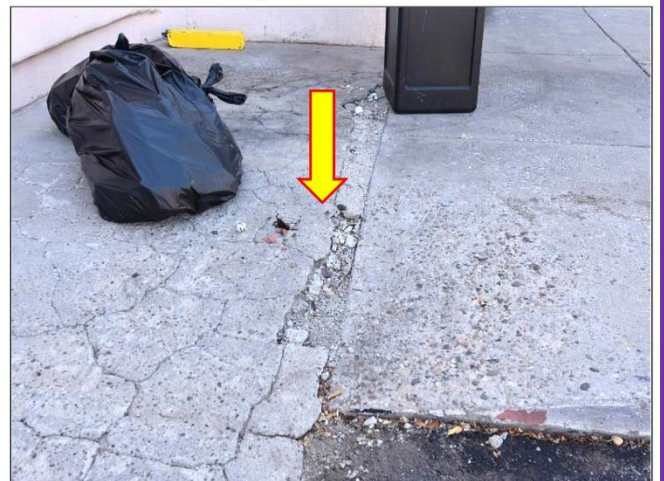
48. Example of broken Concrete flatwork that has deteriorated and will need to be removed & replaced.

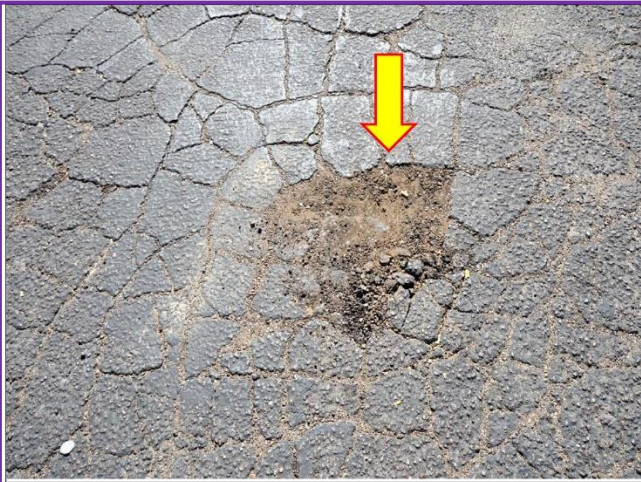
49. Asphalt driveway and parking lots have unraveled, showing alligator cracking and sinking potholes; will need a hot asphalt overlay and restripe.

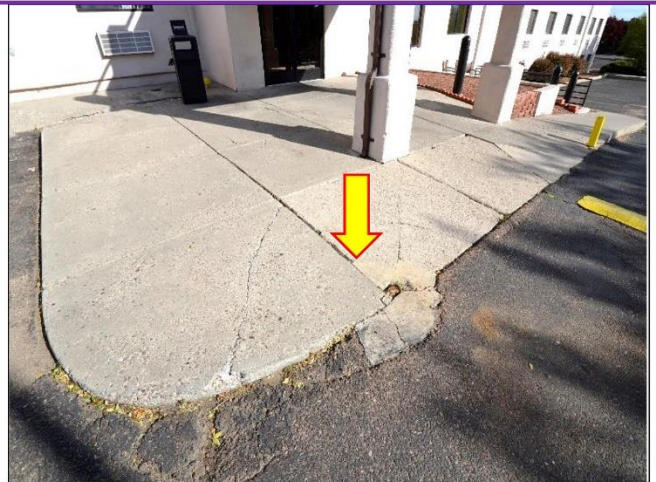
50. Concrete Flatwork is badly cracked in a few areas on the Entrance that can be tripping hazards and will need to be removed & replaced at expansion joints.

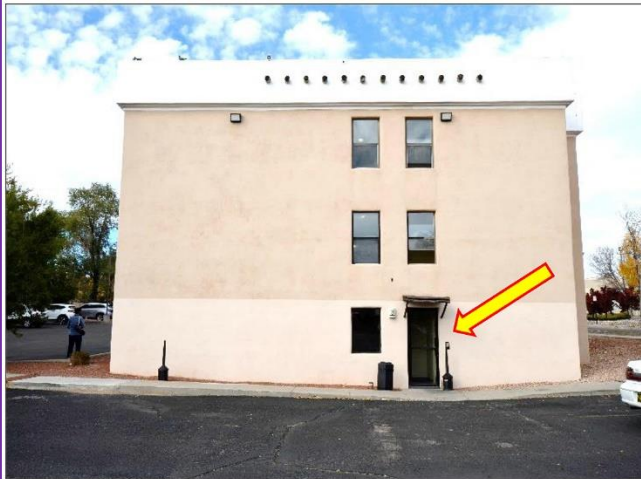
51. Garden Level floor South exit door should remain unlock and if locked should have an operating panic bar to be verified by the Fire Marshall

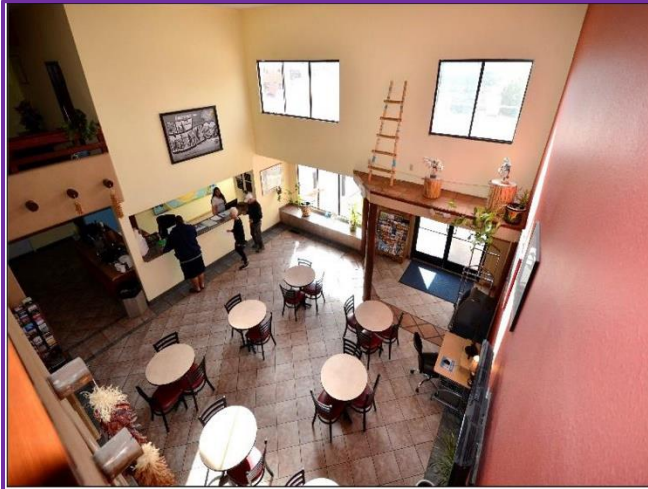
61. Balcony view of the Entrance & Lobby area are in **Satisfactory Condition.**

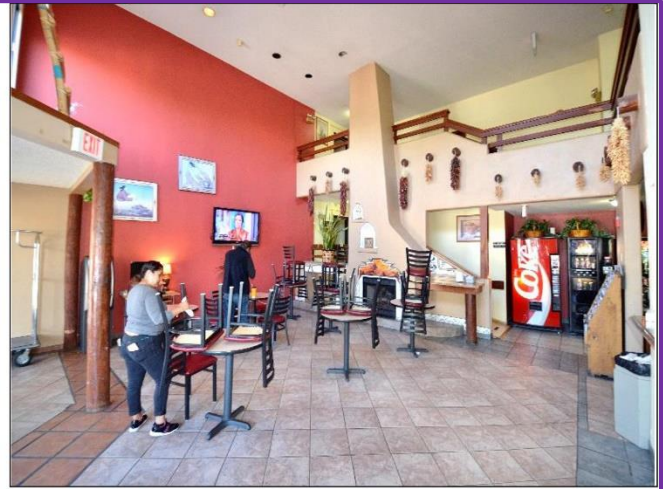
62. First Level of the Entrance & Lobby area are in **Satisfactory Condition.**

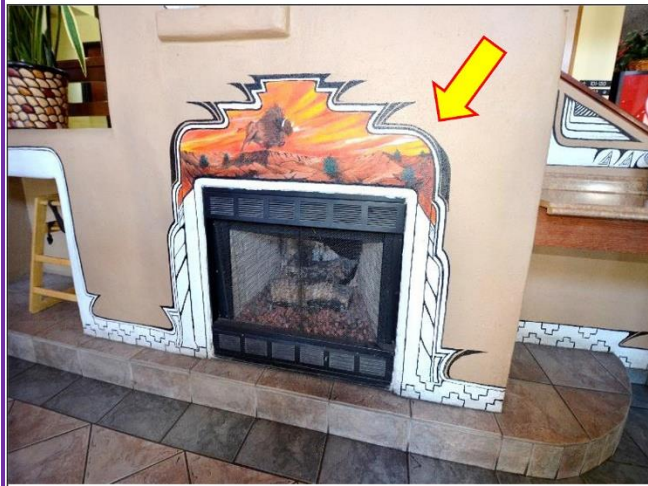
63. Lobby Gas Fireplace needs maintenance.

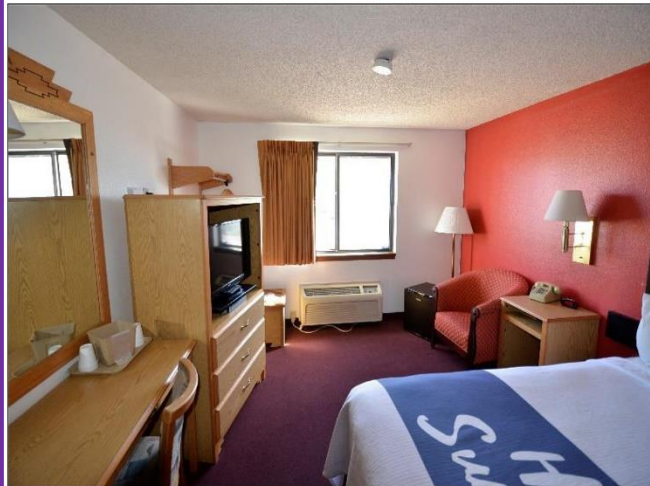
69. Typical Single Guest Room is in **Satisfactory Condition.**

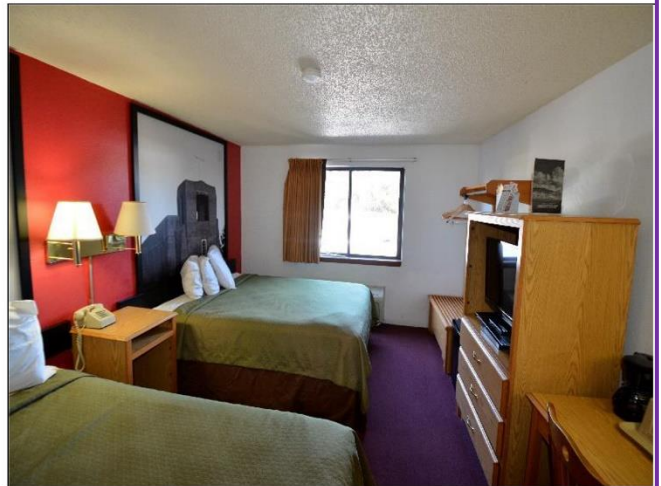
70. Typical Double Guest Room is in **Satisfactory Condition.**

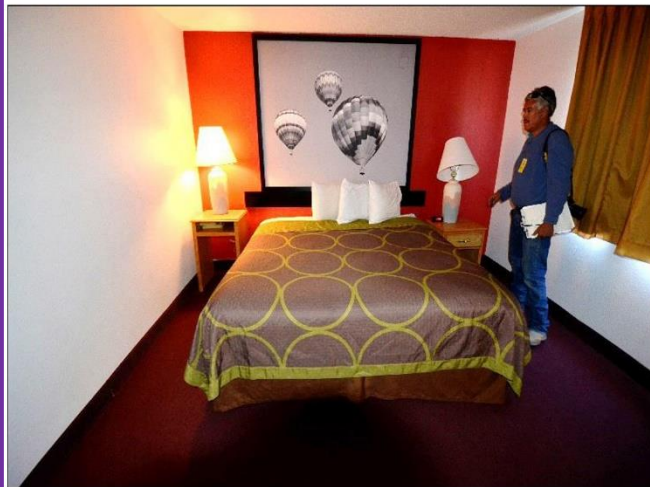
71. Typical Guest Suite out of four Suites are in **Satisfactory Condition.**

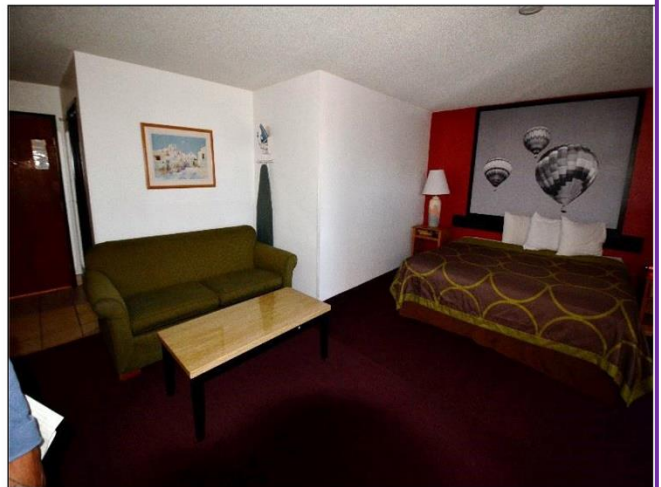
72. Typical Guest Suite out of four Suites are in **Satisfactory Condition.**

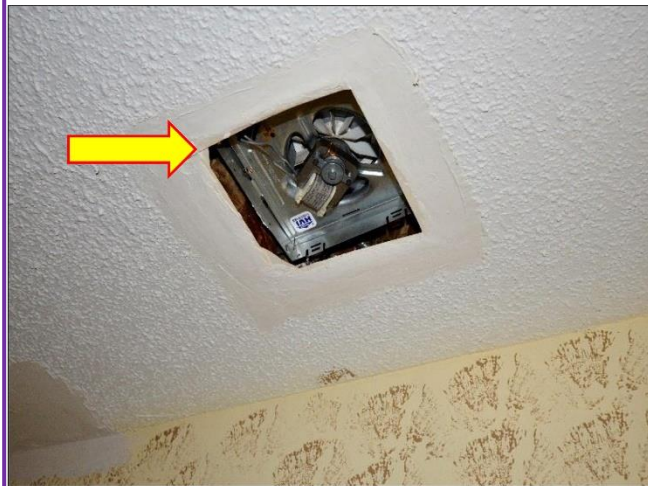
75. Bathroom fan is missing cover and all fans will need to be verified.

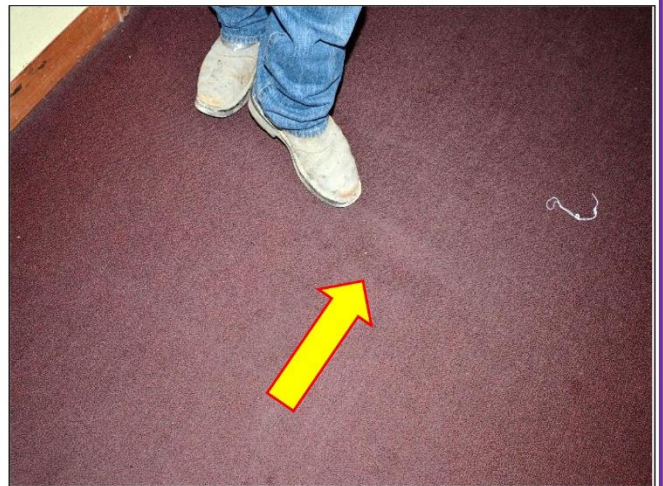
76. Hallways on the 1979 portion of the Building has many soft spots and seam separations under the carpeting that will need immediate attention.

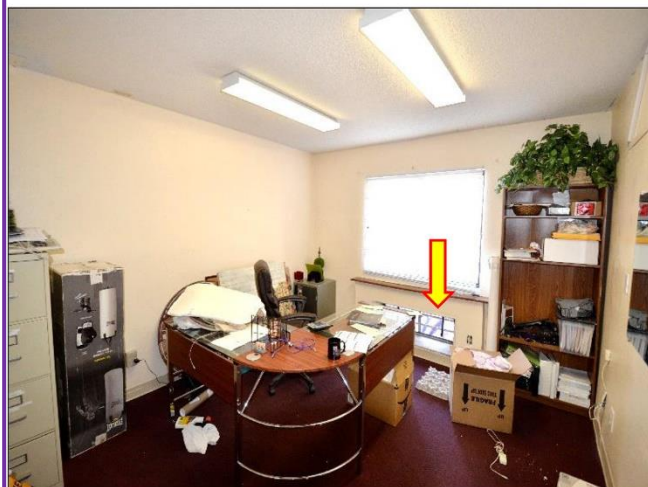
77. Manager's Office behind Reception desk is missing a PTAK heating & cooling Unit.

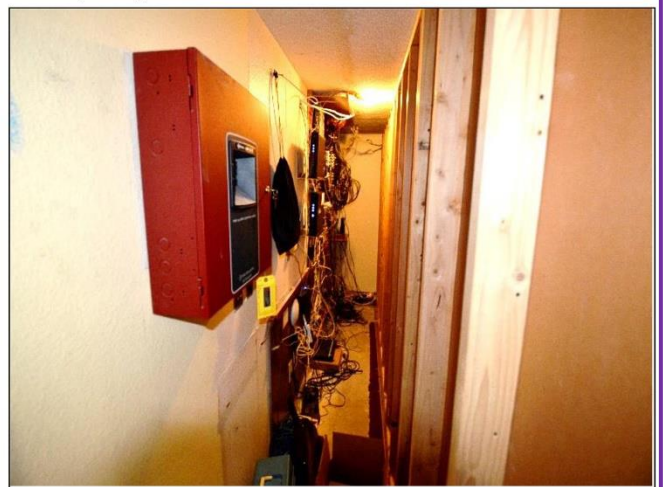
78. Communication closet for Guest rooms is between Office and Reception desk.

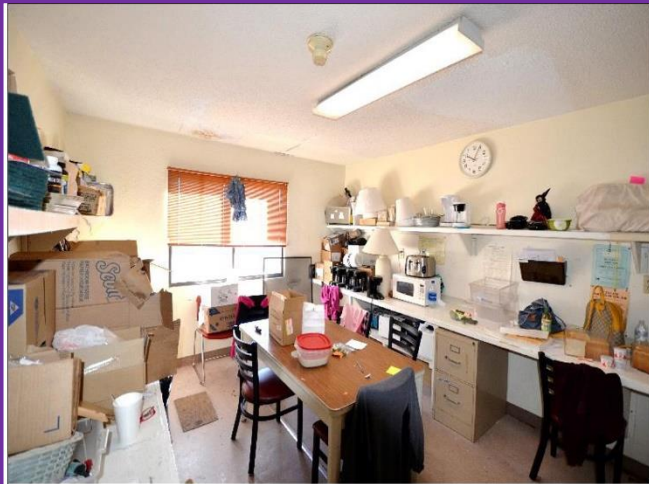
79. Employee's break and lunchroom is in **Satisfactory Condition.**

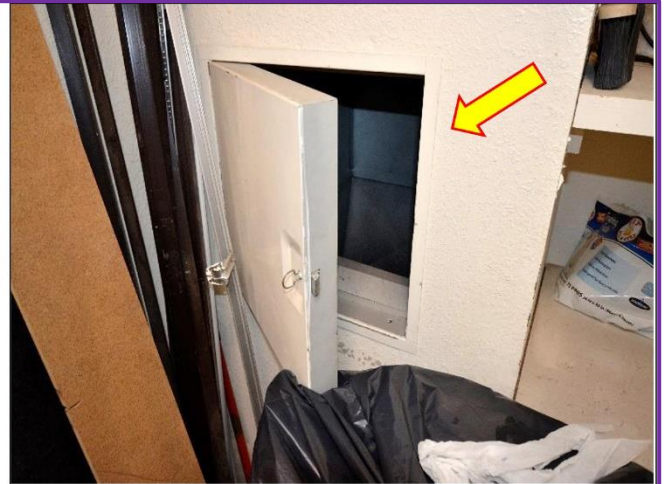
80. Two story Laundry shaft to Laundry room is not in use.

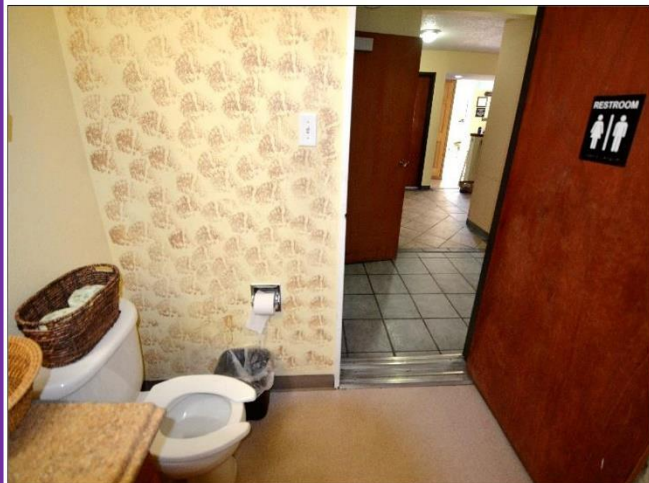
81. Bathroom behind Lobby Hallway is for Public Use is in **Satisfactory Condition.**

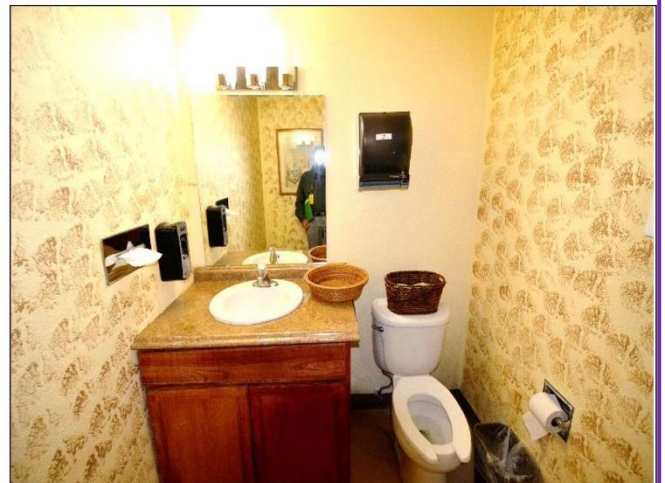
82. Public Bathroom is not ADA compliant without have grab bars, etc.

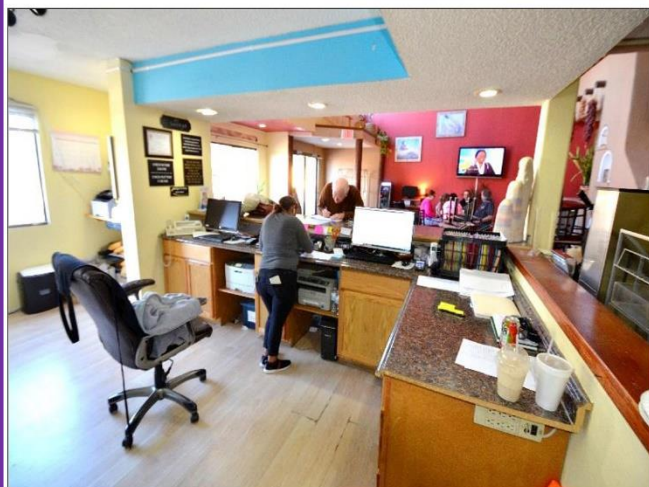
83. Lobby Reception Desk is in **Satisfactory Condition.**

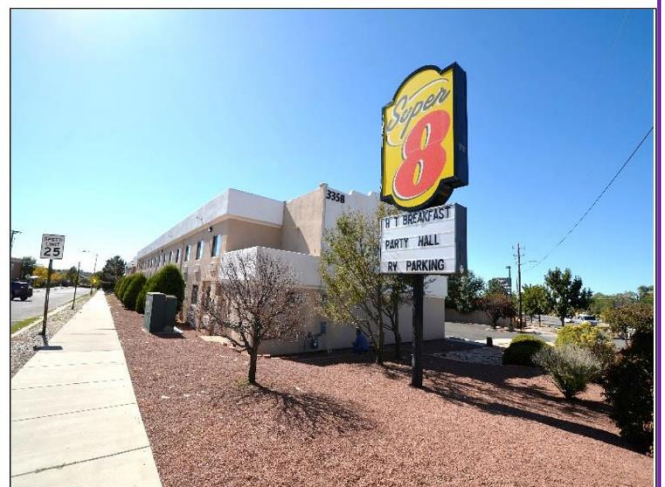
84. Street frontage and signage is in **Satisfactory Condition.**
