# COMMERCIAL INSPECTION REPORT

150 South Saint Francis  
Santa Fe, NM 87501

Inspection Date: 8/12/17

Report Number: **10362**

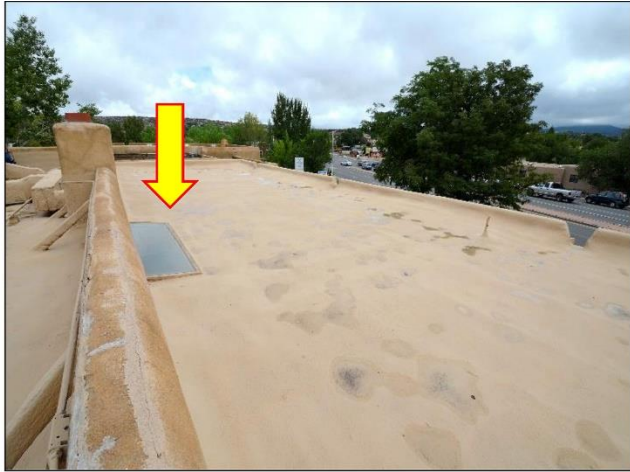
1. South Building Entrance Portal is the Best Foam roof with a longevity of over 20-years. Flat Skylight is questionable.

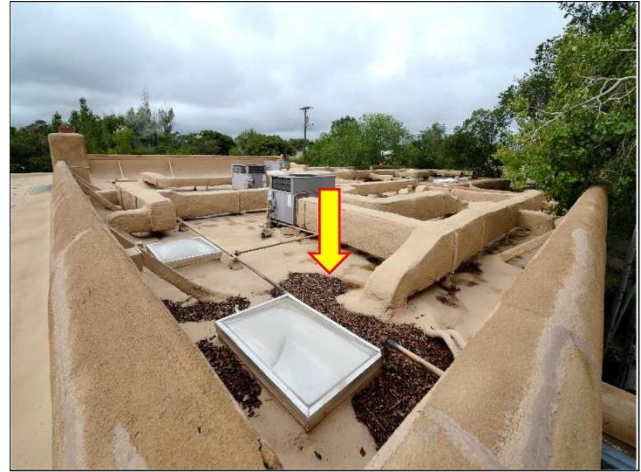
- 9.2.1 The ballast covered roof membrane cover appears to be in serviceable condition.  
 9.2.2 There is evidence of leakage and evidence of past repairs.  
 9.2.3 There was an obvious breach on the Foam at the front of the South Building that needs immediate repair.  
 9.2.4 An infrared roof survey would be recommended to identify areas of necessary repair.  
 9.2.5 The Hot/ Tar & Mob roof covering is in the 11<sup>th</sup> year of a 30-year life expectancy.  
 9.2.6 The front Portal on the South Building are in Good condition.  
 9.2.7 Proper walking surfaces should be installed on the roof to facilitate servicing of equipment.

2. South Building Foam & GACO Roof is full of debris and needs a serious clean and a reappointment due to breaches found on the membrane.

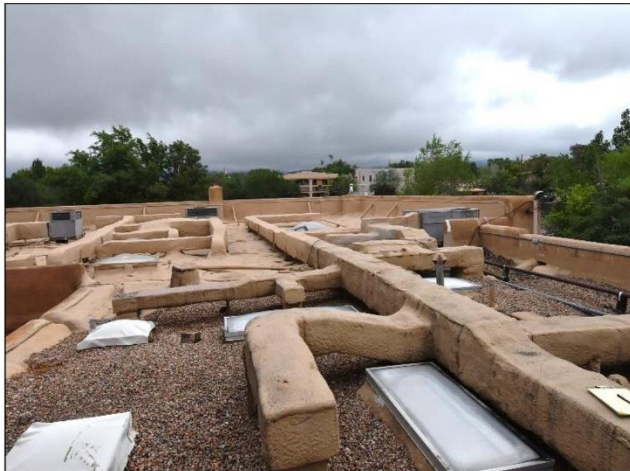
3. Rear Section of foam roof w/ rock on the South Building showing all the ducting needs maintenance to improve on its roofing integrity.

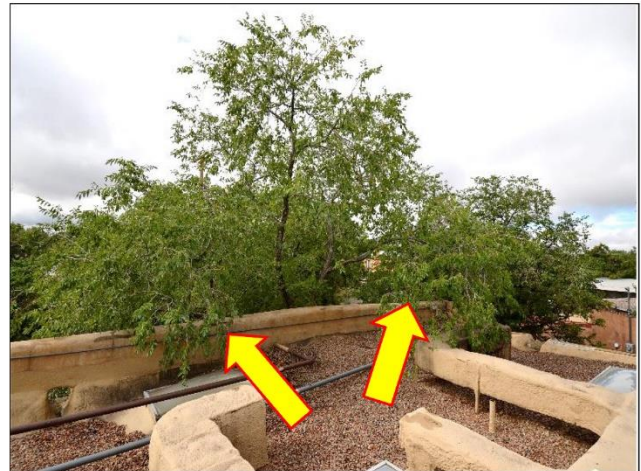
4. Over grown trees needs to be trimmed back to keep their leaves for clogging the drainage Canales on the roof.

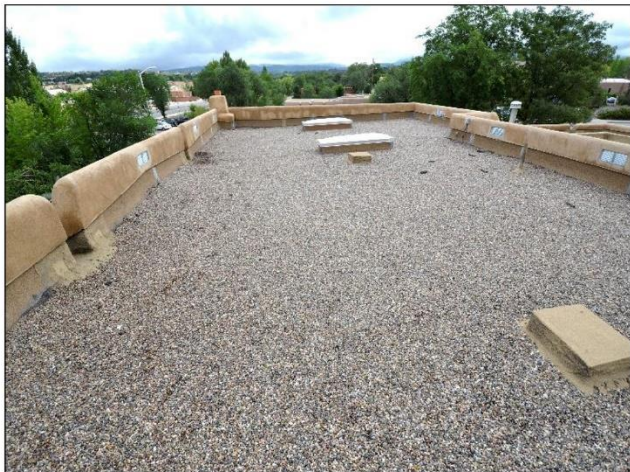
5. North Building Hot/ Tar & Mop roof is in Good Condition with minimal reappointments necessary.

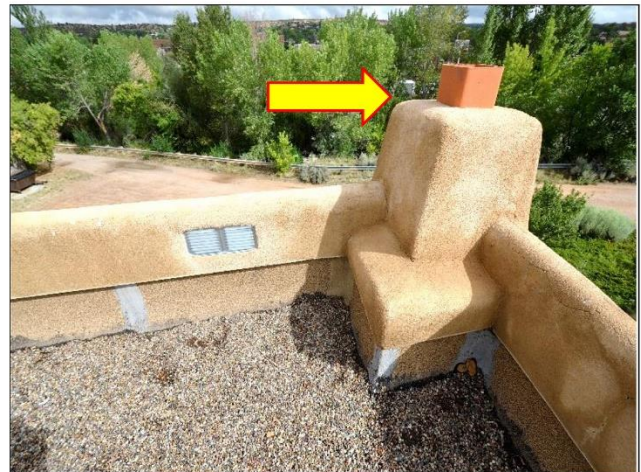
6. Chimneys need spark arrester as per city fire codes.

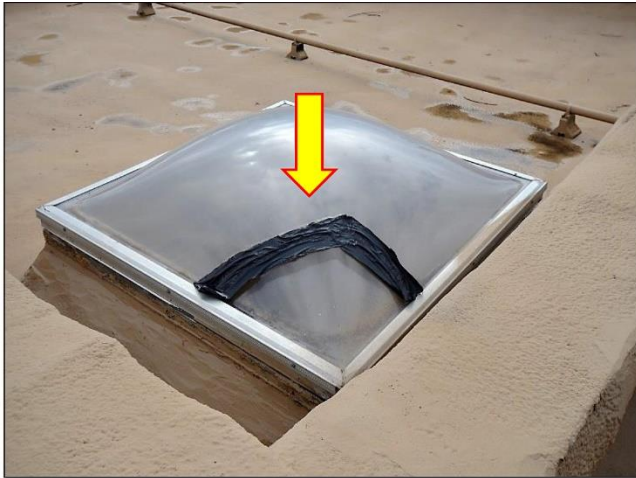
- 9.1.3 Skylights need raising to avoid problems due to their curbs being too low to keep out thawing snow causing leaks. One Skylight is cracked and needs to be replaced.

7. Cracked Skylight is tapped and needs to be replaced.

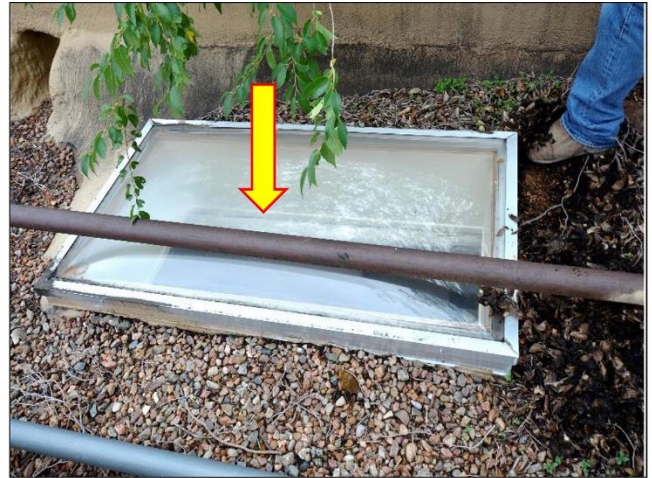
8. Skylight should be removed and/ or gas pipe should be relocated. Curbing is too low and a heavy snow load could cause leaks.

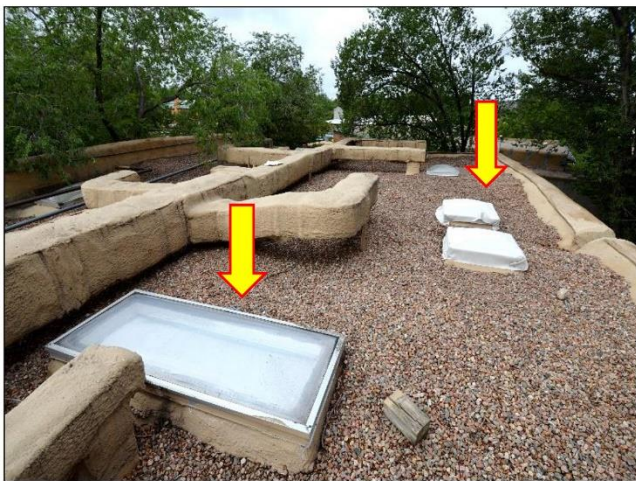
9. All the Skylights on the rear section of the South Building should be raised because the curbs are too low and will leak after a snow fall.

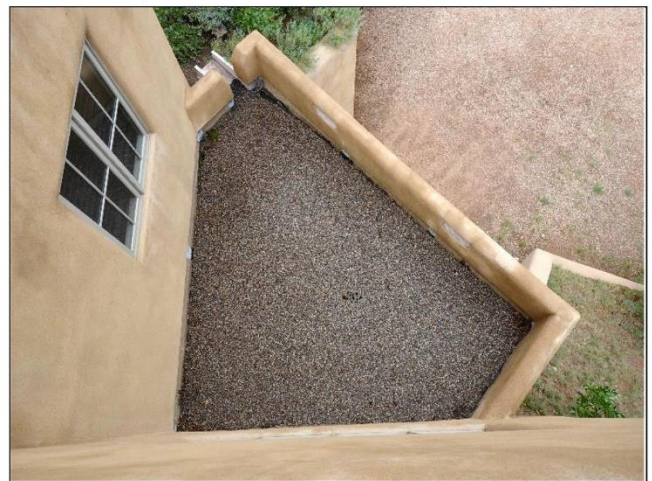
10. Lower roof apron with one drainage Canale of the North Building is in Good Condition.

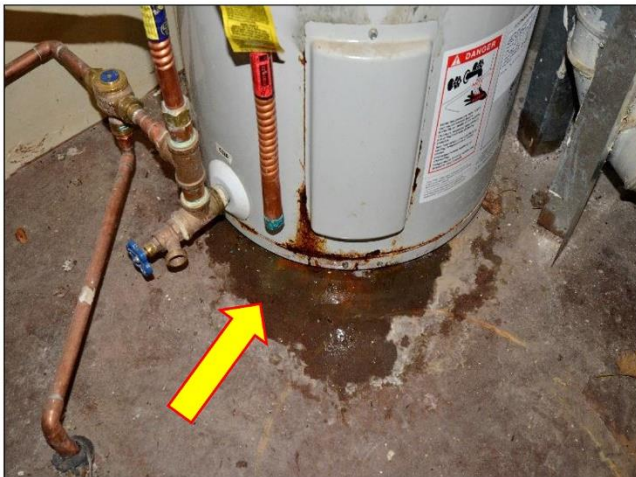
- 8.2.1 The North Building's 20-gallon H<sub>2</sub>O heaters is defective, rusted and is leaking water on the concrete floor and running to the floor drain. This needs to be replaced.
- 8.2.2 The location of the main water line to the property was located on the Southside of the South Building and is branched out to the North Building. determined.

11. 20-gallon Lochinvar H<sub>2</sub>O is badly leaking due to rust and needs to be replaced.

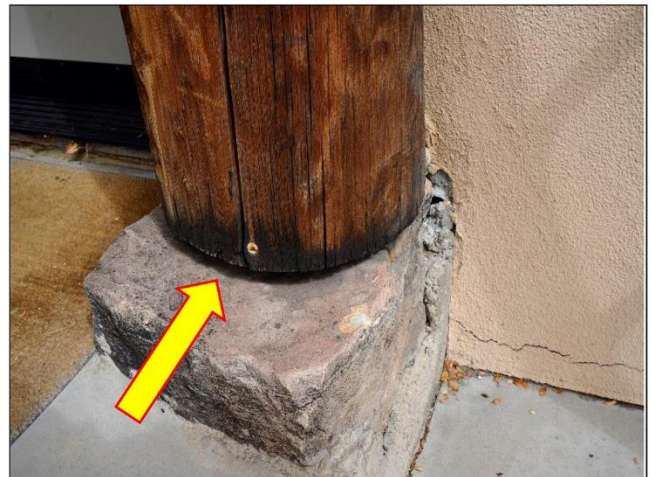
12. Viga post under the North Building Portal need to be grouted for better stability.
