Project #2017-10362  
August 31, 2017

**Phase I Environmental  
Site Assessment**  
(ASTM E 1527-13)  
**150 South Saint  
Francis Drive  
Santa Fe, New Mexico 87501**

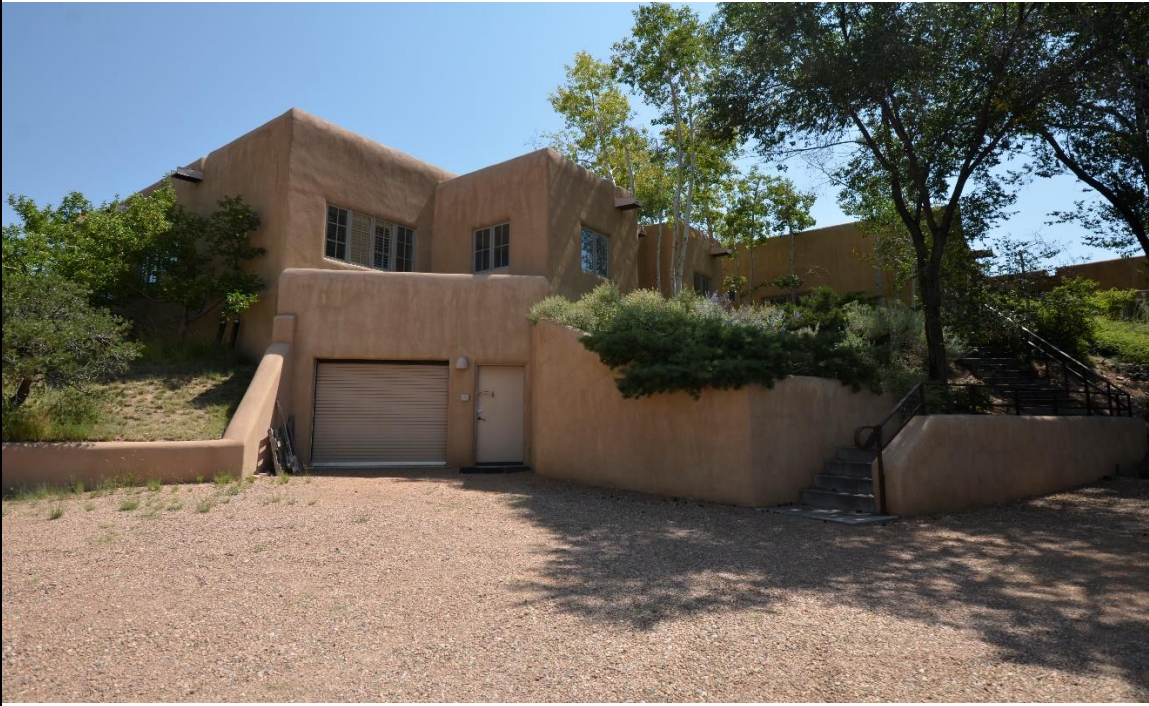
Property overview – North Elevation with natural surface drainage.

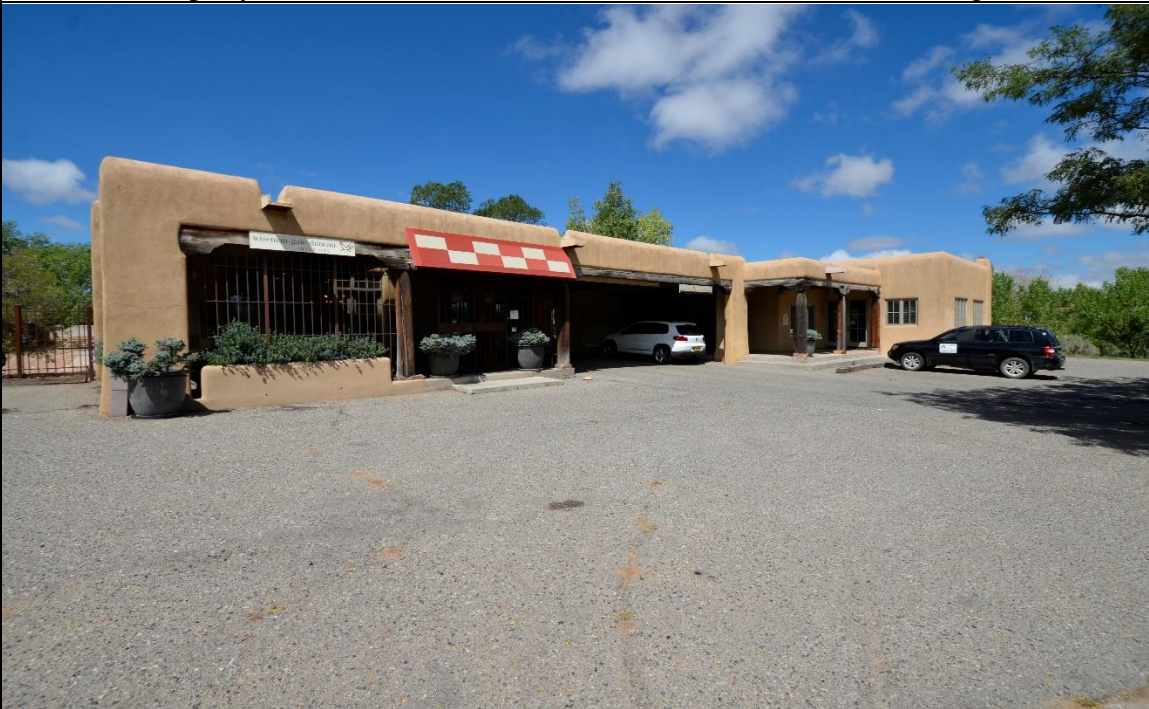
Property overview – East Elevation on the frontage of St. Francis Drive.

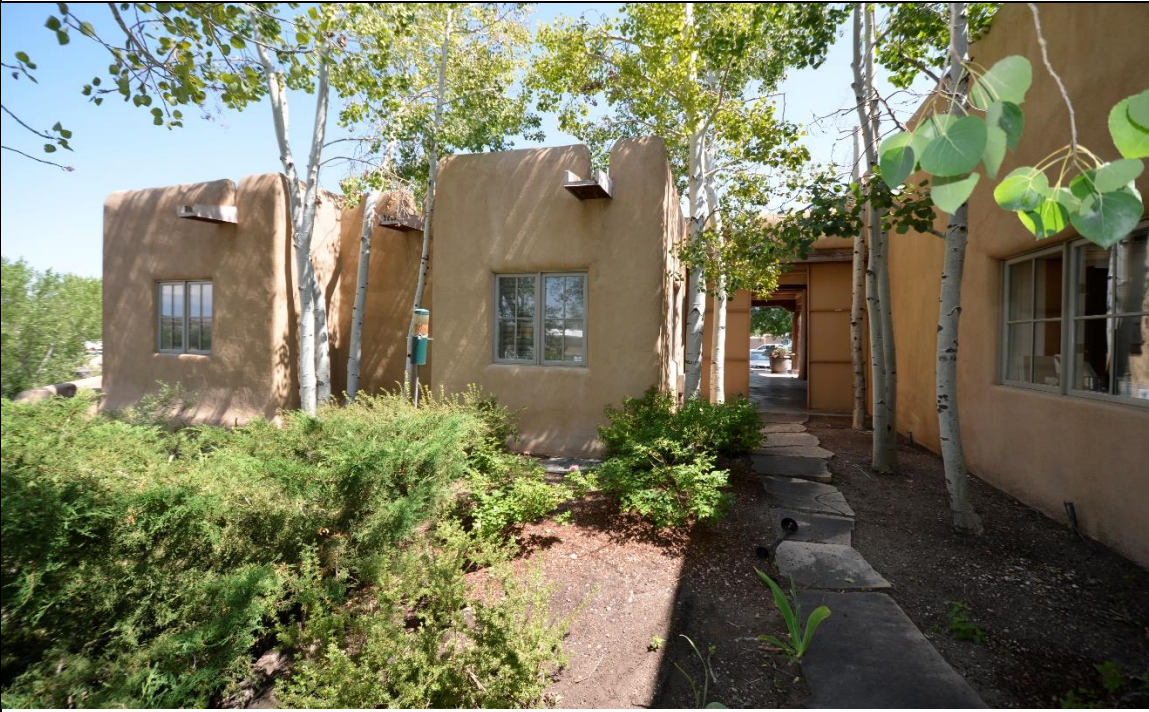
Property overview – South Elevation.

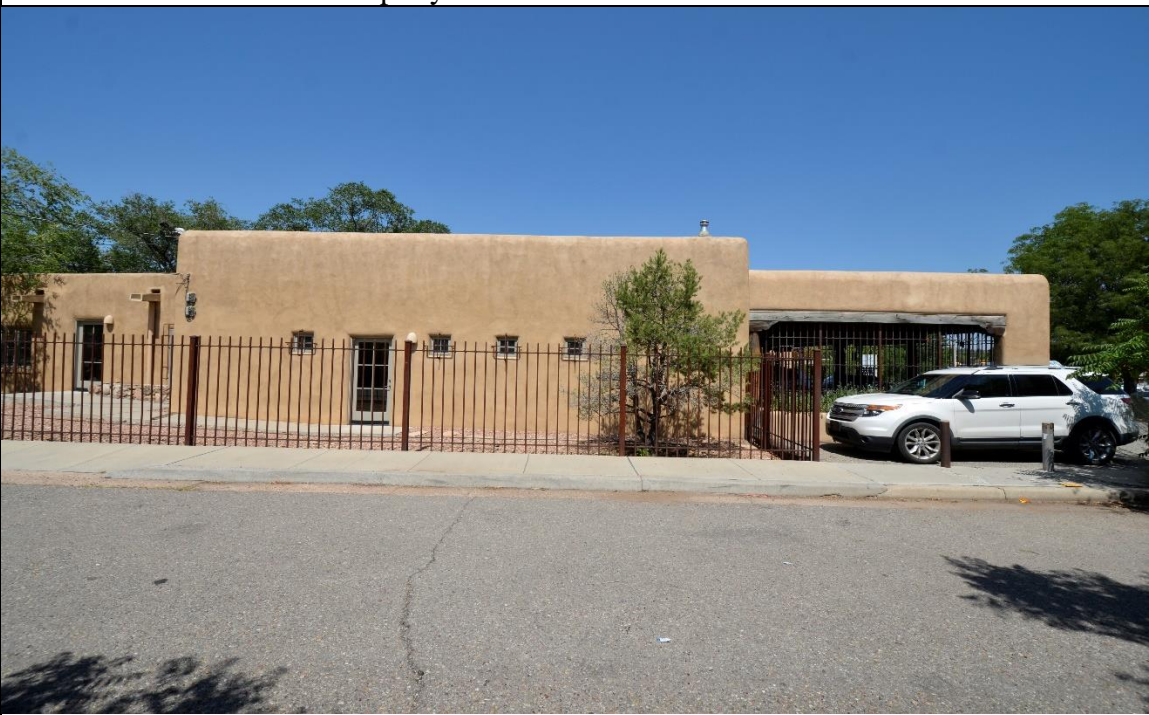
Property overview – West Elevation on Alto Street.

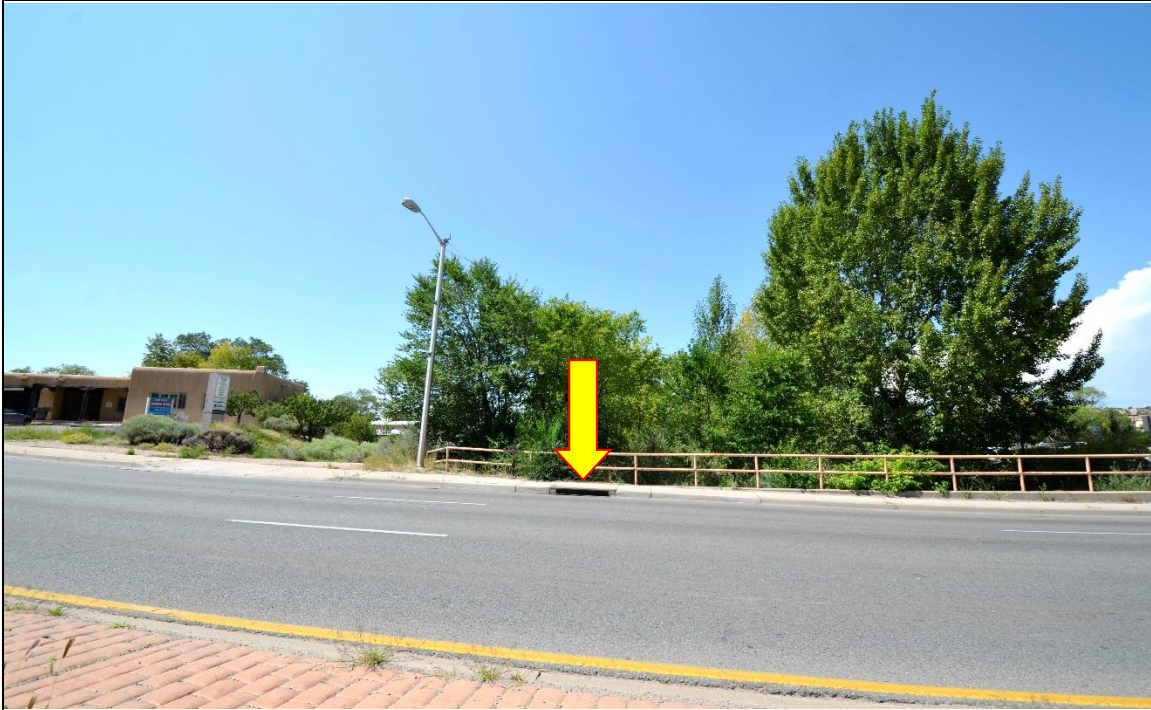
Stormwater drainage to St. Francis Drive culvert.

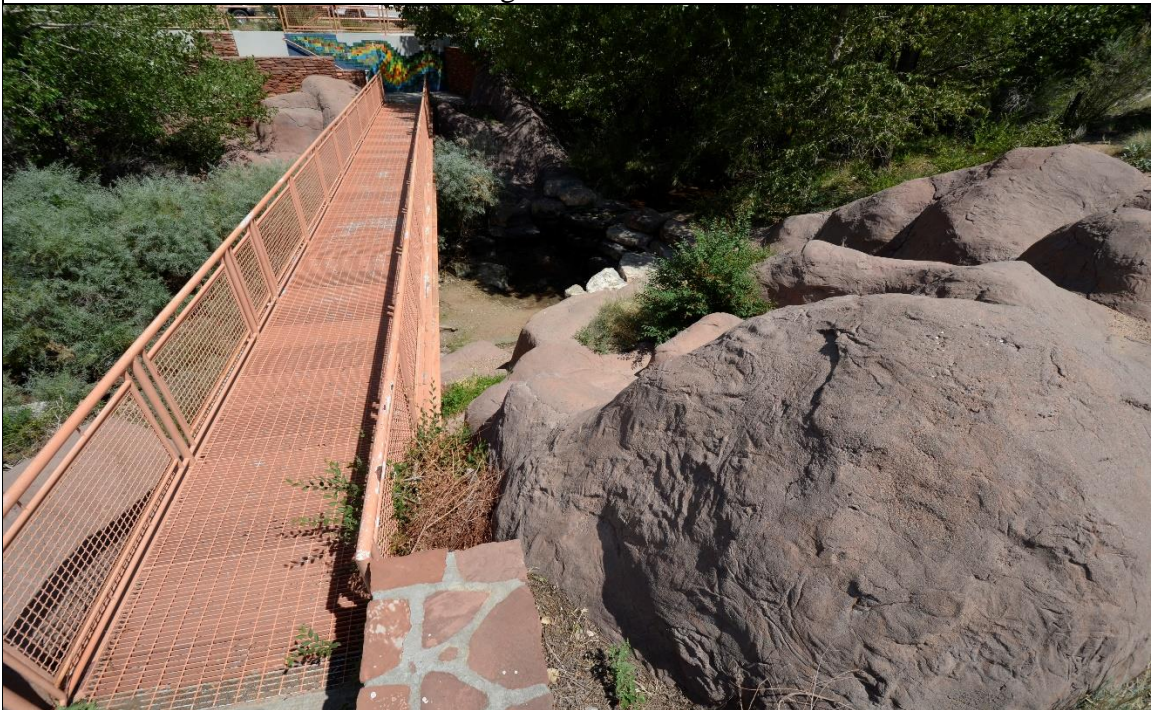
Stormwater drainage to the Santa Fe River basin.

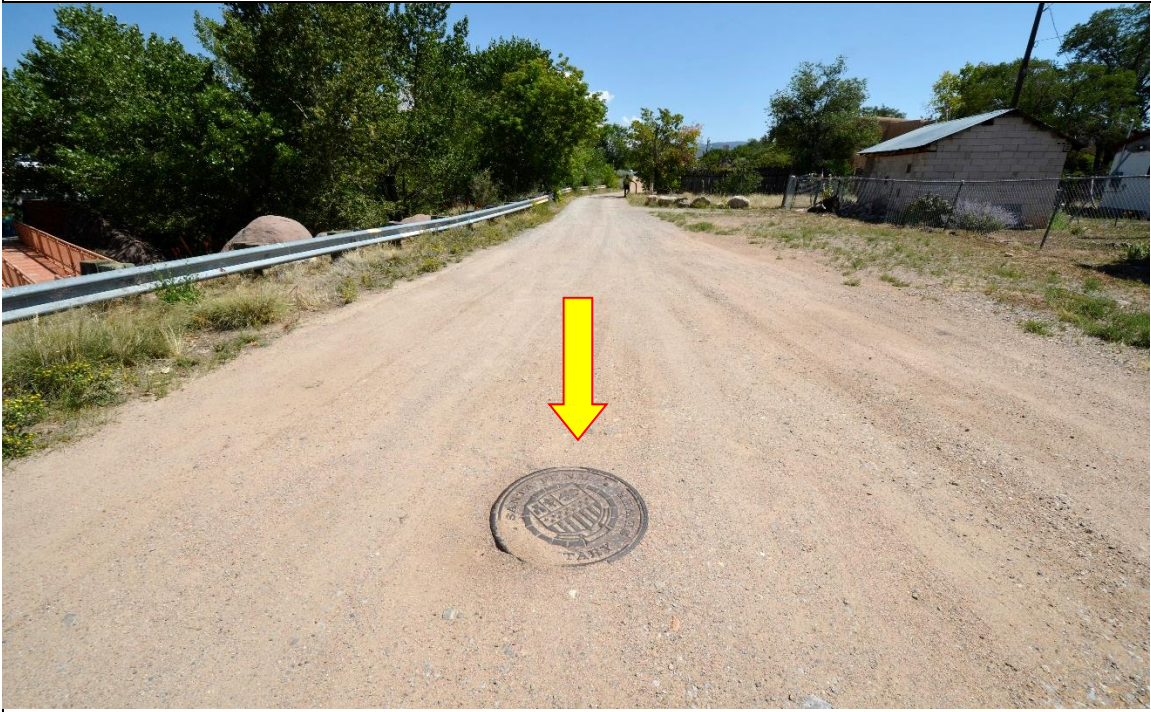
Manhole cover for Santa Fe City Sewer on the Service Road, Northwest of the property.

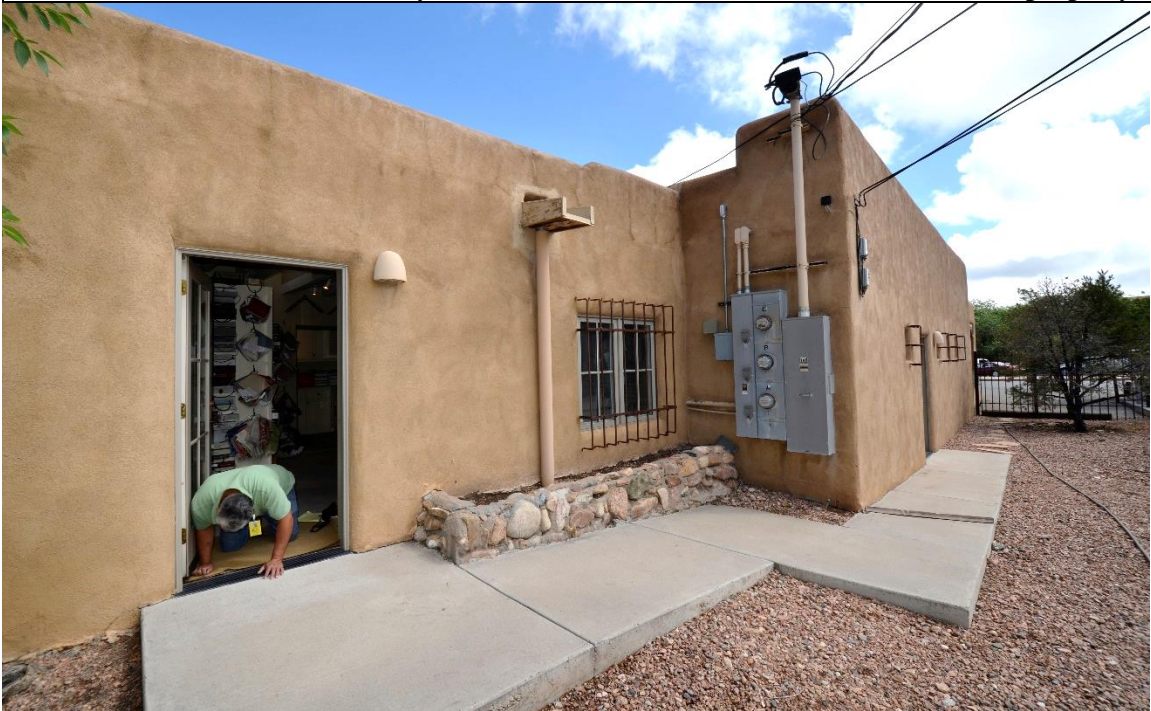
One pole-mounted transformer is present at the main property along Alto Street, while the pole-mounted transformers are located along the northern property boundary. No apparent leaking or staining was noted near or around the transformers.

Electric Service & Pole-mounted transformers Southside of the property.

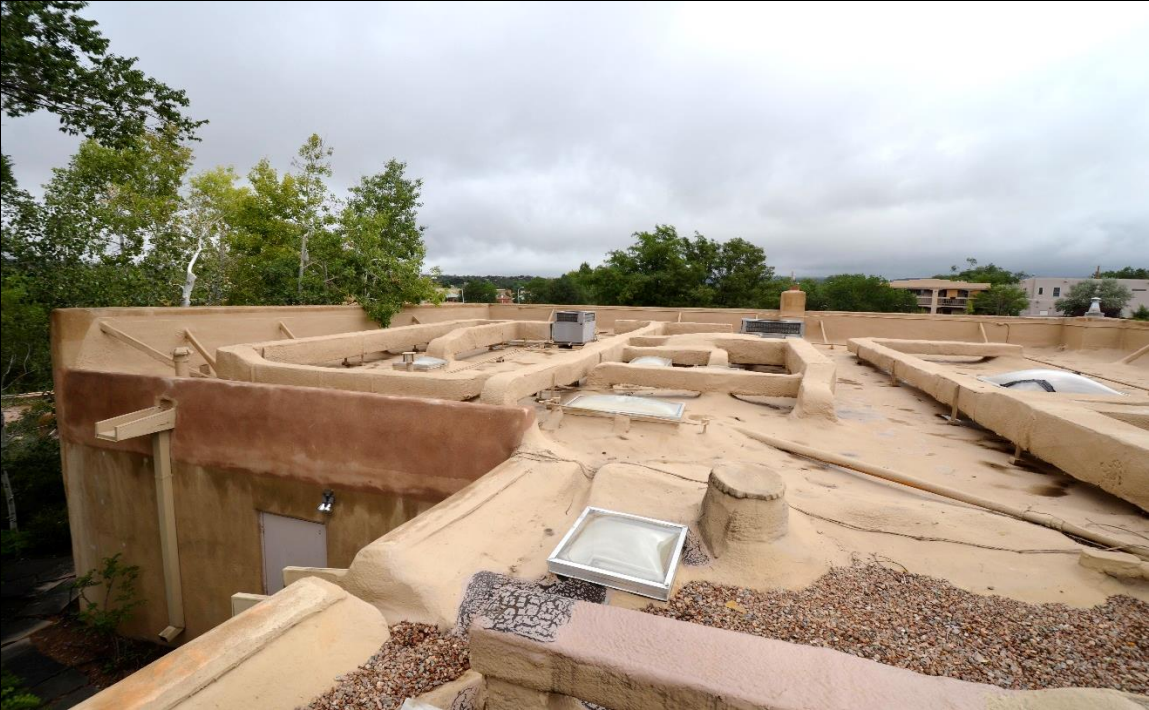
Flat Foam roof section with HVAC units & ducting on South Building.

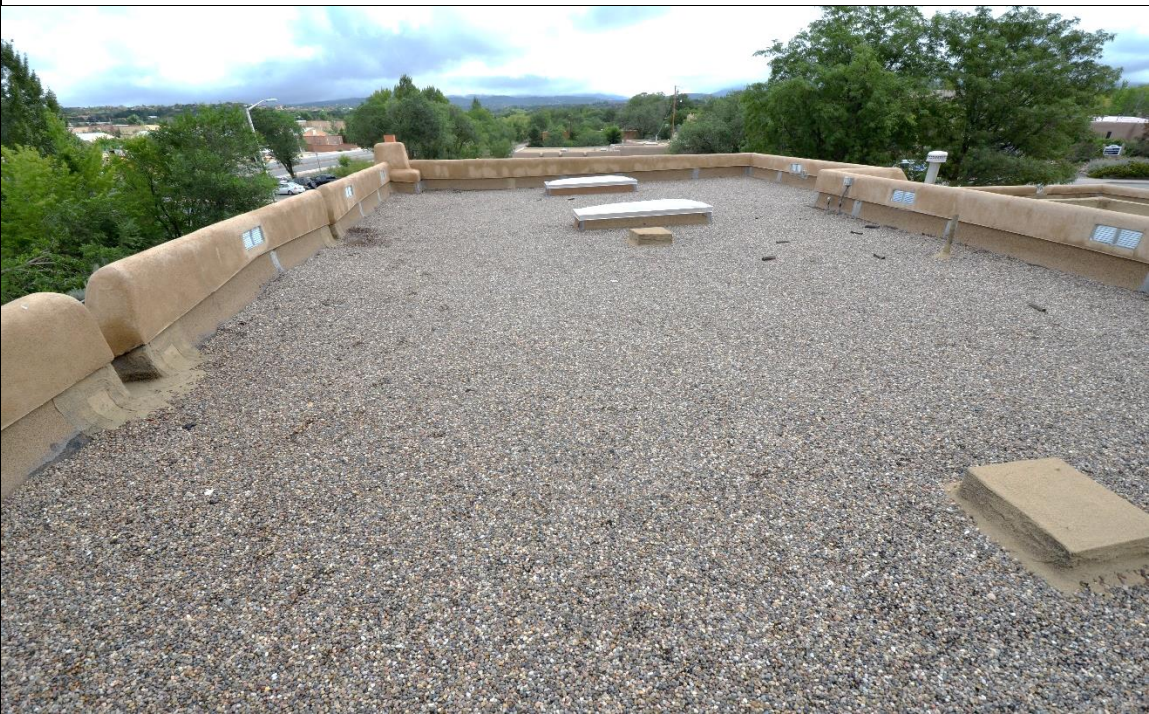
Flat Hot/ Tar & Mastic roof section with parapets on North Building.
